# Hybrid 2l38 Traveler

August 3, 2000

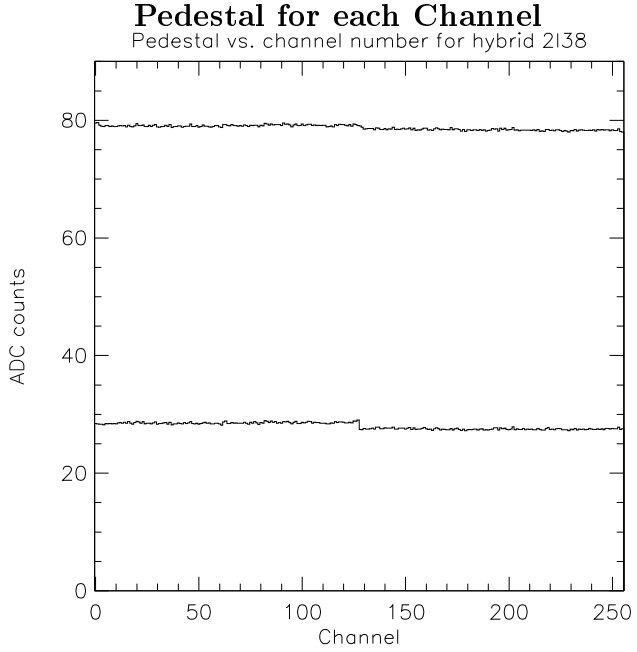
**Pedestal for each Channel**

The following plot shows the pedestals vs. channel number with and without charge injection:

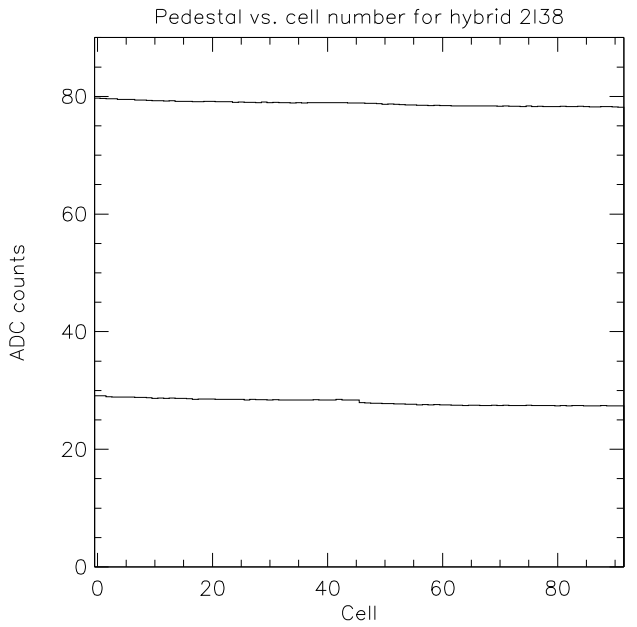
**Pedestal vs. Pipeline Cell ID**

The following plot shows the average pedestal vs. pipeline cell ID with and without charge injection. The x-axis is cell ID offset by 46 for each chip. Thus cell ID 5 for chip 1 is at x=5, chip 2 at x=51, chip 3 at x=97, etc.

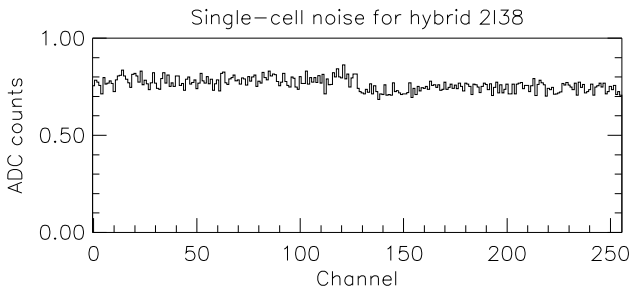
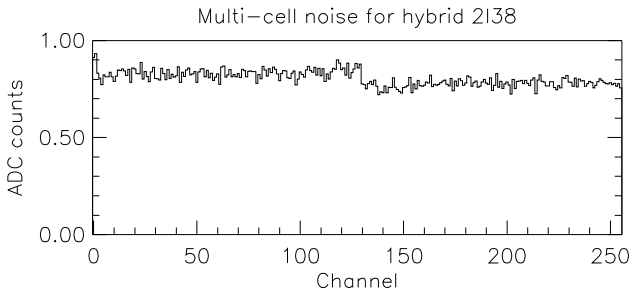
**RMS Noise**

The following plots show the single-cell and multi-cell RMS noise:

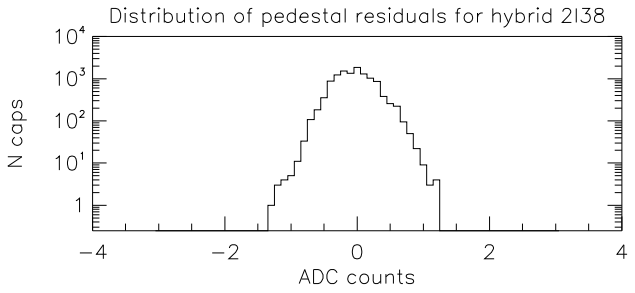
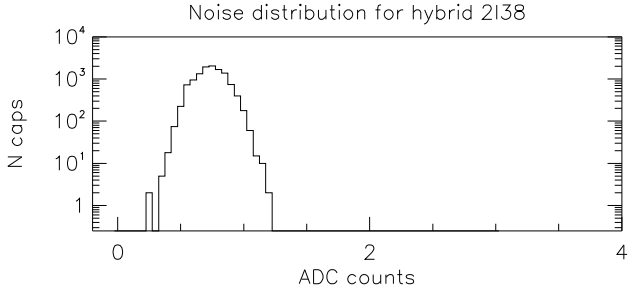
**Distribution of Pedestals and Noise**

The following are histograms of the pedestal of each pipeline capacitor relative to the chip average (top); and the RMS noise of each capacitor (bottom):

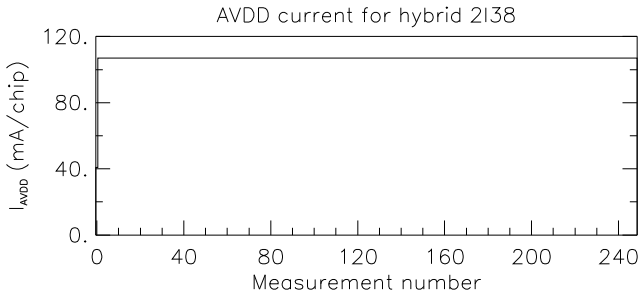
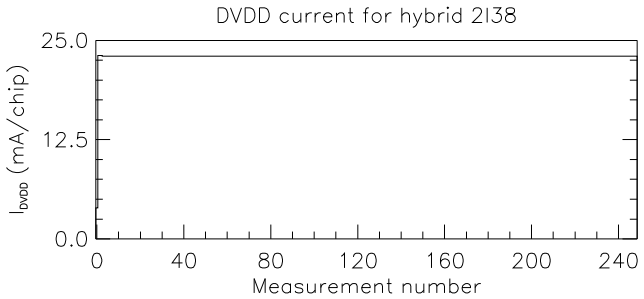
**Supply Currents During Burn-in**

The following plots show the supply currents per chip as a function of measurment number. Currents are measured approximately every 10 minutes:
