Hybrid 2l56 Traveler

August 3, 2000

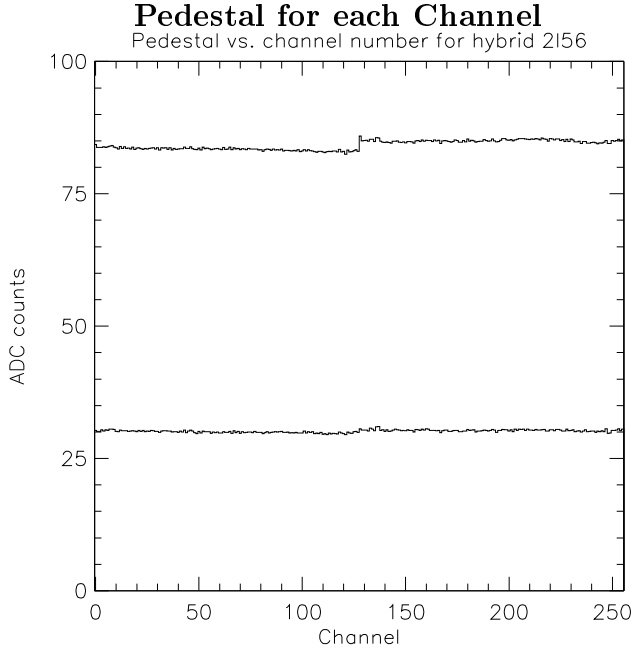
Pedestal for each Channel

The following plot shows the pedestals vs. channel number with and without charge injection:

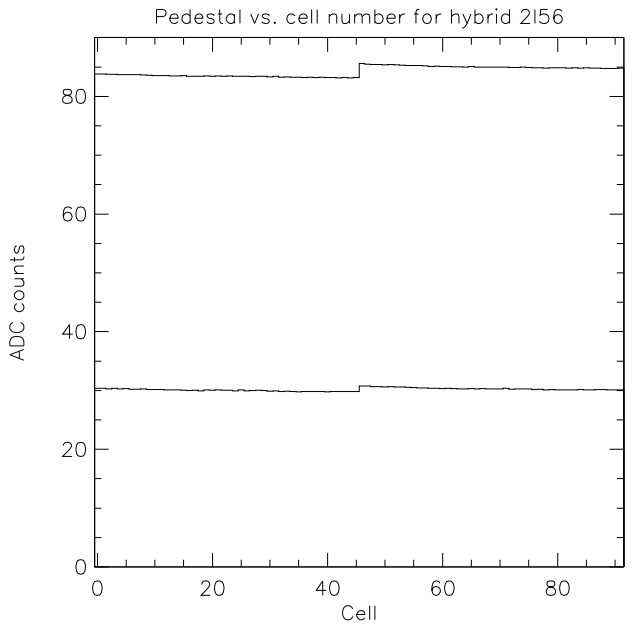
Pedestal vs. Pipeline Cell ID

The following plot shows the average pedestal vs. pipeline cell ID with and without charge injection. The x-axis is cell ID offset by 46 for each chip. Thus cell ID 5 for chip 1 is at x=5, chip 2 at x=51, chip 3 at x=97, etc.

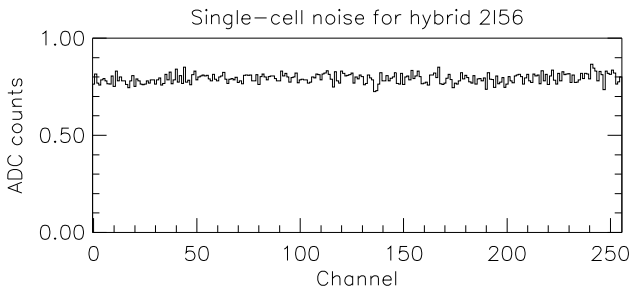
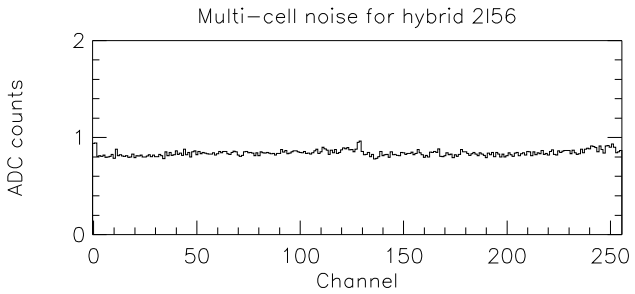
RMS Noise

The following plots show the single-cell and multi-cell RMS noise:

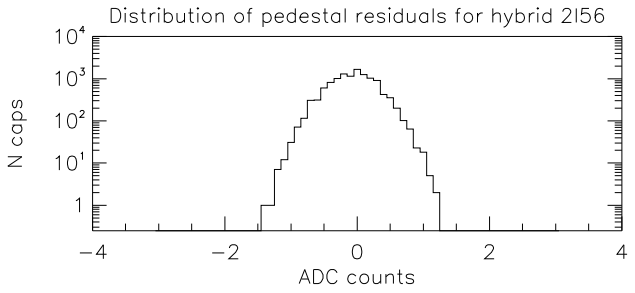
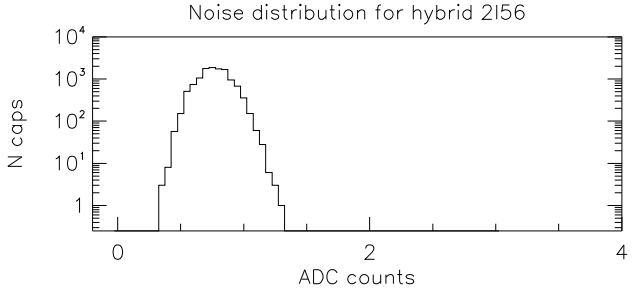
Distribution of Pedestals and Noise

The following are histograms of the pedestal of each pipeline capacitor relative to the chip average (top); and the RMS noise of each capacitor (bottom):

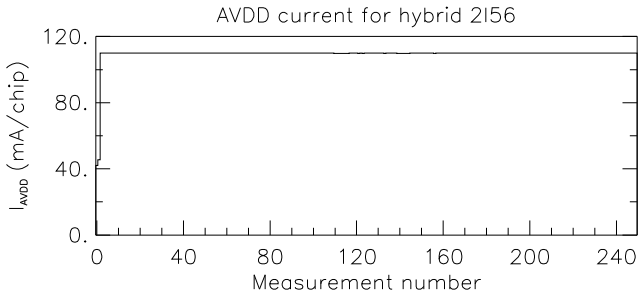
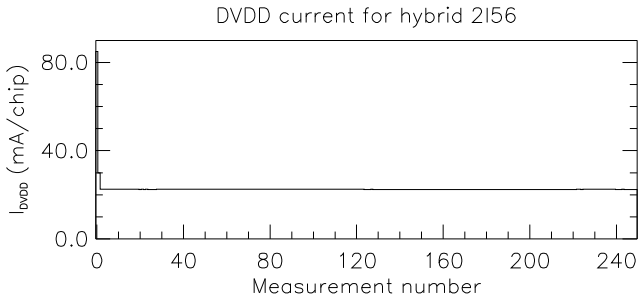
Supply Currents During Burn-in

The following plots show the supply currents per chip as a function of measurment number. Currents are measured approximately every 10 minutes:
