Hybrid 2l58 Traveler

August 10, 2000

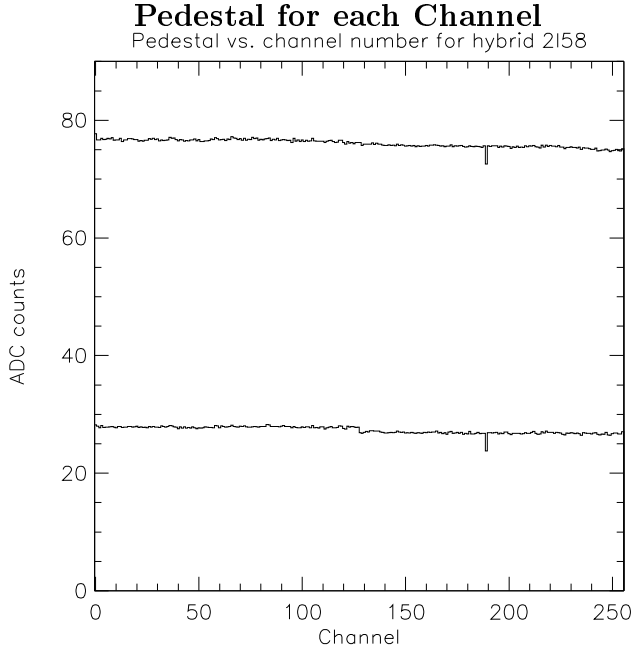
Pedestal for each Channel

Hybrid 2l58 quality: good
Chip classification: good good
Bad channels: none
Bad cells: none
Random bad capacitors: none
Channels at pedestal needed for DCMS: 33.4 33.7
```

The following plot shows the pedestals vs. channel number with and without charge injection:

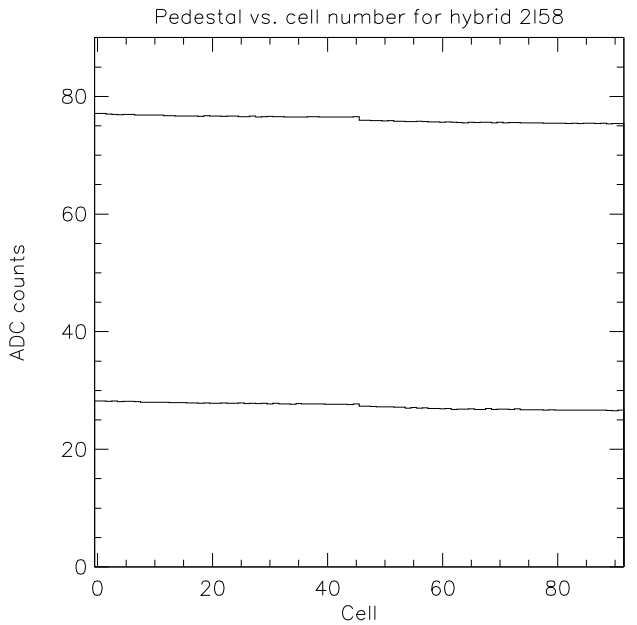
Pedestal vs. Pipeline Cell ID

The following plot shows the average pedestal vs. pipeline cell ID with and without charge injection. The x-axis is cell ID offset by 46 for each chip. Thus cell ID 5 for chip 1 is at x=5, chip 2 at x=51, chip 3 at x=97, etc.

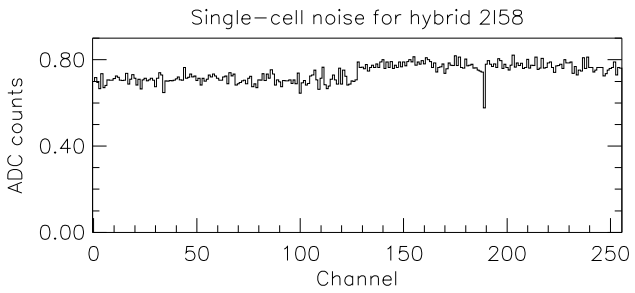
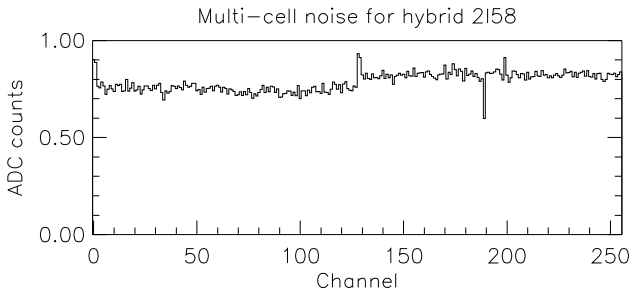
RMS Noise

The following plots show the single-cell and multi-cell RMS noise:

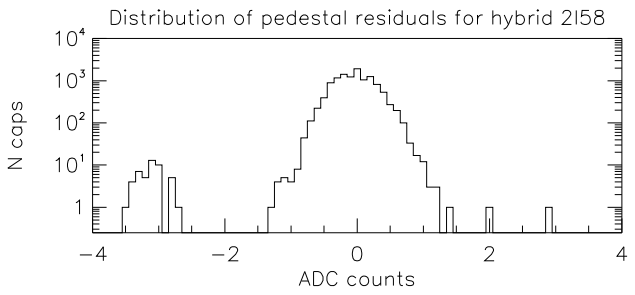
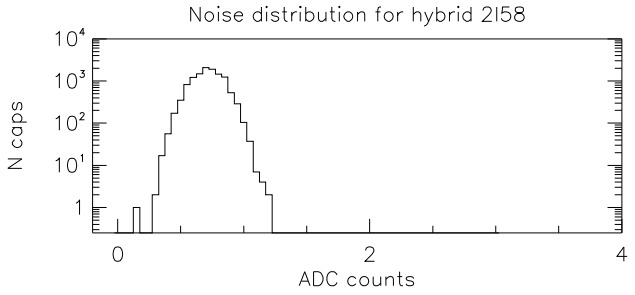
Distribution of Pedestals and Noise

The following are histograms of the pedestal of each pipeline capacitor relative to the chip average (top); and the RMS noise of each capacitor (bottom):

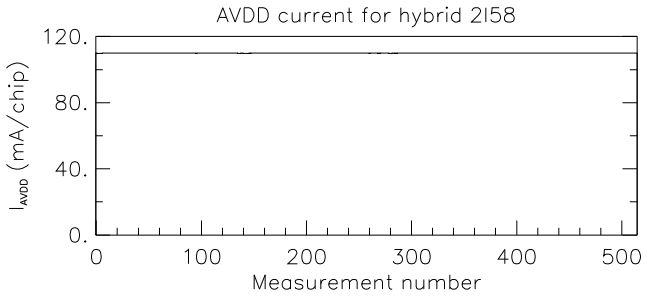
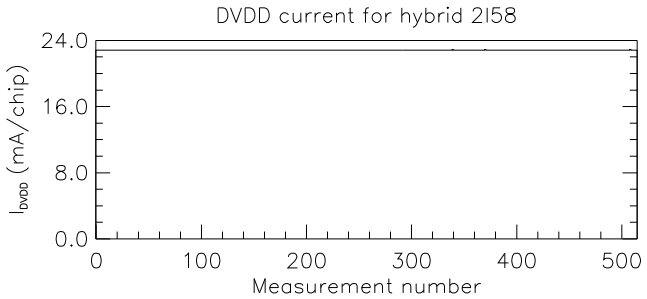
Supply Currents During Burn-in

The following plots show the supply currents per chip as a function of measurment number. Currents are measured approximately every 10 minutes:
