# Hybrid 2l61 Traveler

August 10, 2000

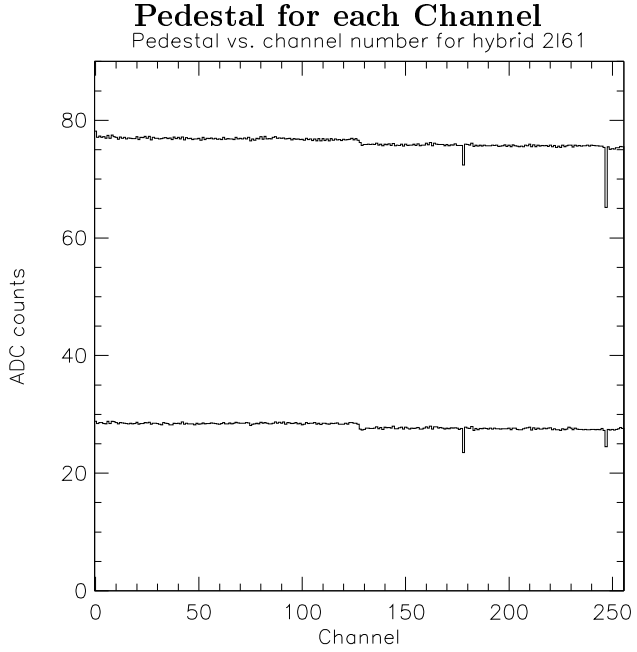
**Pedestal for each Channel**

Hybrid 2l61 quality: fair
Chip classification: good fair
Bad channels (chip-channel): 1-50 1-119
Bad cells: none
Random bad capacitors: none
Channels at pedestal needed for DCMS: 31.8 32.4
```
