# Hybrid 2p111 Traveler

November 15, 1999

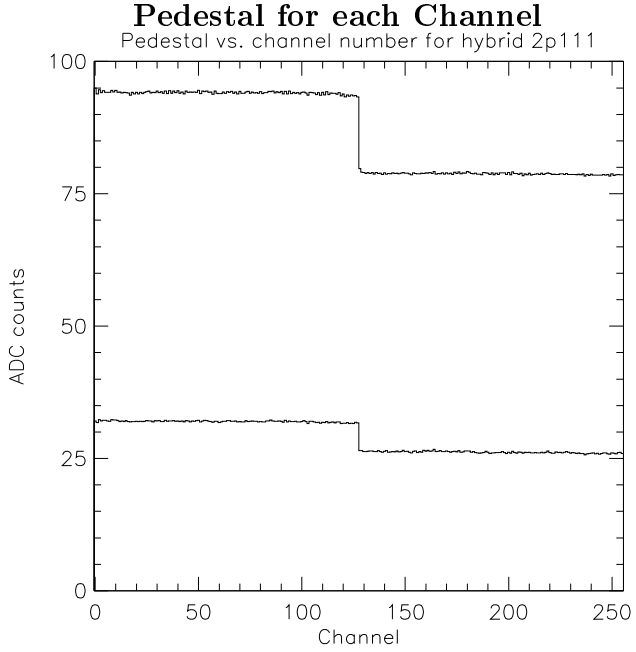
**Pedestal for each Channel**

The following plot shows the pedestals vs. channel number with and without charge injection:

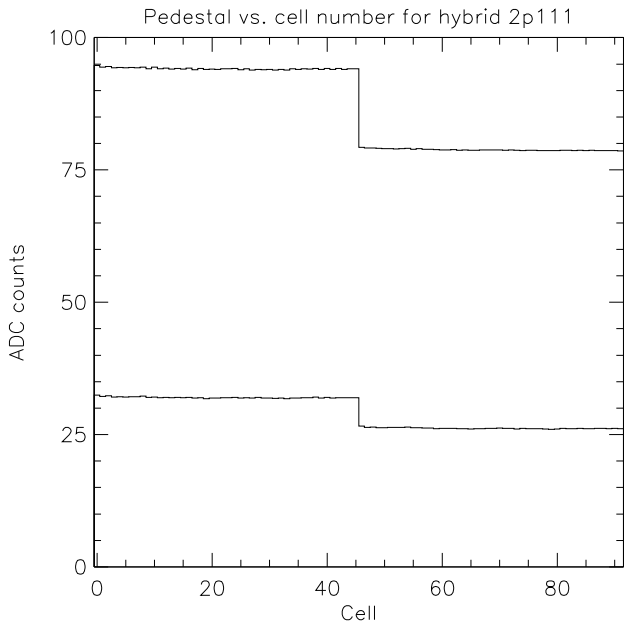
**Pedestal vs. Pipeline Cell ID**

The following plot shows the average pedestal vs. pipeline cell ID with and without charge injection. The x-axis is cell ID offset by 46 for each chip. Thus cell ID 5 for chip 1 is at x=5, chip 2 at x=51, chip 3 at x=97, etc.

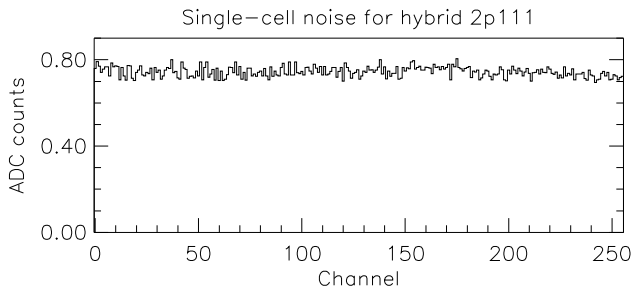
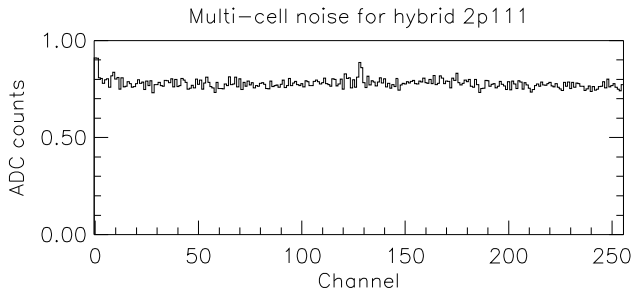
**RMS Noise**

The following plots show the single-cell and multi-cell RMS noise:

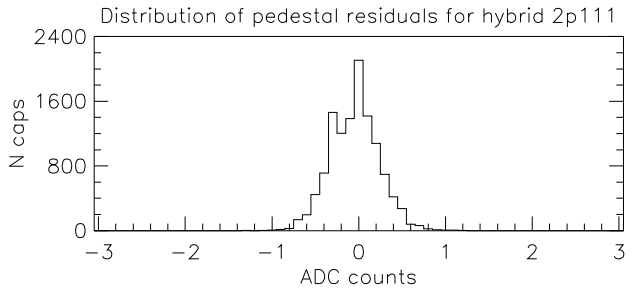
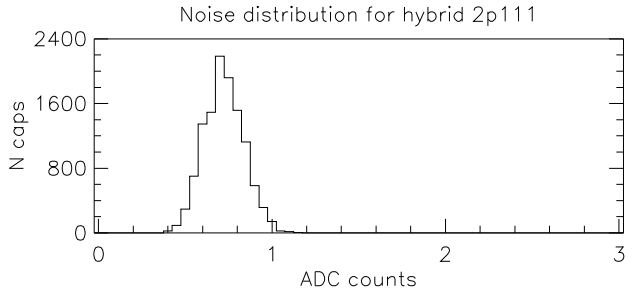
**Distribution of Pedestals and Noise**

The following are histograms of the pedestal of each pipeline capacitor relative to the chip average (top); and the RMS noise of each capacitor (bottom):

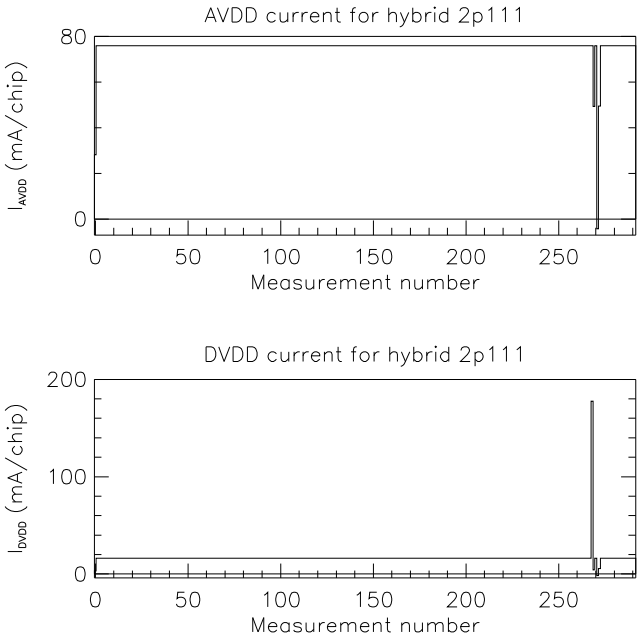
**Supply Currents During Burn-in**

The following plots show the supply currents per chip as a function of measurment number. Currents are measured approximately every 10 minutes:
