Hybrid 2p124 Traveler

October 4, 1999

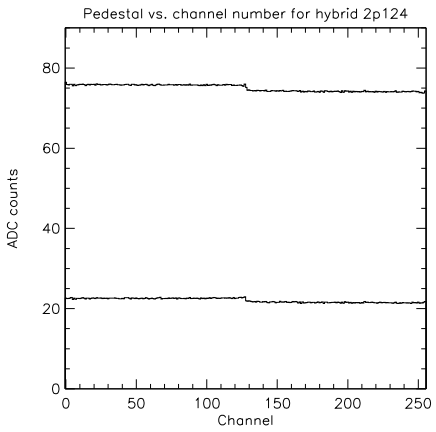
Pedestal for each Channel

The following plot shows the pedestals vs. channel number with and without charge injection:

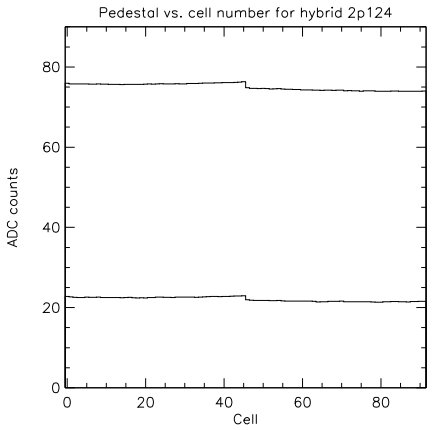
Pedestal vs. Pipeline Cell ID

The following plot shows the average pedestal vs. pipeline cell ID with and without charge injection. The x-axis is cell ID offset by 46 for each chip. Thus cell ID 5 on chip 1 is at x=5, chip 2 at x=49, chip 3 at x=97, etc.

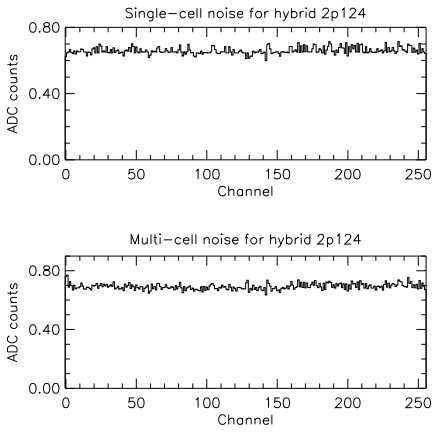
RMS Noise

The following plots show the single-cell and multi-cell RMS noise:

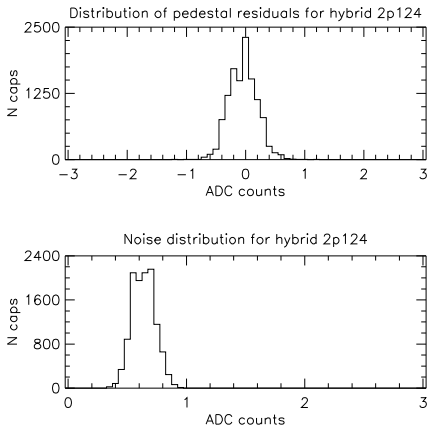
Distribution of pedestals and noise

The upper plot shows the difference between the pedestal of each channel and the average pedestal and the lower plots shows the RMS noise of all the channels:

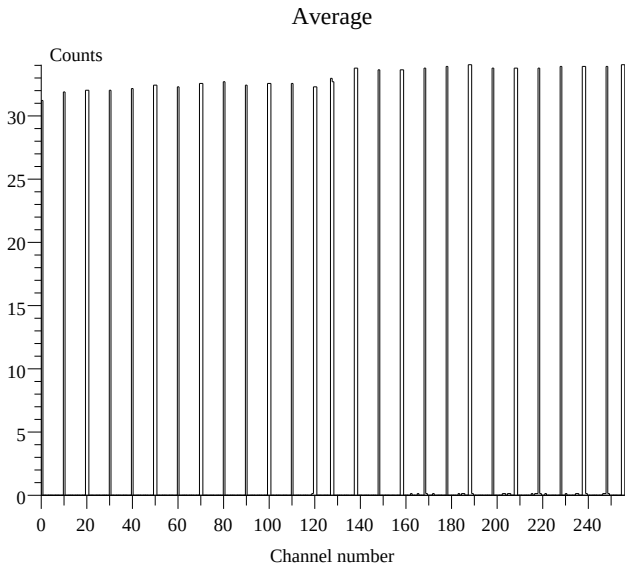
Dynamic Threshold Subtraction

The following plot shows the readout of channels with charge injection with the dynamic threshold subtraction turned on:
