Hybrid 2z108 Traveler

October 11, 1999

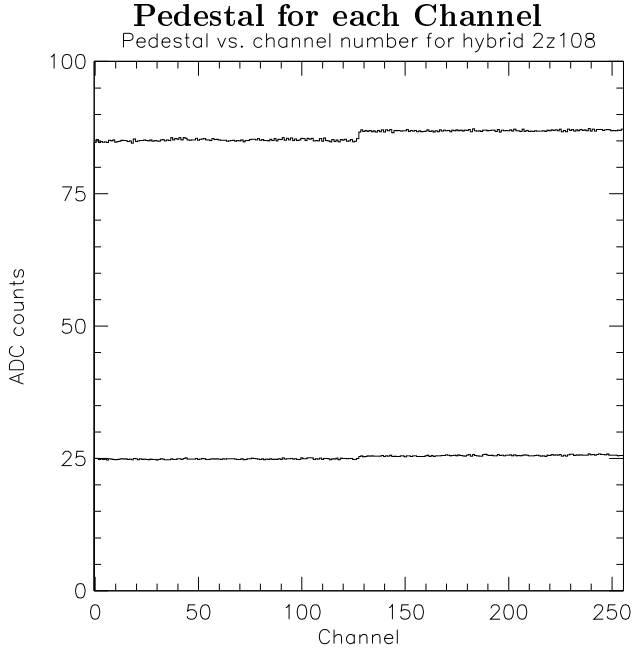
Pedestal for each Channel

The following plot shows the pedestals vs. channel number with and without charge injection:

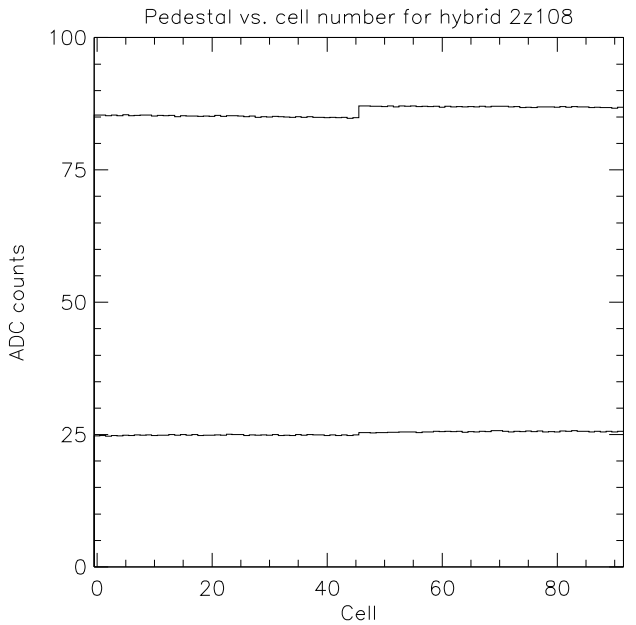
Pedestal vs. Pipeline Cell ID

The following plot shows the average pedestal vs. pipeline cell ID with and without charge injection. The x-axis is cell ID offset by 46 for each chip. Thus cell ID 5 for chip 1 is at x=5, chip 2 at x=51, chip 3 at x=97, etc.

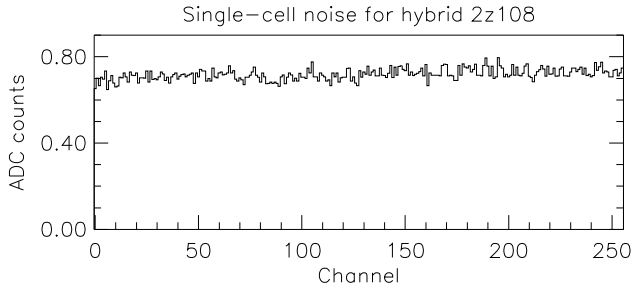
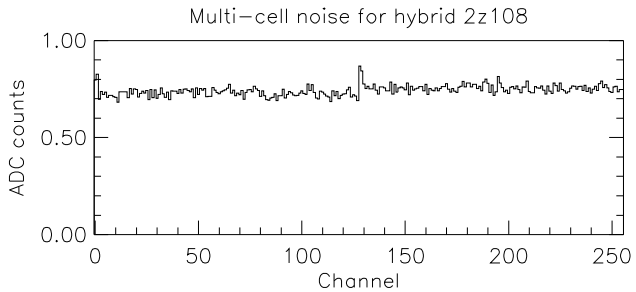
RMS Noise

The following plots show the single-cell and multi-cell RMS noise:

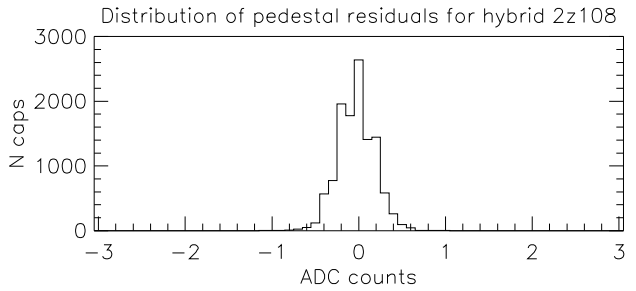
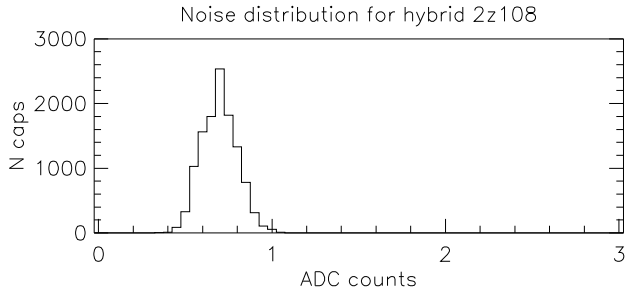
Distribution of Pedestals and Noise

The following are histograms of the pedestal of each pipeline capacitor relative to the chip average (top); and the RMS noise of each capacitor (bottom):

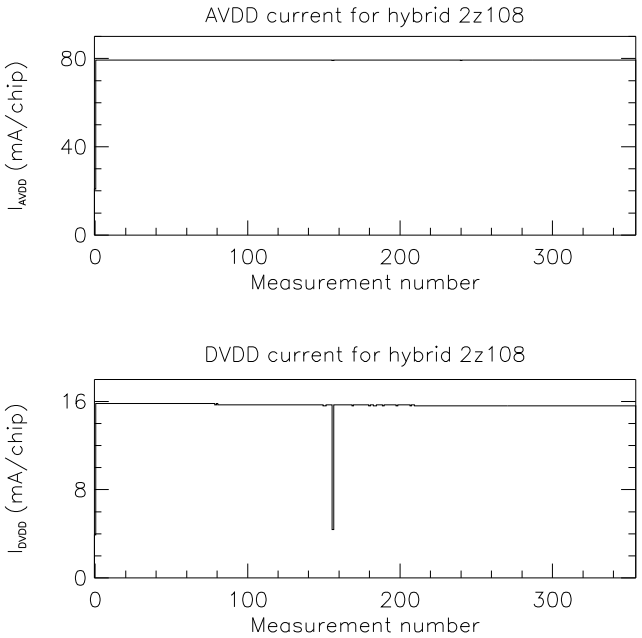
Supply Currents During Burn-in

The following plots show the supply currents per chip as a function of measurment number. Currents are measured approximately every 10 minutes:
