# Hybrid 2z116 Traveler

December 10, 1999

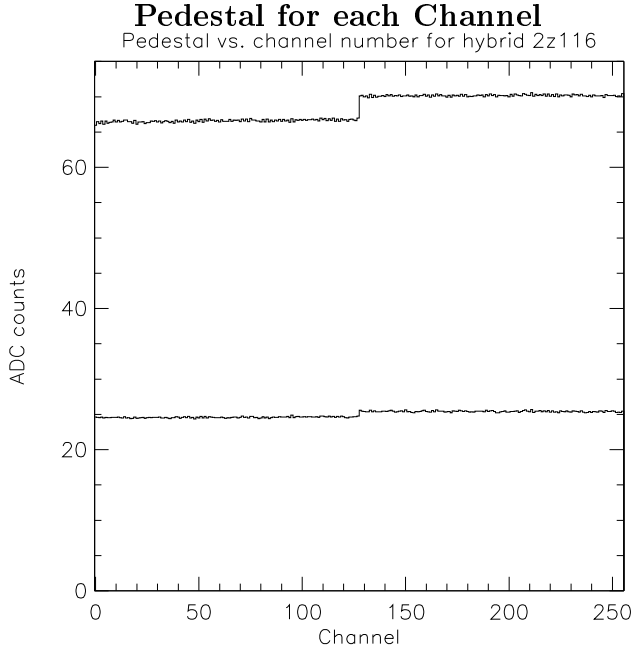
**Pedestal for each Channel**

The following plot shows the pedestals vs. channel number with and without charge injection:

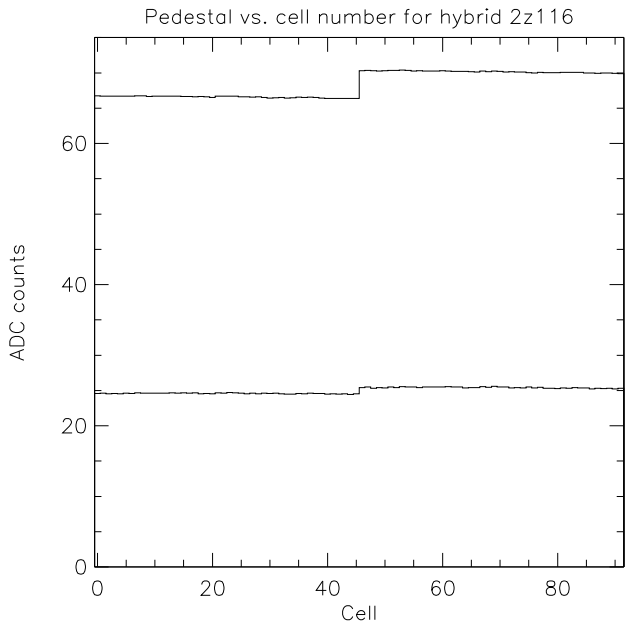
**Pedestal vs. Pipeline Cell ID**

The following plot shows the average pedestal vs. pipeline cell ID with and without charge injection. The x-axis is cell ID offset by 46 for each chip. Thus cell ID 5 for chip 1 is at x=5, chip 2 at x=51, chip 3 at x=97, etc.

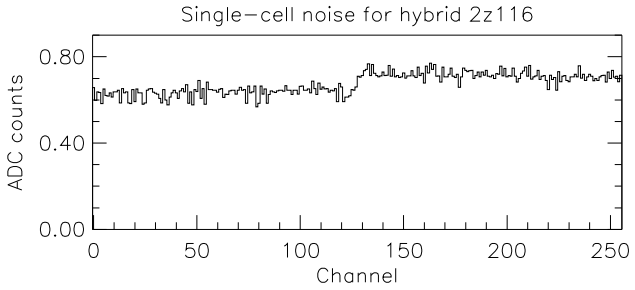
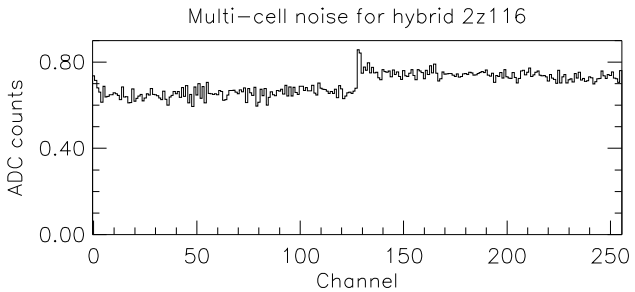
**RMS Noise**

The following plots show the single-cell and multi-cell RMS noise:

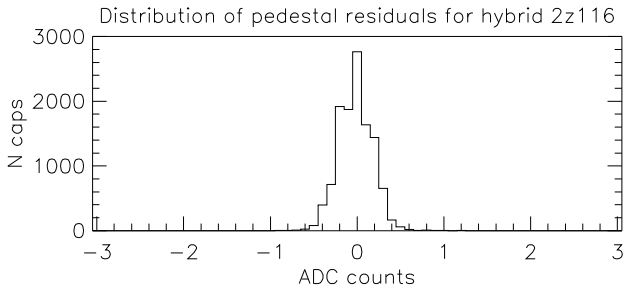
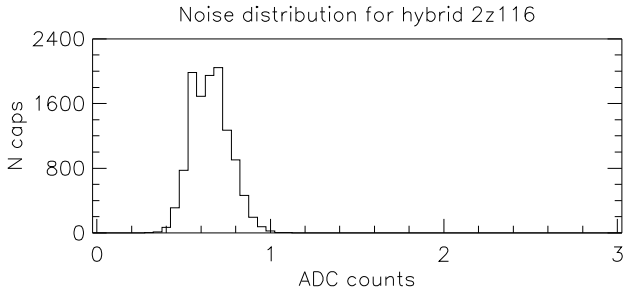
**Distribution of Pedestals and Noise**

The following are histograms of the pedestal of each pipeline capacitor relative to the chip average (top); and the RMS noise of each capacitor (bottom):

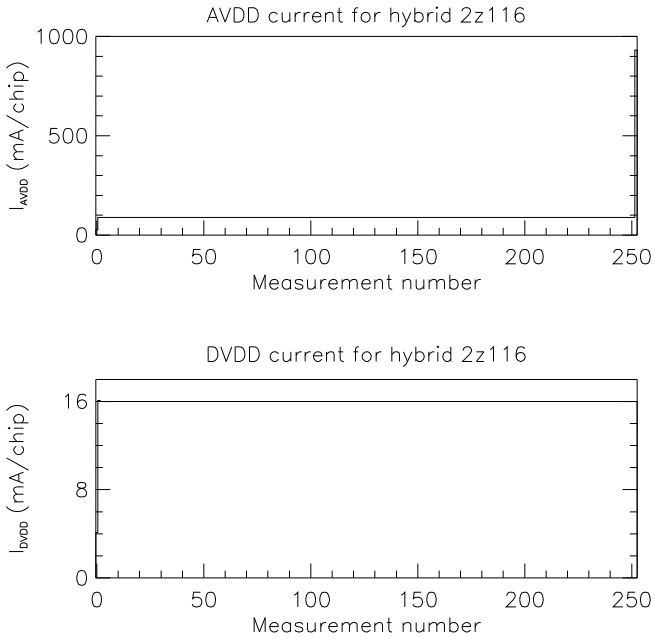
**Supply Currents During Burn-in**

The following plots show the supply currents per chip as a function of measurment number. Currents are measured approximately every 10 minutes:
