Hybrid 2z134 Traveler

November 18, 1999

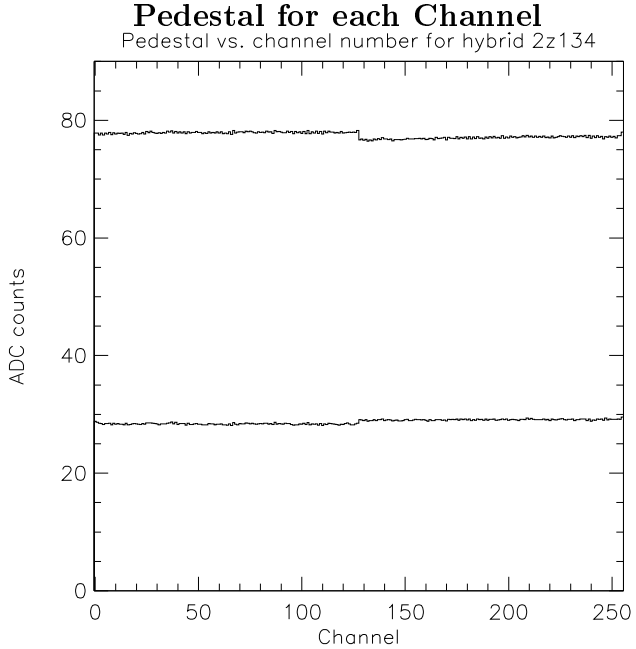
Pedestal for each Channel

The following plot shows the pedestals vs. channel number with and without charge injection:

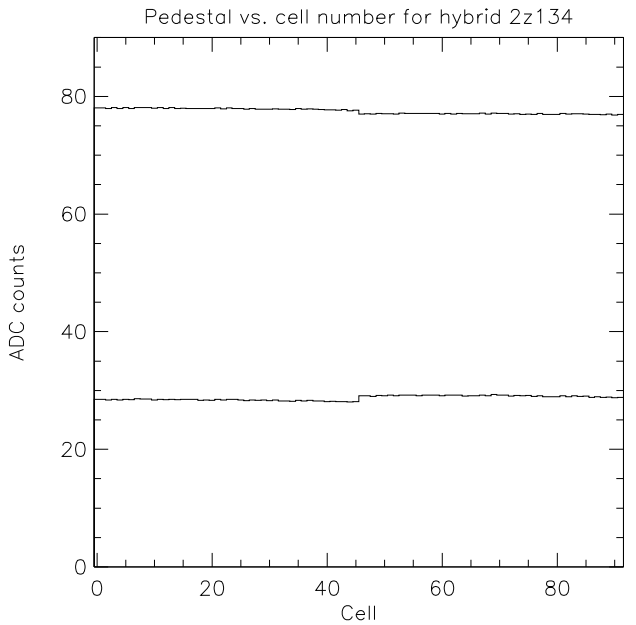
Pedestal vs. Pipeline Cell ID

The following plot shows the average pedestal vs. pipeline cell ID with and without charge injection. The x-axis is cell ID offset by 46 for each chip. Thus cell ID 5 for chip 1 is at x=5, chip 2 at x=51, chip 3 at x=97, etc.

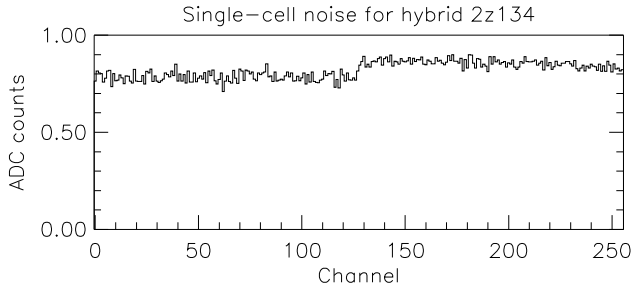
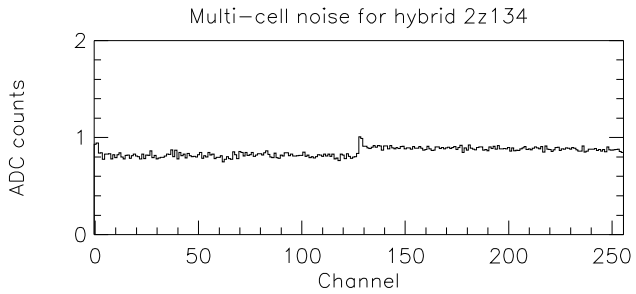
RMS Noise

The following plots show the single-cell and multi-cell RMS noise:

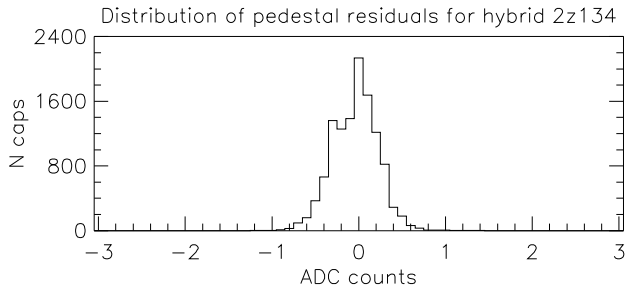
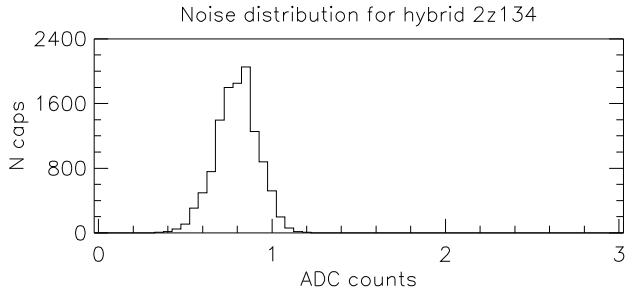
Distribution of Pedestals and Noise

The following are histograms of the pedestal of each pipeline capacitor relative to the chip average (top); and the RMS noise of each capacitor (bottom):

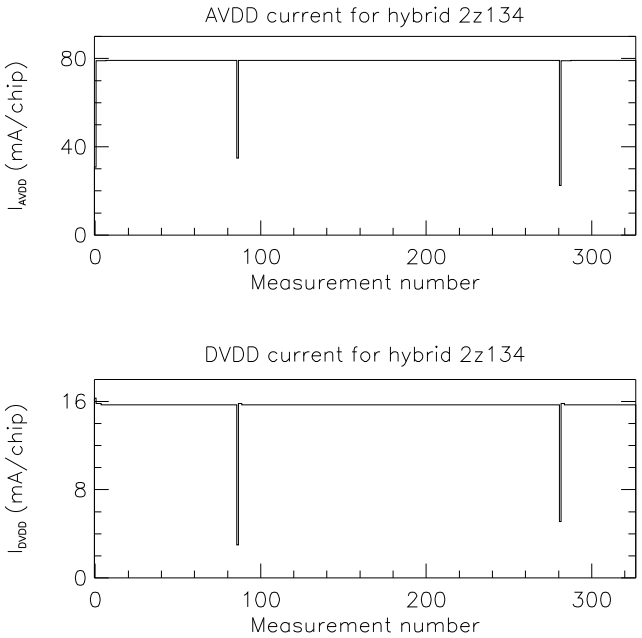
Supply Currents During Burn-in

The following plots show the supply currents per chip as a function of measurment number. Currents are measured approximately every 10 minutes:
