Hybrid 2z135 Traveler

December 3, 1999

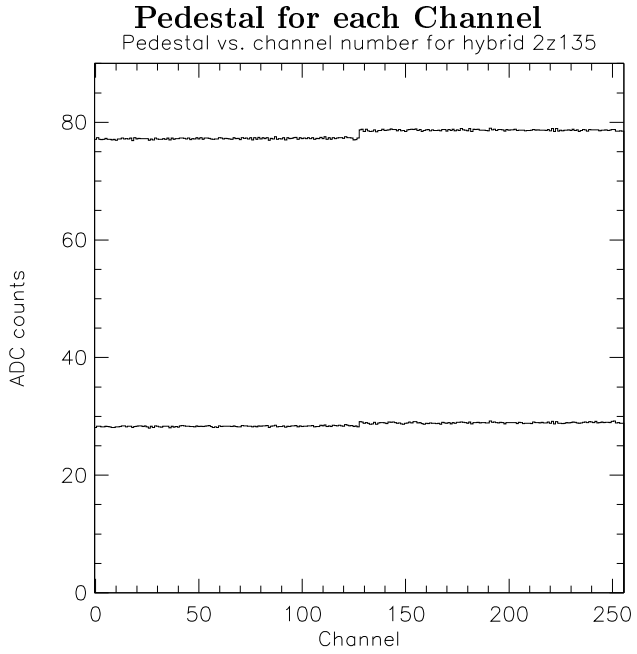
The following plot shows the pedestals vs. channel number with and without charge injection:

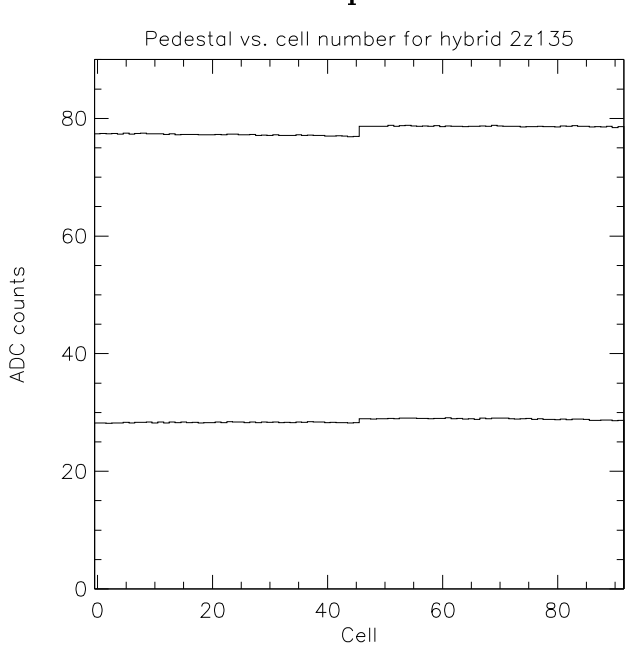
The following plot shows the average pedestal vs. pipeline cell ID with and without charge injection. The x-axis is cell ID offset by 46 for each chip. Thus cell ID 5 for chip 1 is at x=5, chip 2 at x=51, chip 3 at x=97, etc.

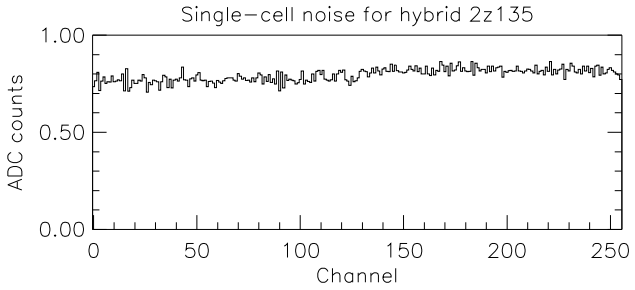
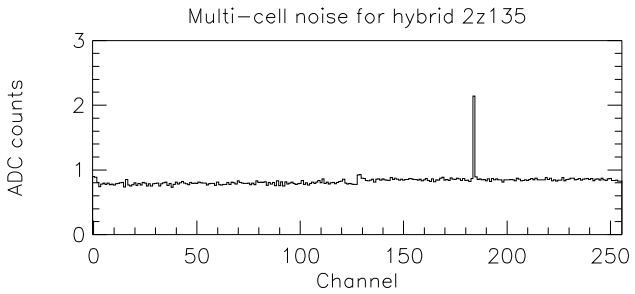
RMS Noise

The following plots show the single-cell and multi-cell RMS noise:

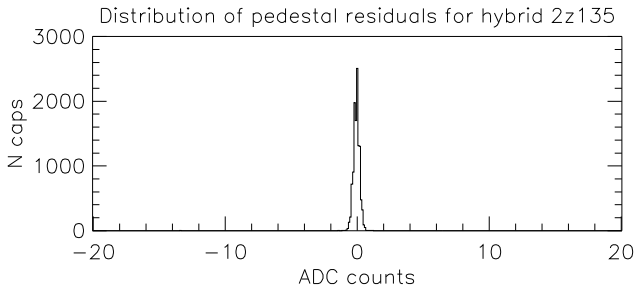
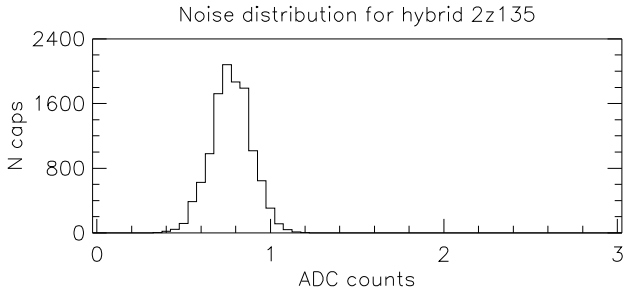
Distribution of Pedestals and Noise

The following are histograms of the pedestal of each pipeline capacitor relative to the chip average (top); and the RMS noise of each capacitor (bottom):

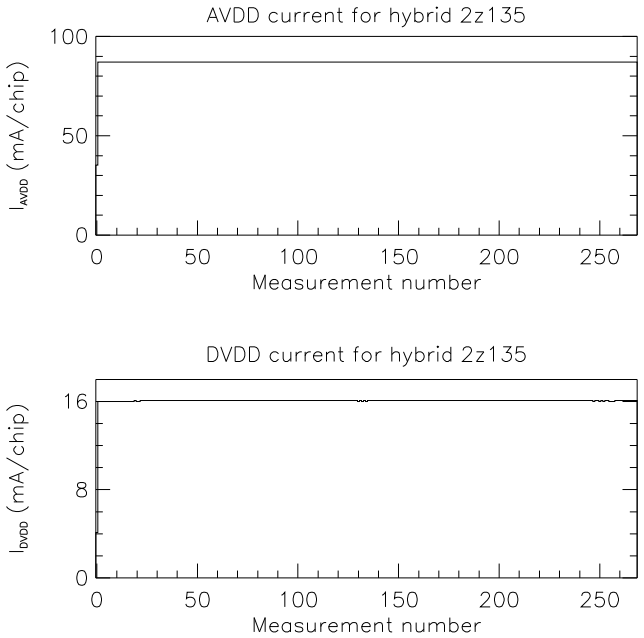
Supply Currents During Burn-in

The following plots show the supply currents per chip as a function of measurment number. Currents are measured approximately every 10 minutes:
