Hybrid 2z223 Traveler

March 14, 2000

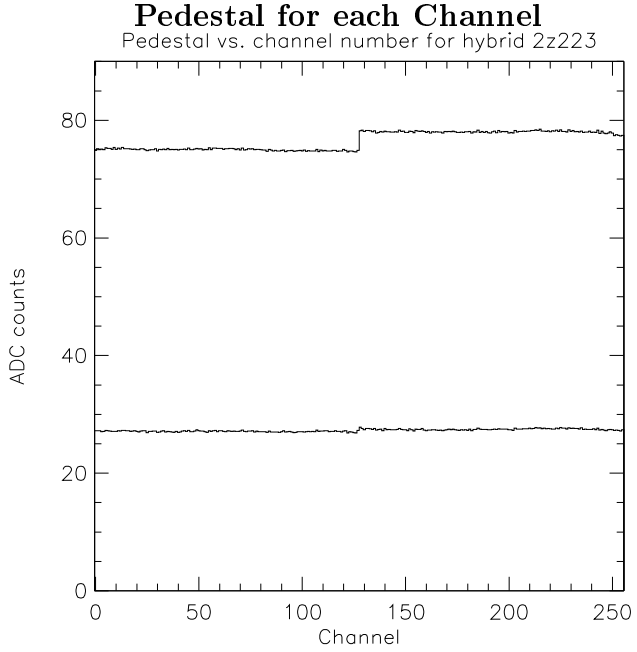
Pedestal for each Channel

The following plot shows the pedestals vs. channel number with and without charge injection:

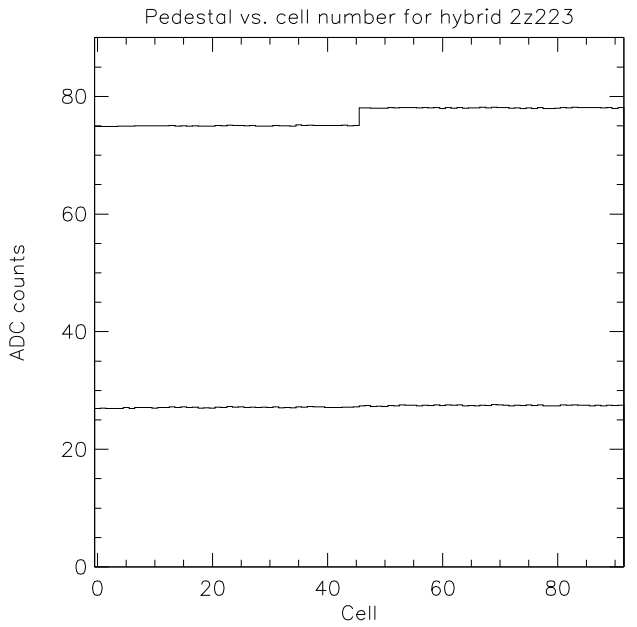
Pedestal vs. Pipeline Cell ID

The following plot shows the average pedestal vs. pipeline cell ID with and without charge injection. The x-axis is cell ID offset by 46 for each chip. Thus cell ID 5 for chip 1 is at x=5, chip 2 at x=51, chip 3 at x=97, etc.

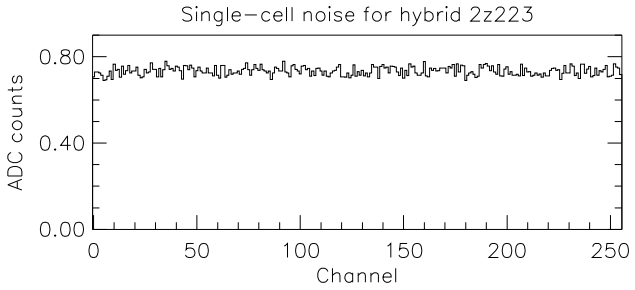
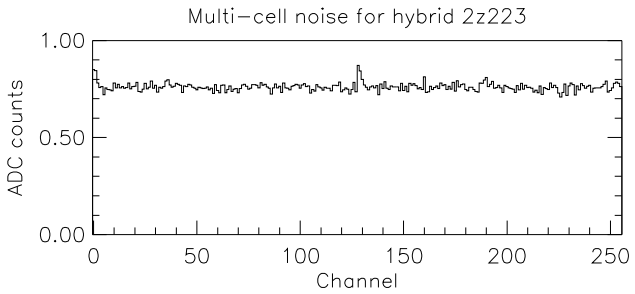
RMS Noise

The following plots show the single-cell and multi-cell RMS noise:

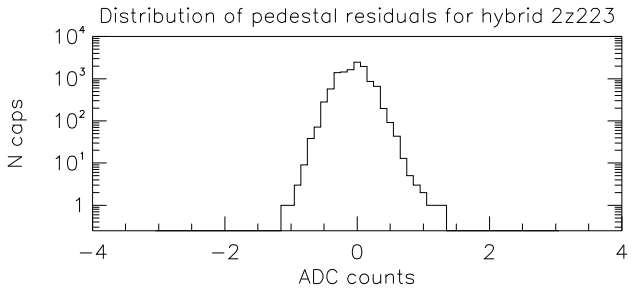
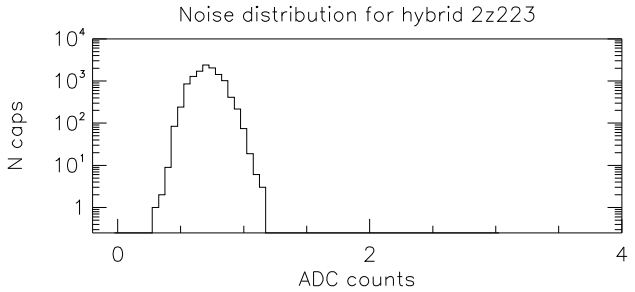
Distribution of Pedestals and Noise

The following are histograms of the pedestal of each pipeline capacitor relative to the chip average (top); and the RMS noise of each capacitor (bottom):

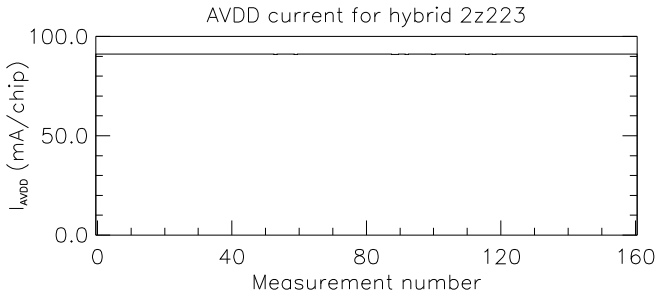
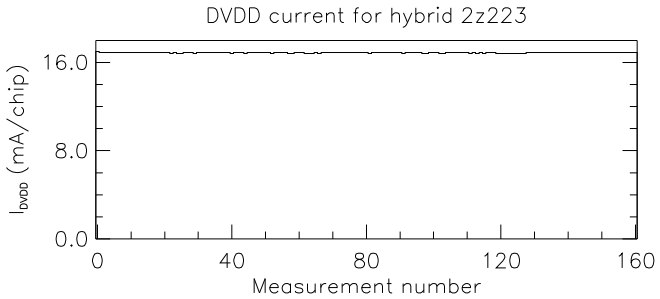
Supply Currents During Burn-in

The following plots show the supply currents per chip as a function of measurment number. Currents are measured approximately every 10 minutes:
