Hybrid 2z27 Traveler

October 11, 1999

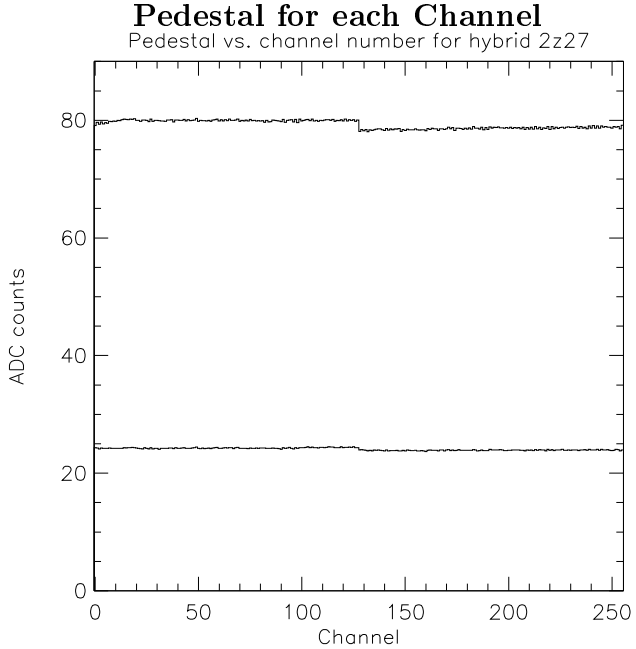
Pedestal for each Channel

The following plot shows the pedestals vs. channel number with and without charge injection:

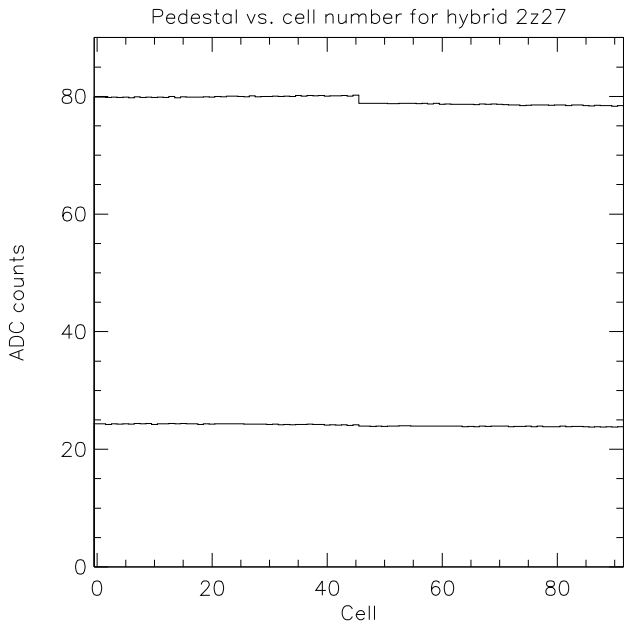
Pedestal vs. Pipeline Cell ID

The following plot shows the average pedestal vs. pipeline cell ID with and without charge injection. The x-axis is cell ID offset by 46 for each chip. Thus cell ID 5 for chip 1 is at x=5, chip 2 at x=51, chip 3 at x=97, etc.

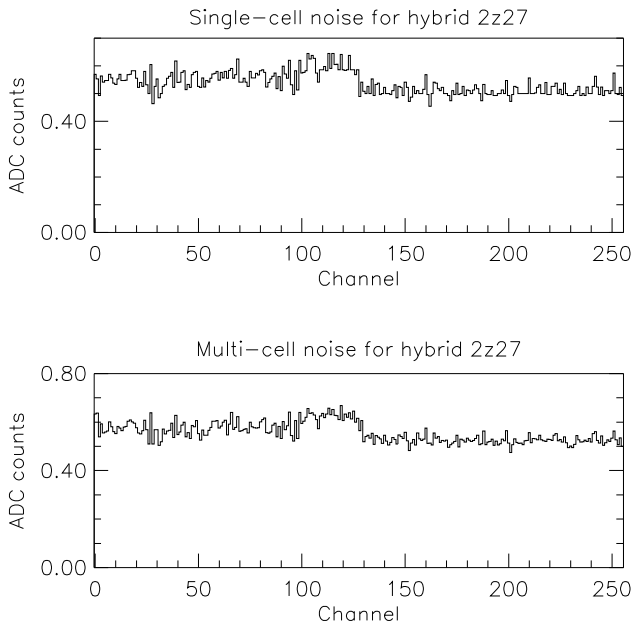
RMS Noise

The following plots show the single-cell and multi-cell RMS noise:

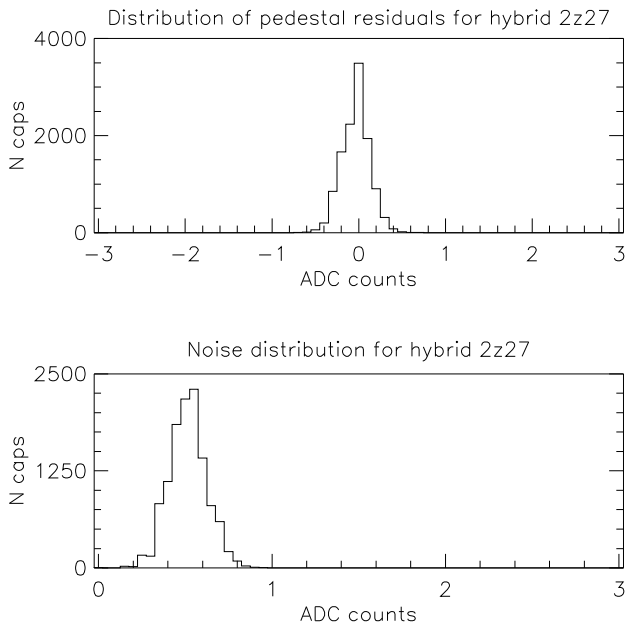
Distribution of Pedestals and Noise

The following are histograms of the pedestal of each pipeline capacitor relative to the chip average (top); and the RMS noise of each capacitor (bottom):

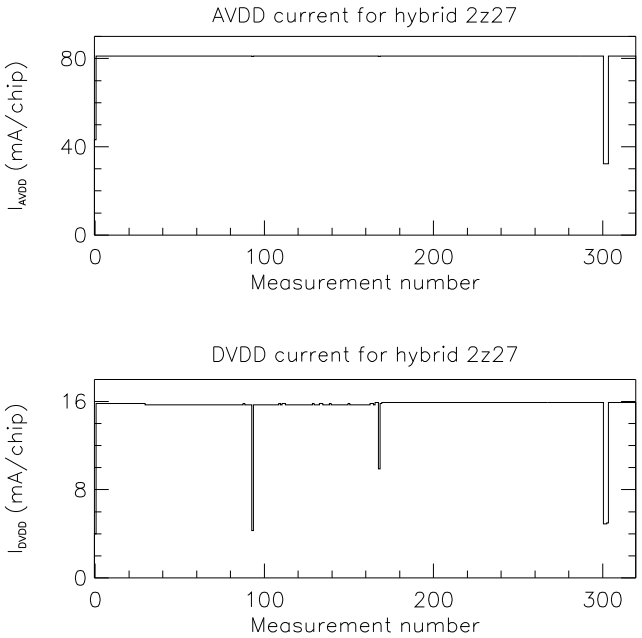
Supply Currents During Burn-in

The following plots show the supply currents per chip as a function of measurment number. Currents are measured approximately every 10 minutes:
