Hybrid 2z34 Traveler

September 29, 1999

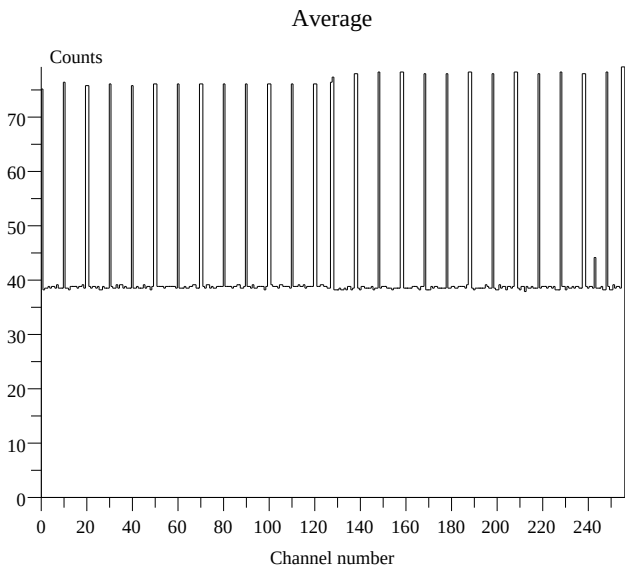
Pedestal

The following plot shows the pedestals vs. channel number

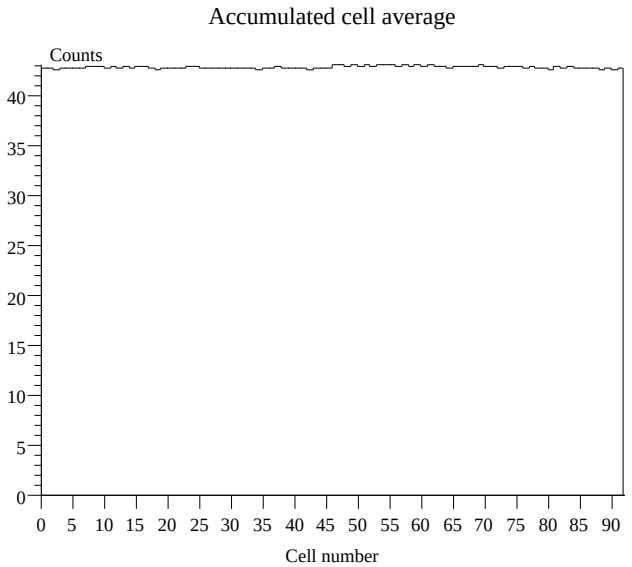
Pedestal vs. Pipeline Cell ID

The following plot shows the average pedestal vs. pipeline cell ID. The x-axis is cell ID offset by 46 for each chip. Thus cell ID 5 on chip 1 ia at x=5, chip 2 at x=49, chip 3 at x=97, etc.

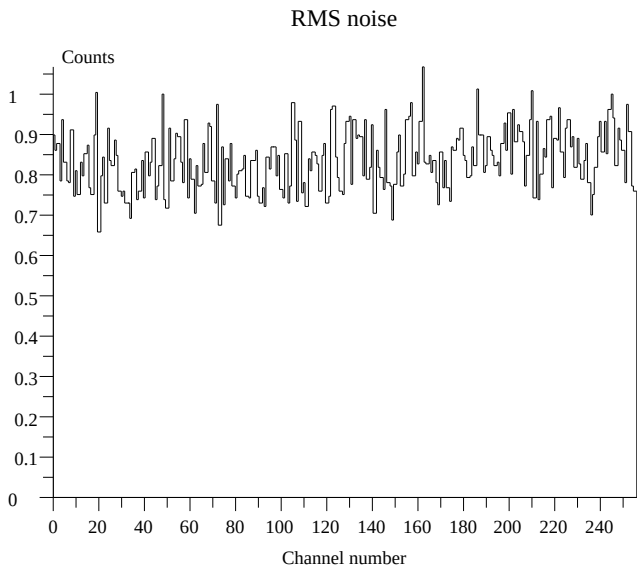
RMS Noise

The following plot shows the single cell RMS noise:

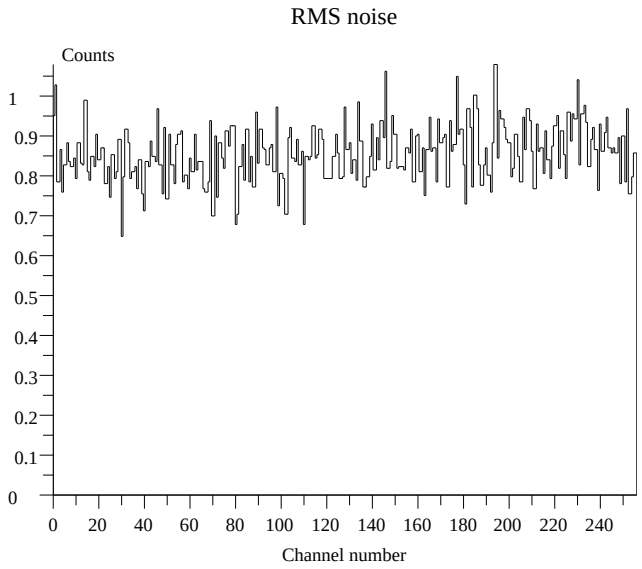
Multi-Cell Noise

The following plot show the multi-cell RMS noise:

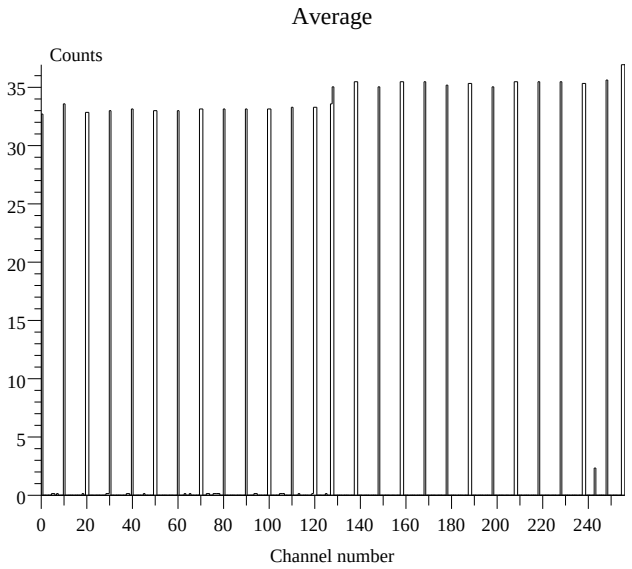
Dynamic Threshold Subtraction

The following plot shows the readout of channels with charge injection with the dynamic threshold subtraction turned on:
