Hybrid 2z46 Traveler

December 2, 1999

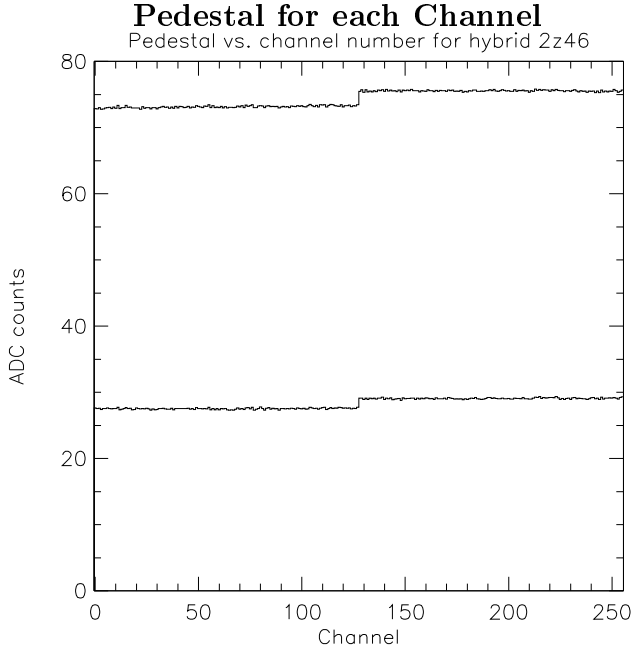
Pedestal for each Channel

Hybrid 2z46 quality: fair
Chip classification: fair good
Bad channels (chip-channel): 0-92
Bad cells: none
Random bad capacitors (chip-cell-channel): 0-10-92 0-10-93
Channels at pedestal needed for DCMS: 34.6 36.7
```

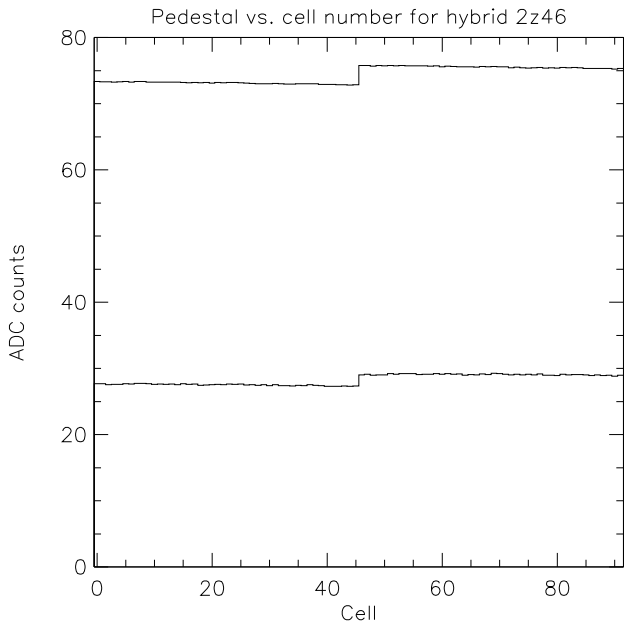
Pedestal vs. Pipeline Cell ID

The following plot shows the average pedestal vs. pipeline cell ID with and without charge injection. The x-axis is cell ID offset by 46 for each chip. Thus cell ID 5 for chip 1 is at x=5, chip 2 at x=51, chip 3 at x=97, etc.

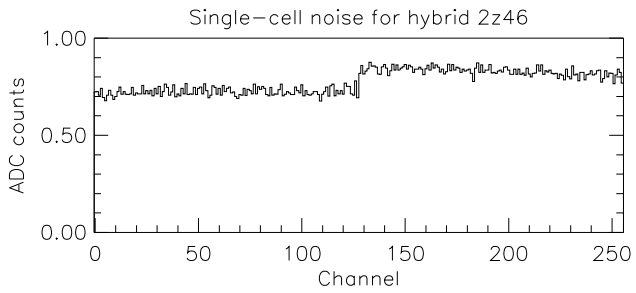
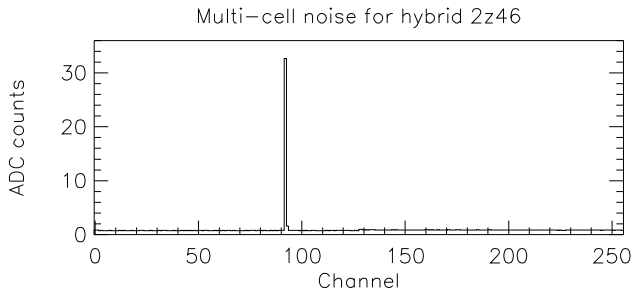
RMS Noise

The following plots show the single-cell and multi-cell RMS noise:

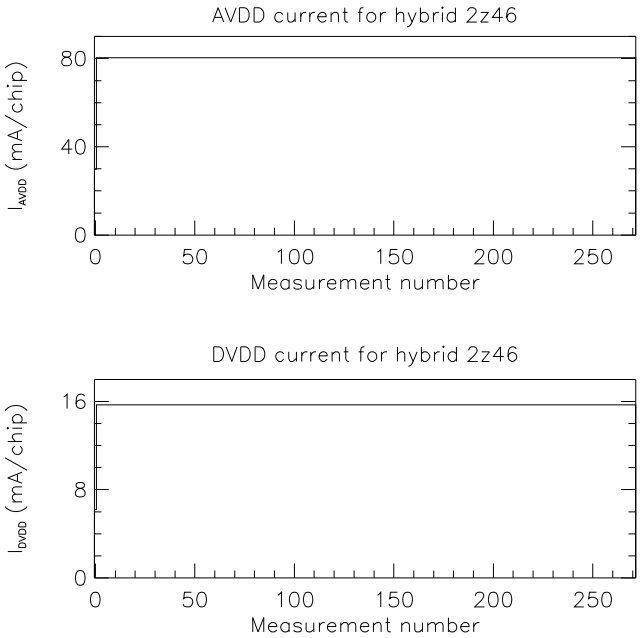
Supply Currents During Burn-in

The following plots show the supply currents per chip as a function of measurment number. Currents are measured approximately every 10 minutes:
