Hybrid 2z47 Traveler

December 2, 1999

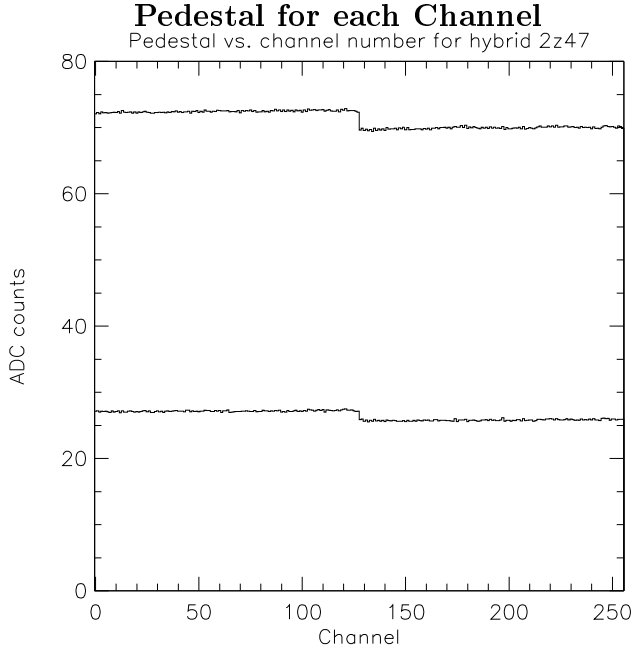
Pedestal for each Channel

The following plot shows the pedestals vs. channel number with and without charge injection:

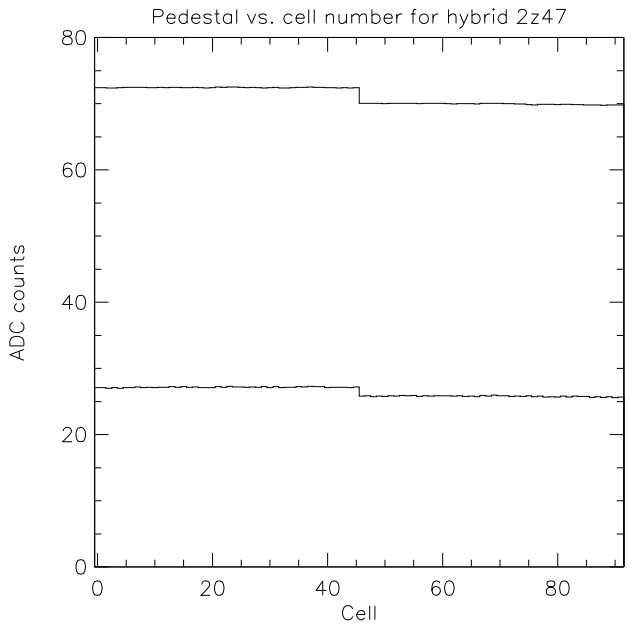
Pedestal vs. Pipeline Cell ID

The following plot shows the average pedestal vs. pipeline cell ID with and without charge injection. The x-axis is cell ID offset by 46 for each chip. Thus cell ID 5 for chip 1 is at x=5, chip 2 at x=51, chip 3 at x=97, etc.

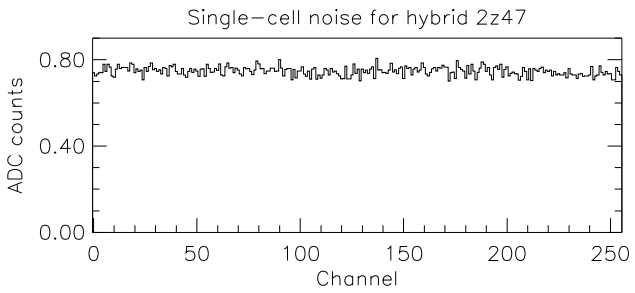
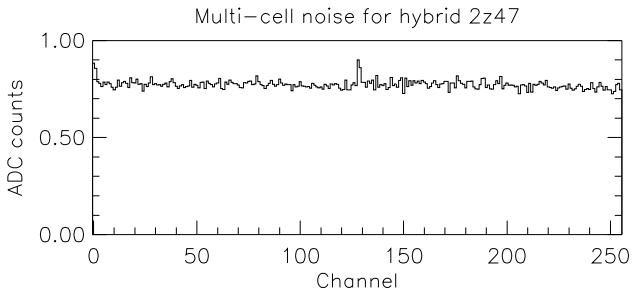
RMS Noise

The following plots show the single-cell and multi-cell RMS noise:

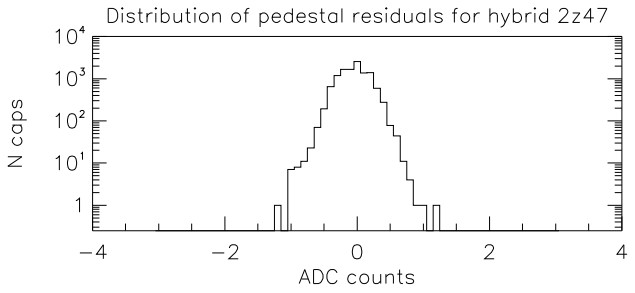
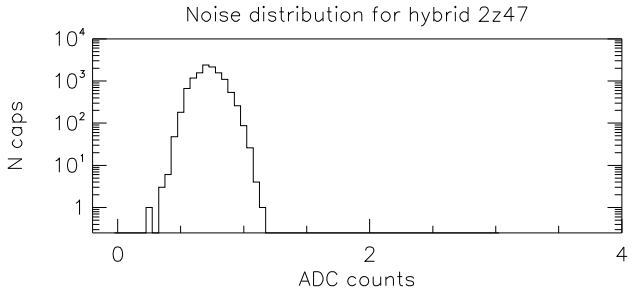
Distribution of Pedestals and Noise

The following are histograms of the pedestal of each pipeline capacitor relative to the chip average (top); and the RMS noise of each capacitor (bottom):

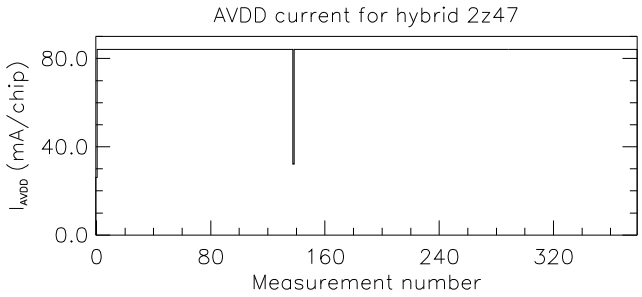
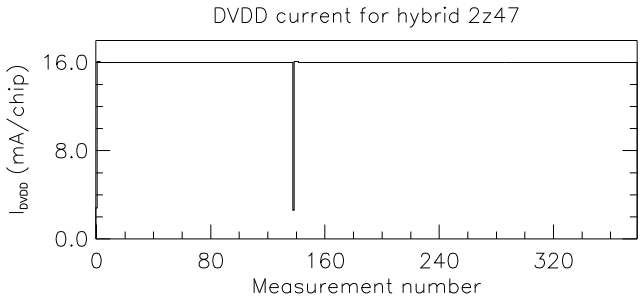
Supply Currents During Burn-in

The following plots show the supply currents per chip as a function of measurment number. Currents are measured approximately every 10 minutes:
