Hybrid 2z49 Traveler

November 23, 1999

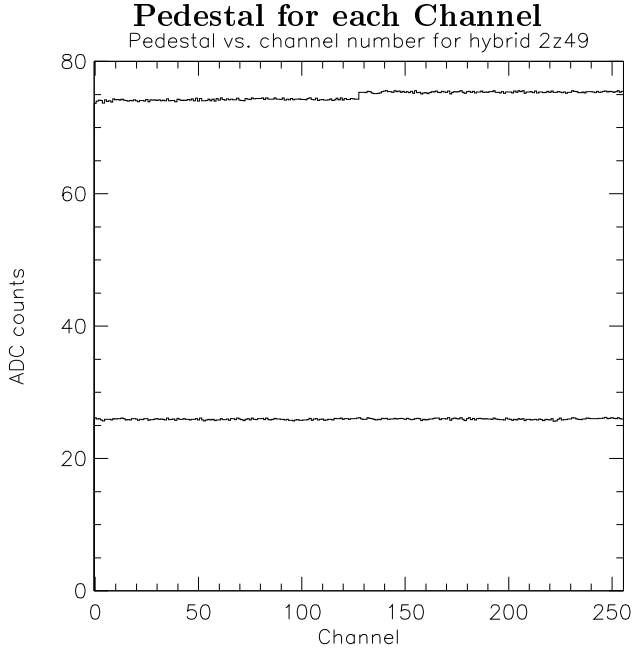
Pedestal for each Channel

The following plot shows the pedestals vs. channel number with and without charge injection:

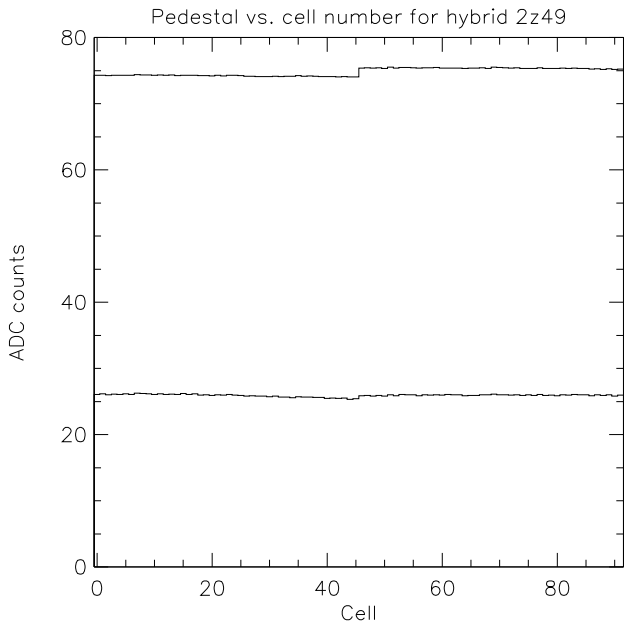
Pedestal vs. Pipeline Cell ID

The following plot shows the average pedestal vs. pipeline cell ID with and without charge injection. The x-axis is cell ID offset by 46 for each chip. Thus cell ID 5 for chip 1 is at x=5, chip 2 at x=51, chip 3 at x=97, etc.

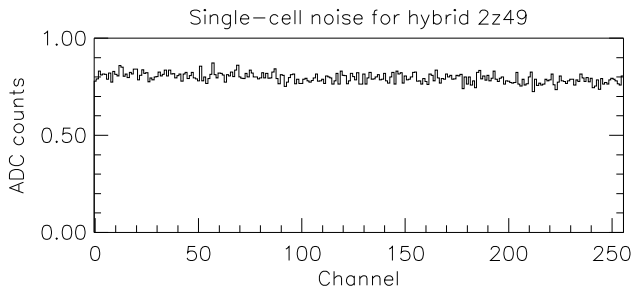
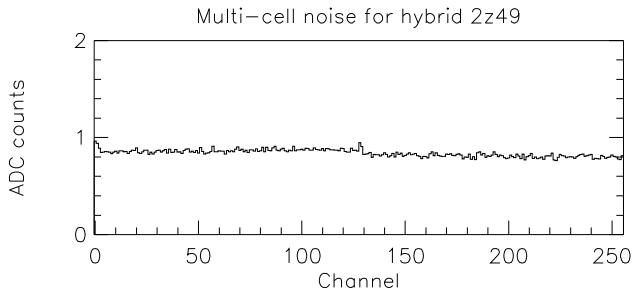
RMS Noise

The following plots show the single-cell and multi-cell RMS noise:

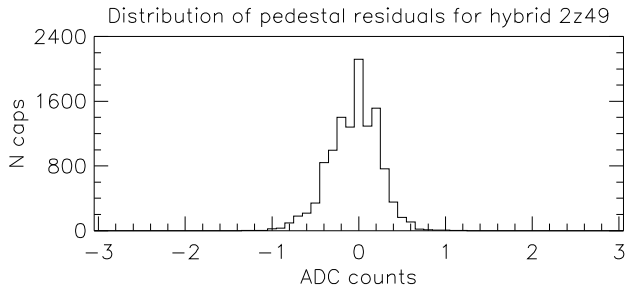
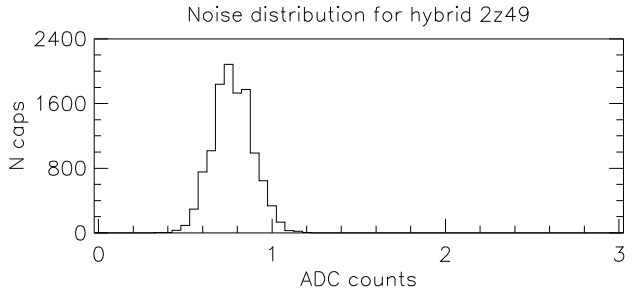
Distribution of Pedestals and Noise

The following are histograms of the pedestal of each pipeline capacitor relative to the chip average (top); and the RMS noise of each capacitor (bottom):

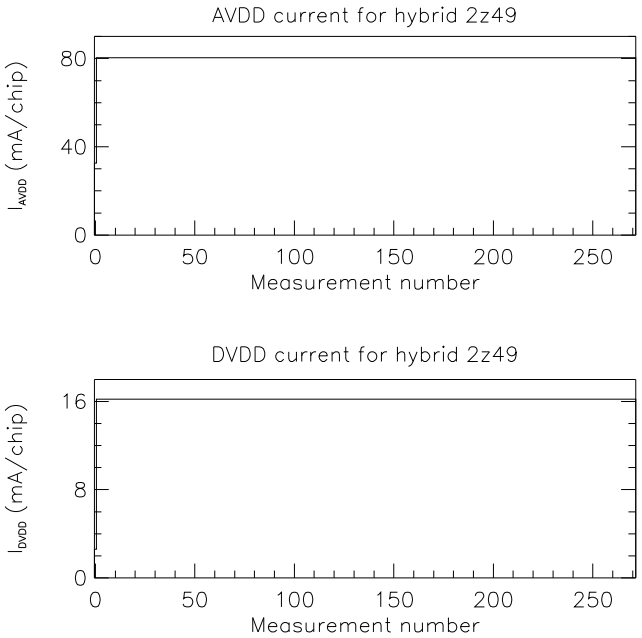
Supply Currents During Burn-in

The following plots show the supply currents per chip as a function of measurment number. Currents are measured approximately every 10 minutes:
