Hybrid 2z56 Traveler

November 15, 1999

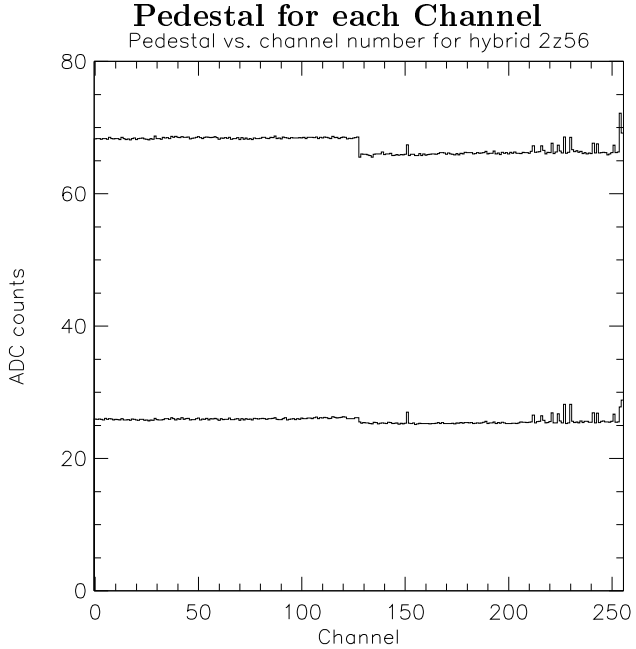
Pedestal for each Channel

The following plot shows the pedestals vs. channel number with and without charge injection:

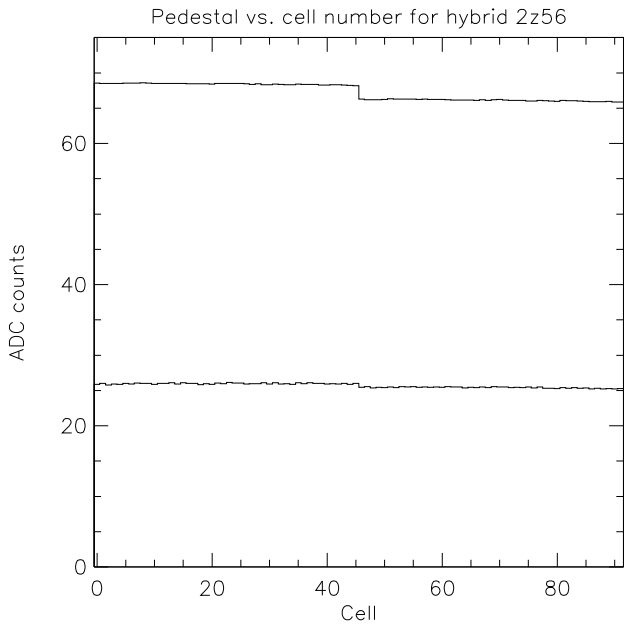
Pedestal vs. Pipeline Cell ID

The following plot shows the average pedestal vs. pipeline cell ID with and without charge injection. The x-axis is cell ID offset by 46 for each chip. Thus cell ID 5 for chip 1 is at x=5, chip 2 at x=51, chip 3 at x=97, etc.

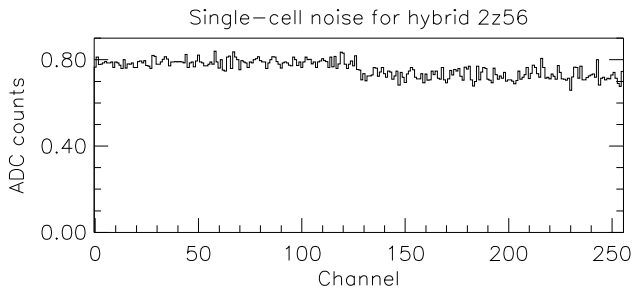
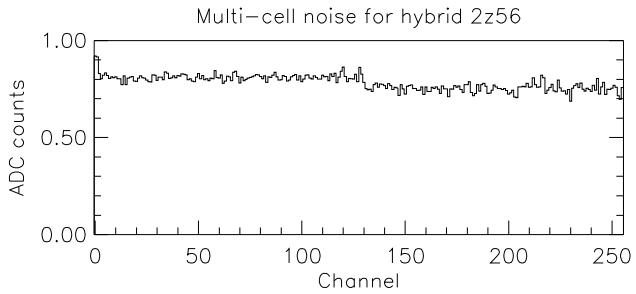
RMS Noise

The following plots show the single-cell and multi-cell RMS noise:

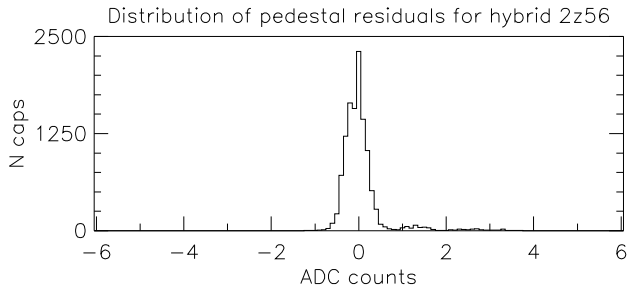
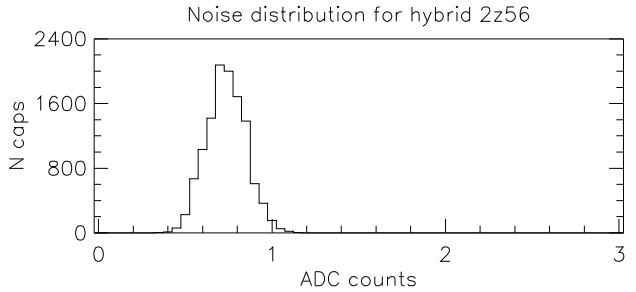
Distribution of Pedestals and Noise

The following are histograms of the pedestal of each pipeline capacitor relative to the chip average (top); and the RMS noise of each capacitor (bottom):

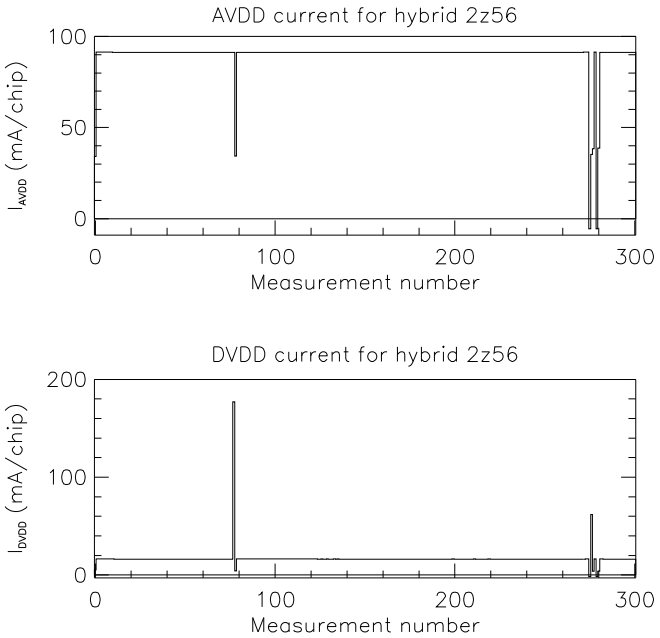
Supply Currents During Burn-in

The following plots show the supply currents per chip as a function of measurment number. Currents are measured approximately every 10 minutes:
