Hybrid 2z66 Traveler

January 4, 2000

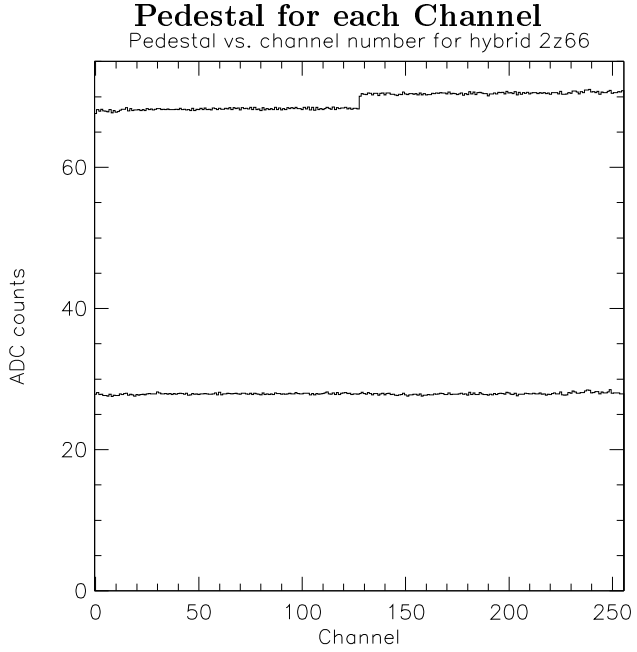
Pedestal for each Channel

The following plot shows the pedestals vs. channel number with and without charge injection:

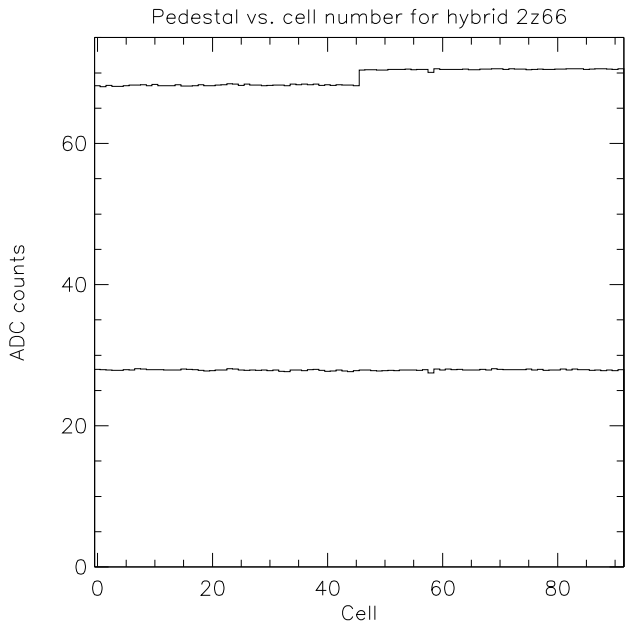
Pedestal vs. Pipeline Cell ID

The following plot shows the average pedestal vs. pipeline cell ID with and without charge injection. The x-axis is cell ID offset by 46 for each chip. Thus cell ID 5 for chip 1 is at x=5, chip 2 at x=51, chip 3 at x=97, etc.

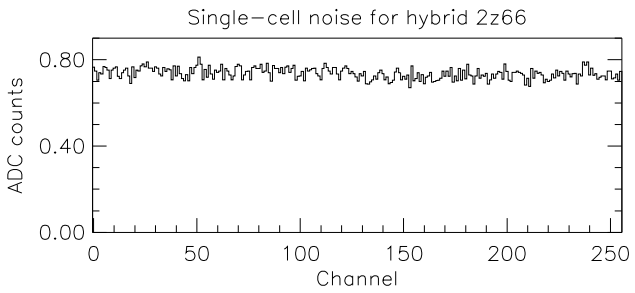
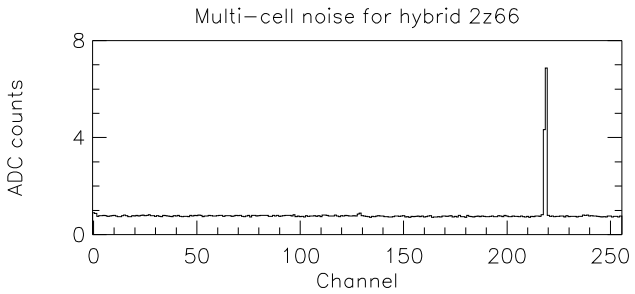
RMS Noise

The following plots show the single-cell and multi-cell RMS noise:

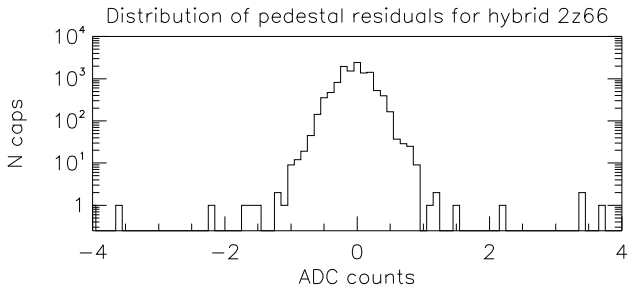
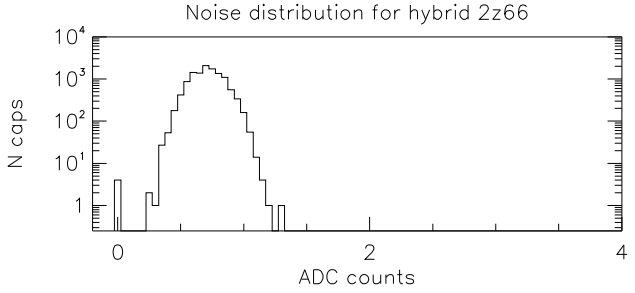
Distribution of Pedestals and Noise

The following are histograms of the pedestal of each pipeline capacitor relative to the chip average (top); and the RMS noise of each capacitor (bottom):

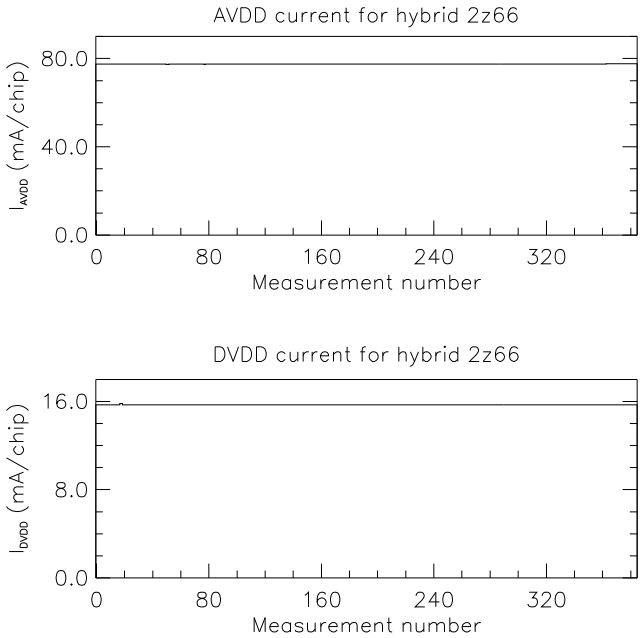
Supply Currents During Burn-in

The following plots show the supply currents per chip as a function of measurment number. Currents are measured approximately every 10 minutes:
