Hybrid 2z69 Traveler

October 21, 1999

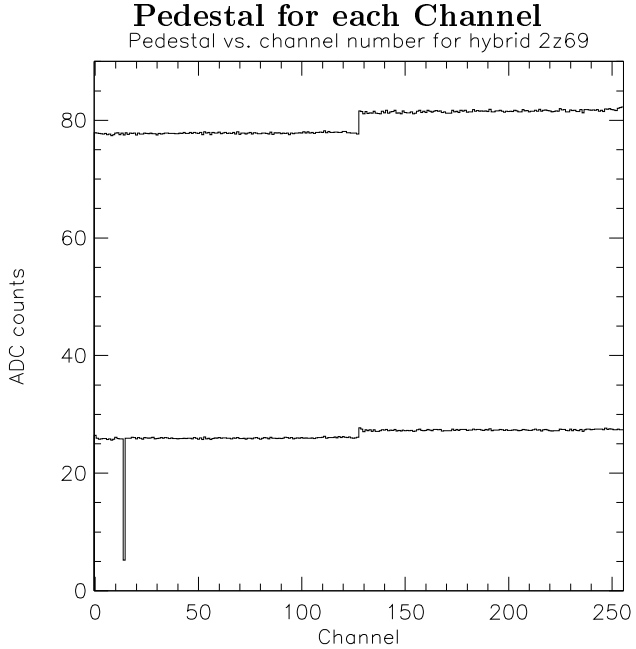
Pedestal for each Channel

Hybrid 2z69 quality: fair
Chip classification: fair good
Bad channels (chip-channel): 0-14
Bad cells: none
Random bad capacitors: none
Channels at pedestal needed for DCMS: 35.7 31.6
```
