Hybrid 2z70 Traveler

October 29, 1999

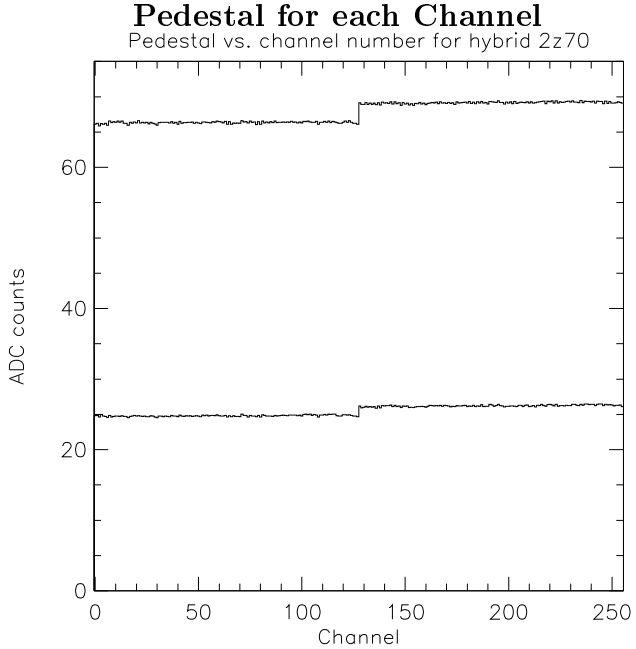
Pedestal for each Channel

The following plot shows the pedestals vs. channel number with and without charge injection:

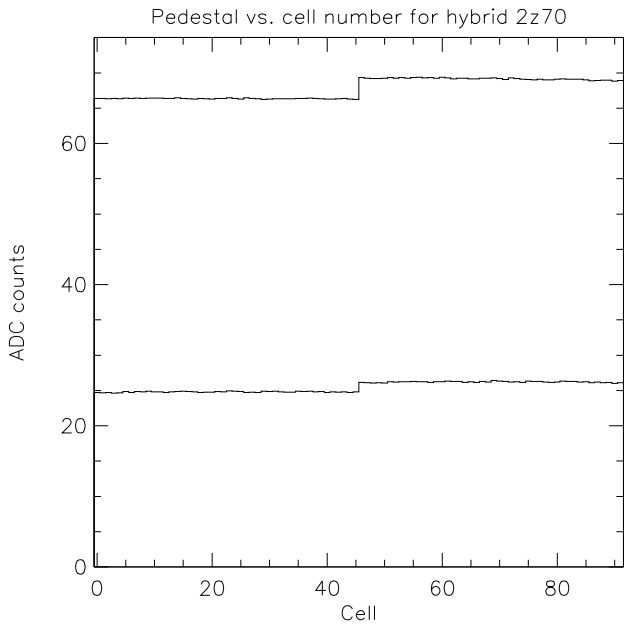
Pedestal vs. Pipeline Cell ID

The following plot shows the average pedestal vs. pipeline cell ID with and without charge injection. The x-axis is cell ID offset by 46 for each chip. Thus cell ID 5 for chip 1 is at x=5, chip 2 at x=51, chip 3 at x=97, etc.

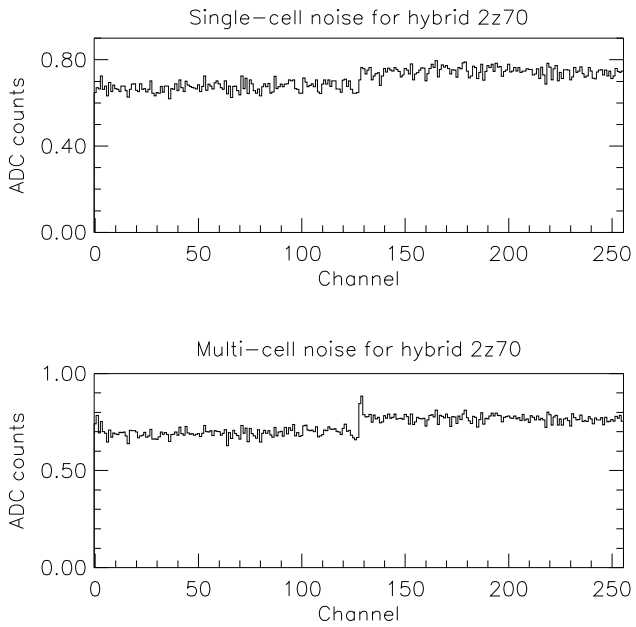
RMS Noise

The following plots show the single-cell and multi-cell RMS noise:

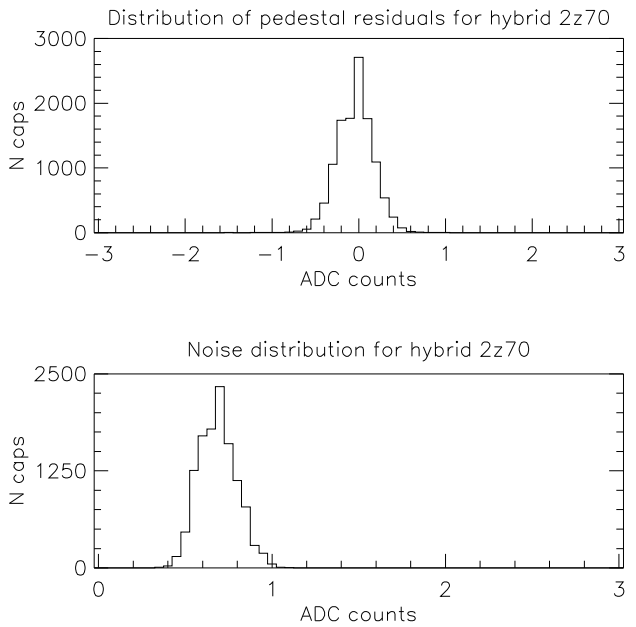
Distribution of Pedestals and Noise

The following are histograms of the pedestal of each pipeline capacitor relative to the chip average (top); and the RMS noise of each capacitor (bottom):

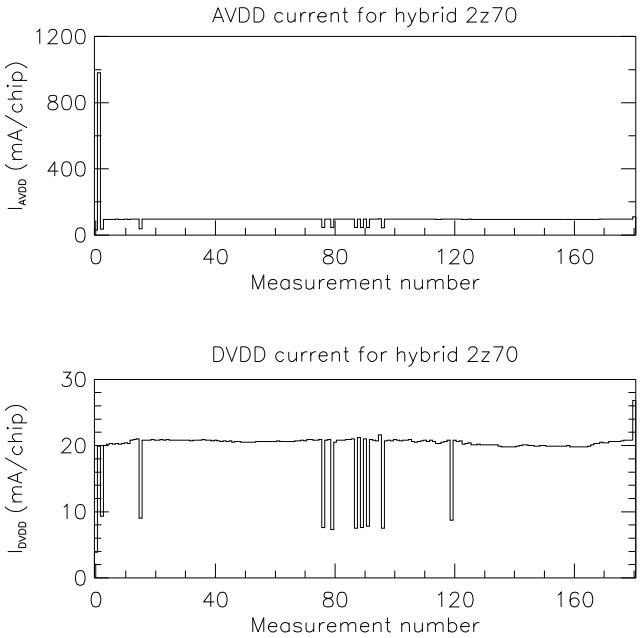
Supply Currents During Burn-in

The following plots show the supply currents per chip as a function of measurment number. Currents are measured approximately every 10 minutes:
