Hybrid 2z72 Traveler

February 17, 2000

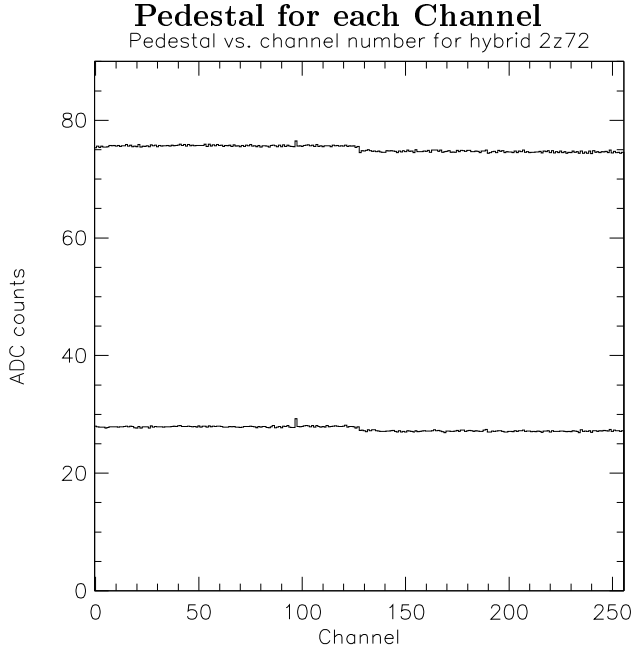
Pedestal for each Channel

The following plot shows the pedestals vs. channel number with and without charge injection:

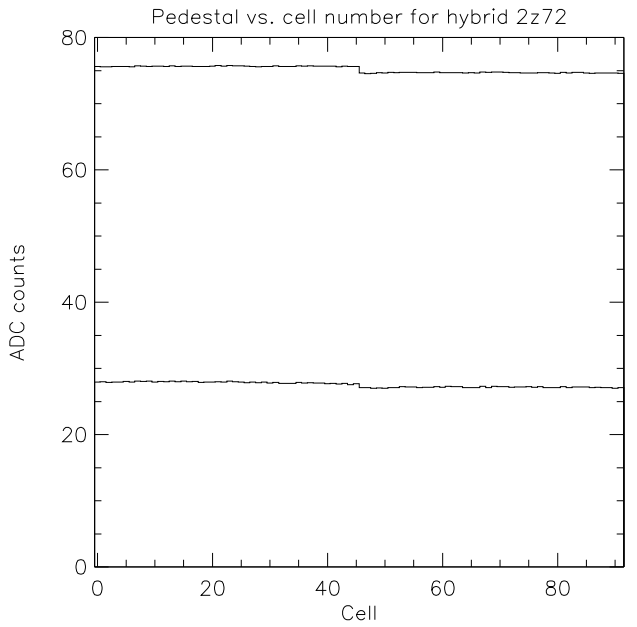
Pedestal vs. Pipeline Cell ID

The following plot shows the average pedestal vs. pipeline cell ID with and without charge injection. The x-axis is cell ID offset by 46 for each chip. Thus cell ID 5 for chip 1 is at x=5, chip 2 at x=51, chip 3 at x=97, etc.

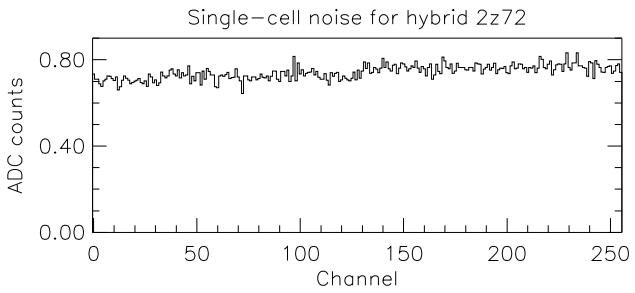
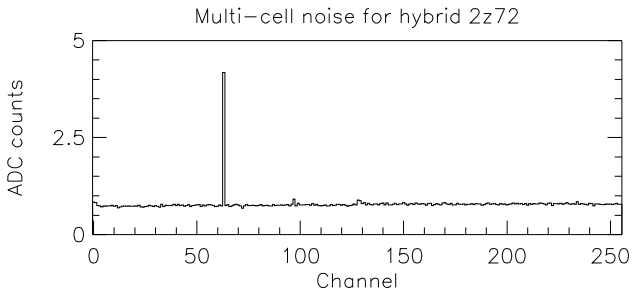
RMS Noise

The following plots show the single-cell and multi-cell RMS noise:

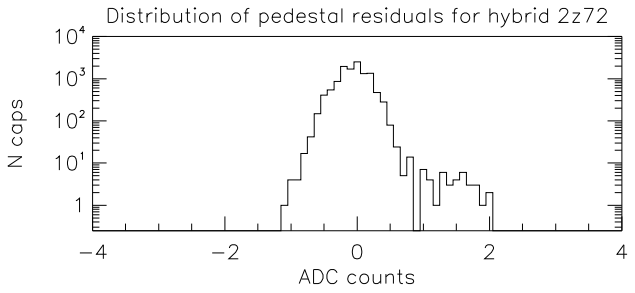
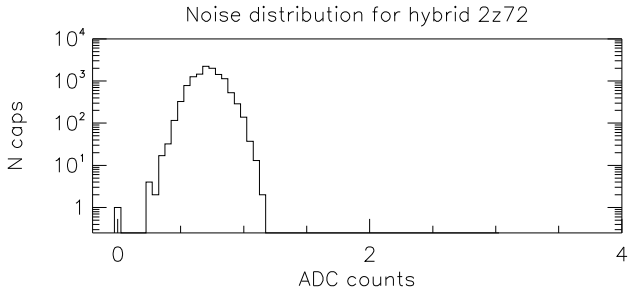
Distribution of Pedestals and Noise

The following are histograms of the pedestal of each pipeline capacitor relative to the chip average (top); and the RMS noise of each capacitor (bottom):

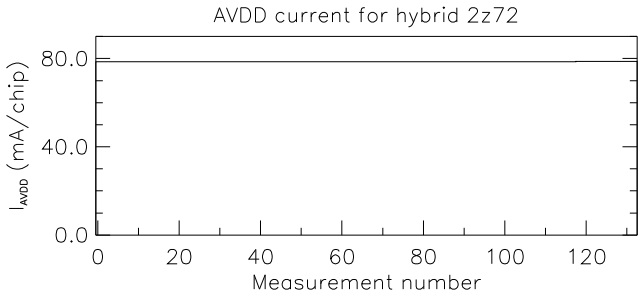
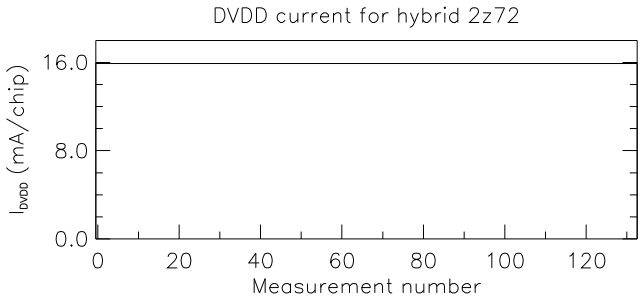
Supply Currents During Burn-in

The following plots show the supply currents per chip as a function of measurment number. Currents are measured approximately every 10 minutes:
