Hybrid 2z85 Traveler

December 21, 1999

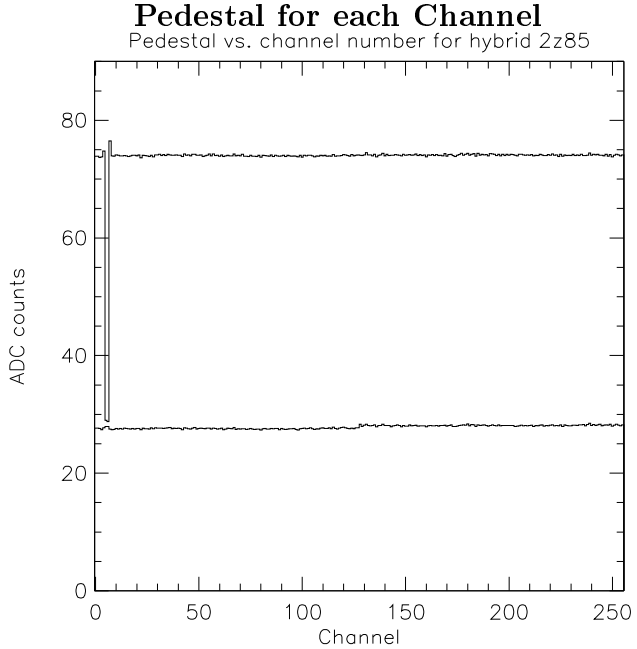
Pedestal for each Channel

Hybrid 2z85 quality: fair
Chip classification: fair good
Bad channels (chip-channel): 0-5 0-6
Bad cells: none
Random bad capacitors: none
Channels at pedestal needed for DCMS: 30.8 32.3
```

The following plot shows the pedestals vs. channel number with and without charge injection:

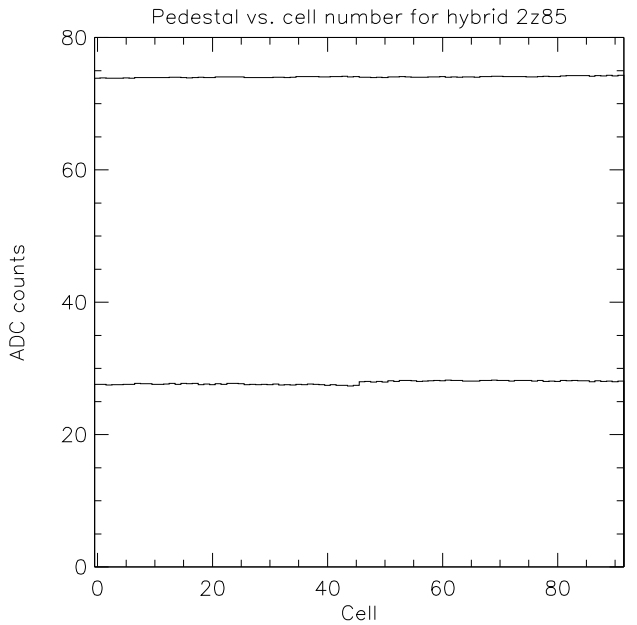
Pedestal vs. Pipeline Cell ID

The following plot shows the average pedestal vs. pipeline cell ID with and without charge injection. The x-axis is cell ID offset by 46 for each chip. Thus cell ID 5 for chip 1 is at x=5, chip 2 at x=51, chip 3 at x=97, etc.

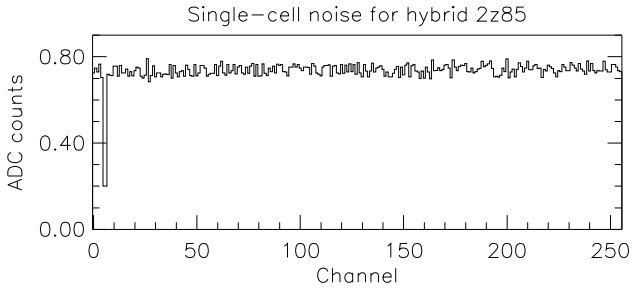
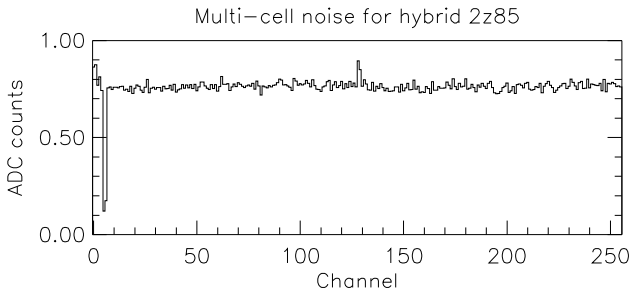
RMS Noise

The following plots show the single-cell and multi-cell RMS noise:

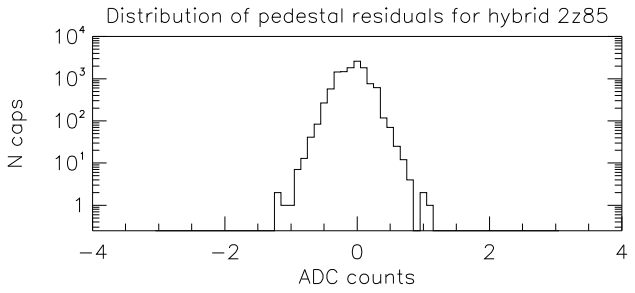
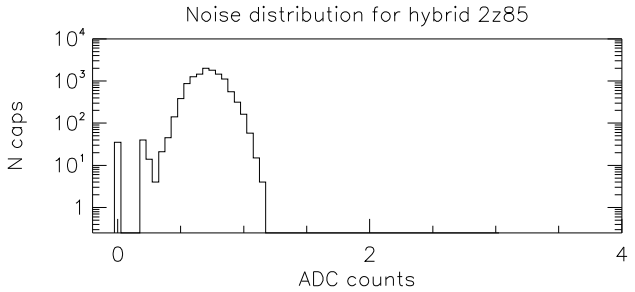
Distribution of Pedestals and Noise

The following are histograms of the pedestal of each pipeline capacitor relative to the chip average (top); and the RMS noise of each capacitor (bottom):

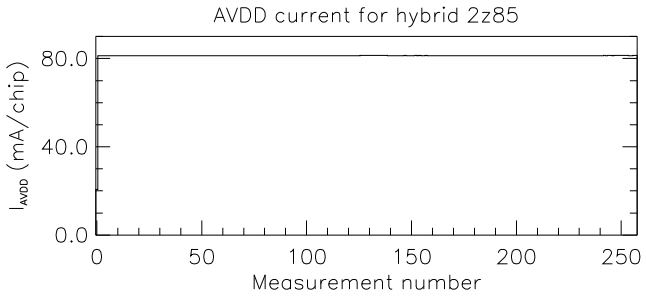
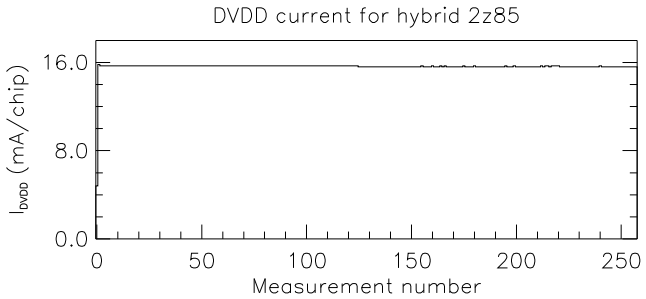
Supply Currents During Burn-in

The following plots show the supply currents per chip as a function of measurment number. Currents are measured approximately every 10 minutes:
