Hybrid 3l11 Traveler

May 8, 2000

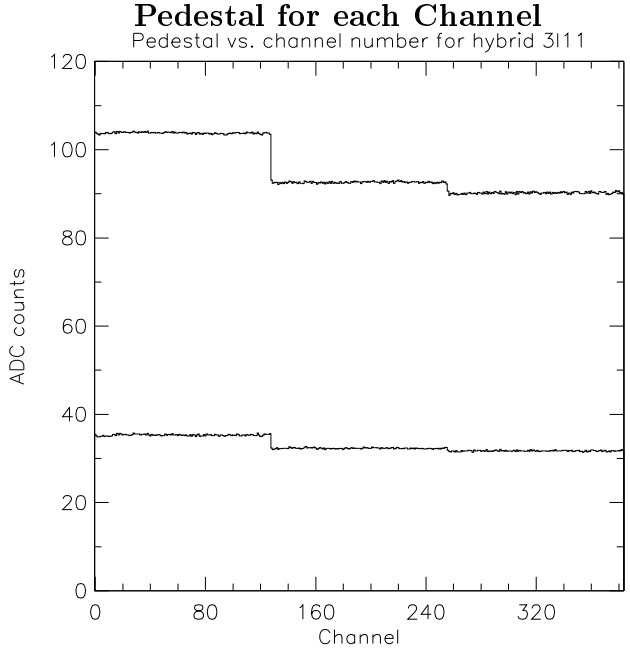
Pedestal for each Channel

The following plot shows the pedestals vs. channel number with and without charge injection:

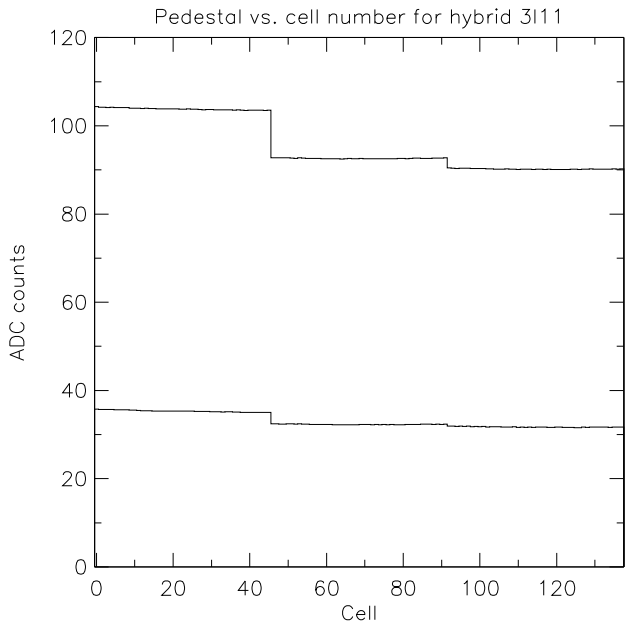
Pedestal vs. Pipeline Cell ID

The following plot shows the average pedestal vs. pipeline cell ID with and without charge injection. The x-axis is cell ID offset by 46 for each chip. Thus cell ID 5 for chip 1 is at x=5, chip 2 at x=51, chip 3 at x=97, etc.

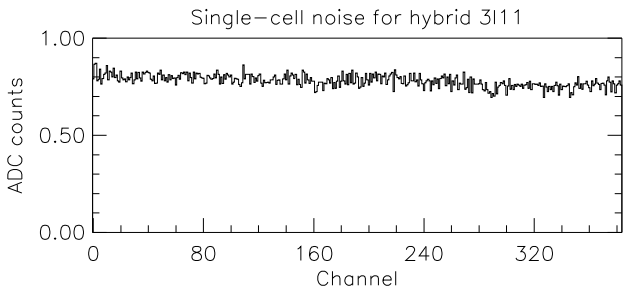
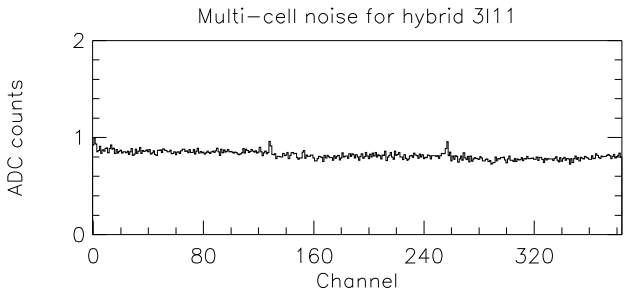
RMS Noise

The following plots show the single-cell and multi-cell RMS noise:

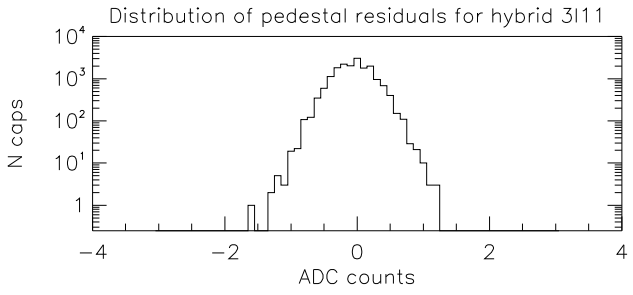
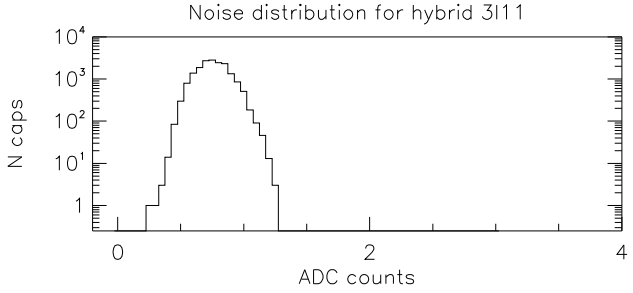
Distribution of Pedestals and Noise

The following are histograms of the pedestal of each pipeline capacitor relative to the chip average (top); and the RMS noise of each capacitor (bottom):

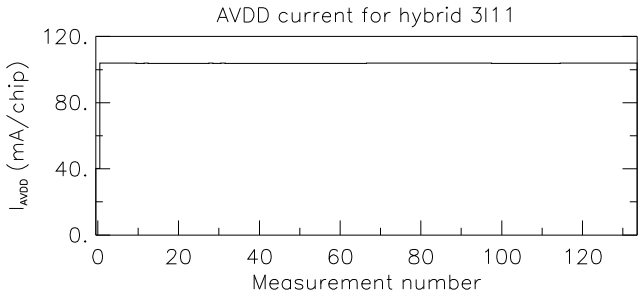
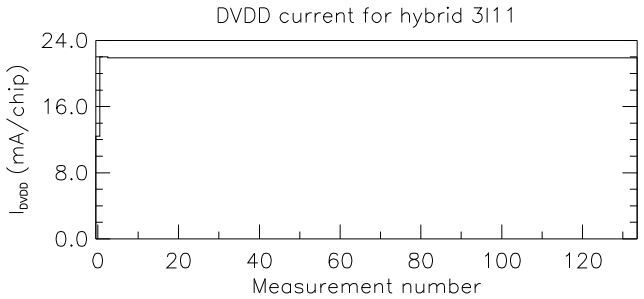
Supply Currents During Burn-in

The following plots show the supply currents per chip as a function of measurment number. Currents are measured approximately every 10 minutes:
