Hybrid 3l6 Traveler

May 1, 2000

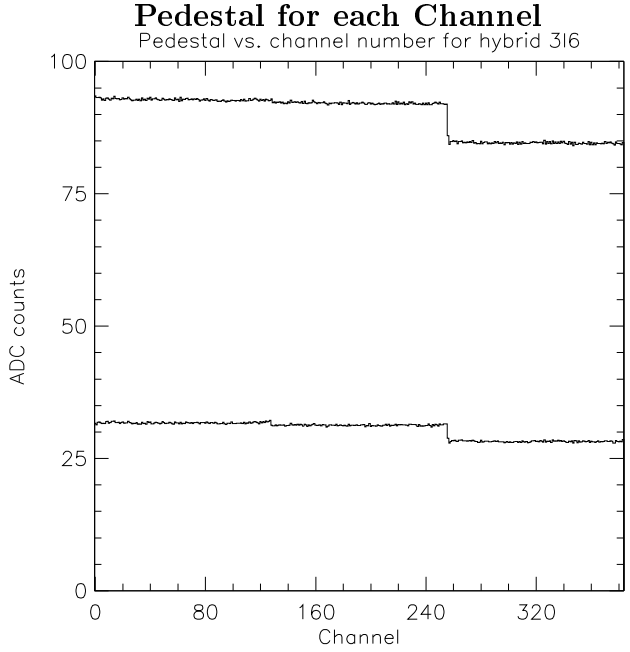
Pedestal for each Channel

The following plot shows the pedestals vs. channel number with and without charge injection:

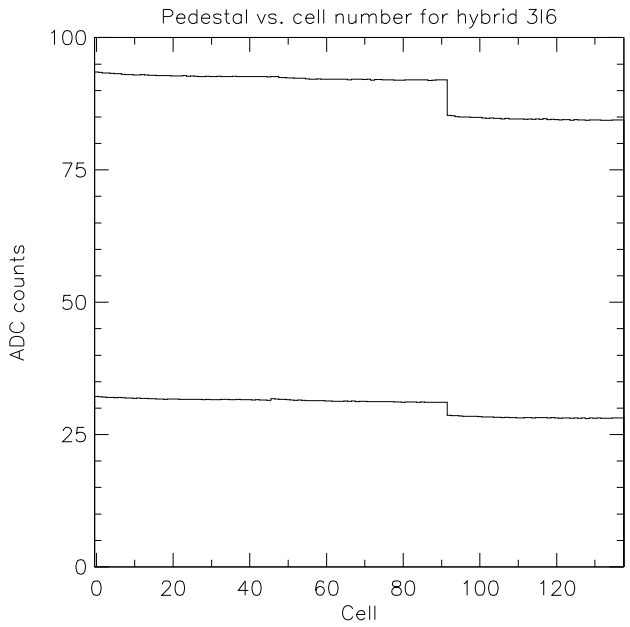
Pedestal vs. Pipeline Cell ID

The following plot shows the average pedestal vs. pipeline cell ID with and without charge injection. The x-axis is cell ID offset by 46 for each chip. Thus cell ID 5 for chip 1 is at x=5, chip 2 at x=51, chip 3 at x=97, etc.

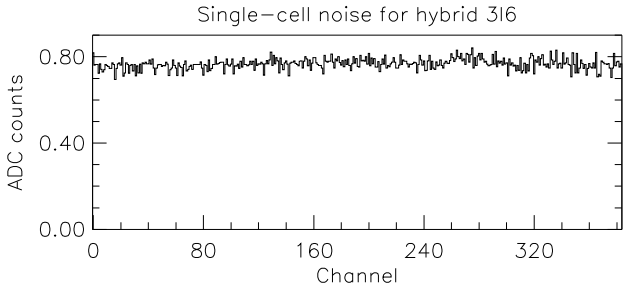
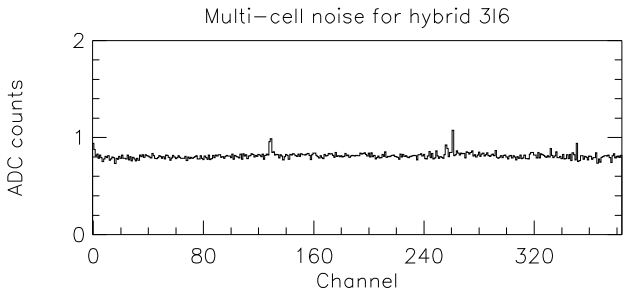
RMS Noise

The following plots show the single-cell and multi-cell RMS noise:

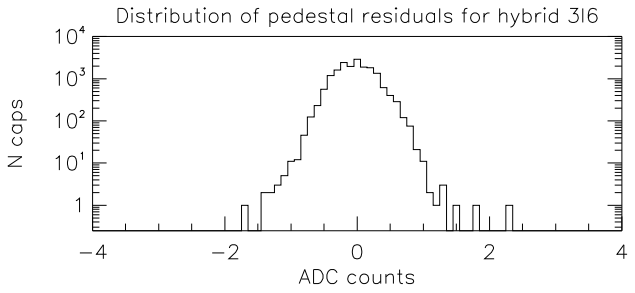
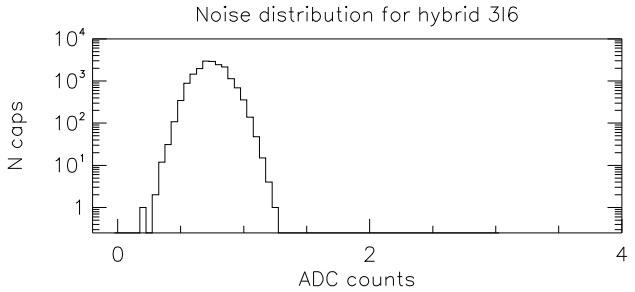
Distribution of Pedestals and Noise

The following are histograms of the pedestal of each pipeline capacitor relative to the chip average (top); and the RMS noise of each capacitor (bottom):

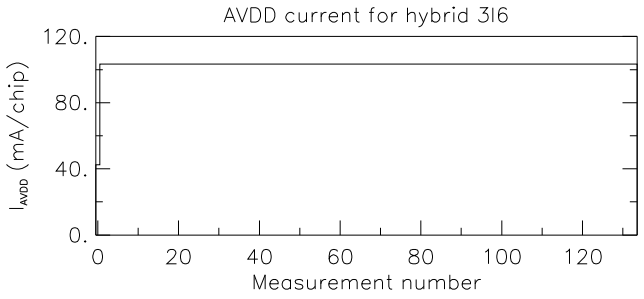
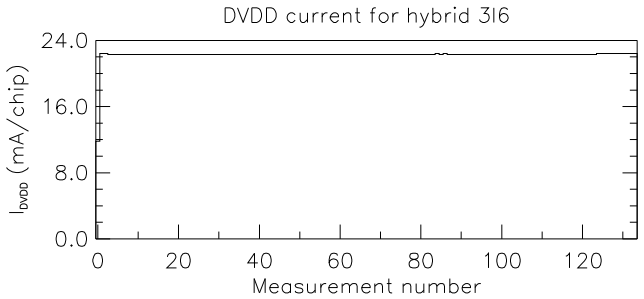
Supply Currents During Burn-in

The following plots show the supply currents per chip as a function of measurment number. Currents are measured approximately every 10 minutes:
