Hybrid 3l7 Traveler

May 8, 2000

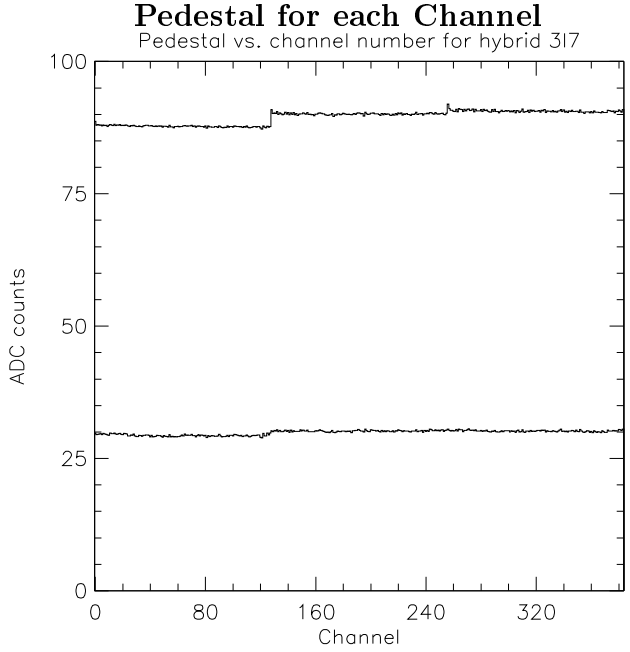
Pedestal for each Channel

Hybrid 3l7 quality: bad
Chip classification: bad bad bad
Bad channels: N_bad_total = 111 (too many to list all of them)
Bad cells: none
Random bad capacitors: none
Channels at pedestal needed for DCMS: 31.6 29.6 31.7
```
