# Hybrid 3l9 Traveler

May 8, 2000

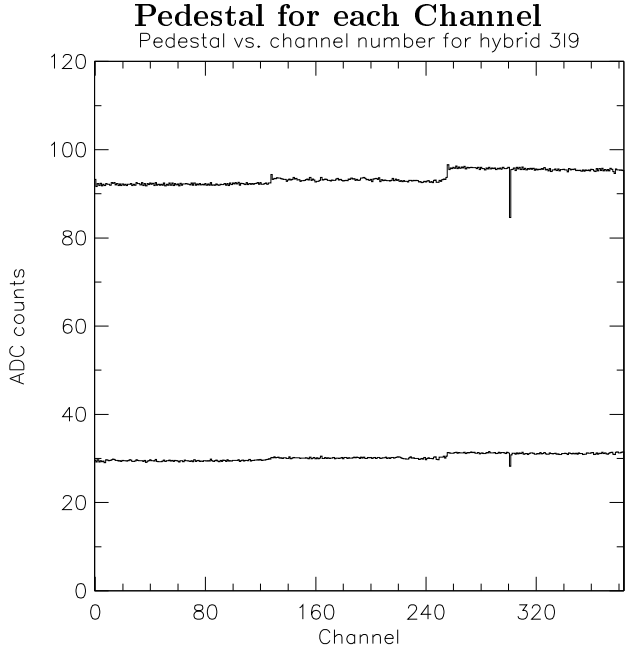
**Pedestal for each Channel**

The following plot shows the pedestals vs. channel number with and without charge injection:

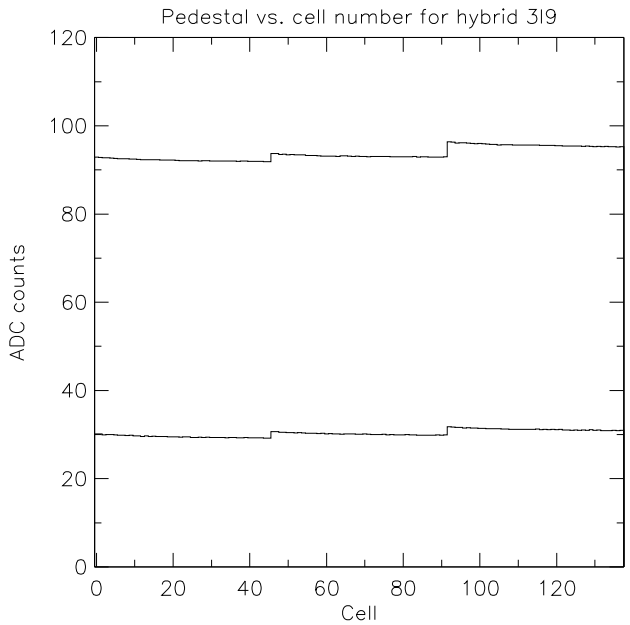
**Pedestal vs. Pipeline Cell ID**

The following plot shows the average pedestal vs. pipeline cell ID with and without charge injection. The x-axis is cell ID offset by 46 for each chip. Thus cell ID 5 for chip 1 is at x=5, chip 2 at x=51, chip 3 at x=97, etc.

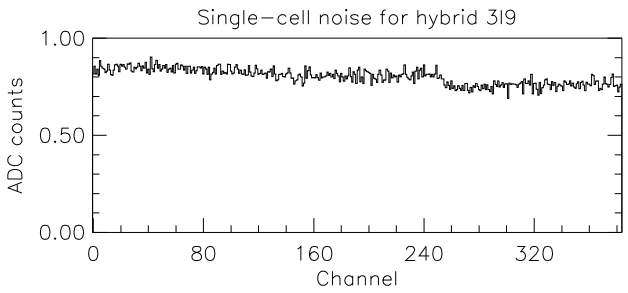
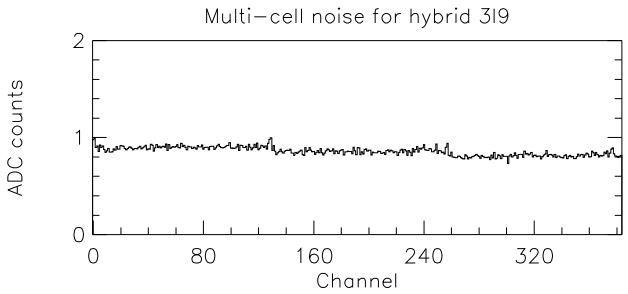
**RMS Noise**

The following plots show the single-cell and multi-cell RMS noise:

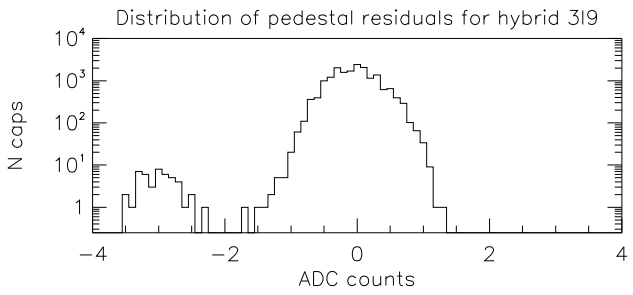
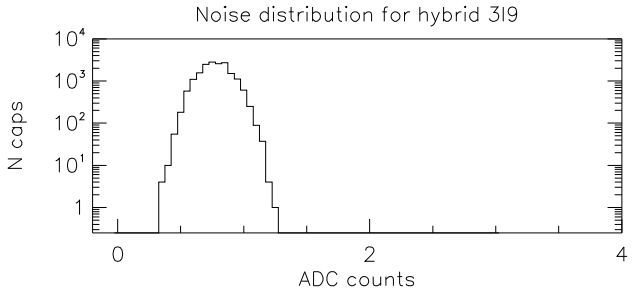
**Distribution of Pedestals and Noise**

The following are histograms of the pedestal of each pipeline capacitor relative to the chip average (top); and the RMS noise of each capacitor (bottom):

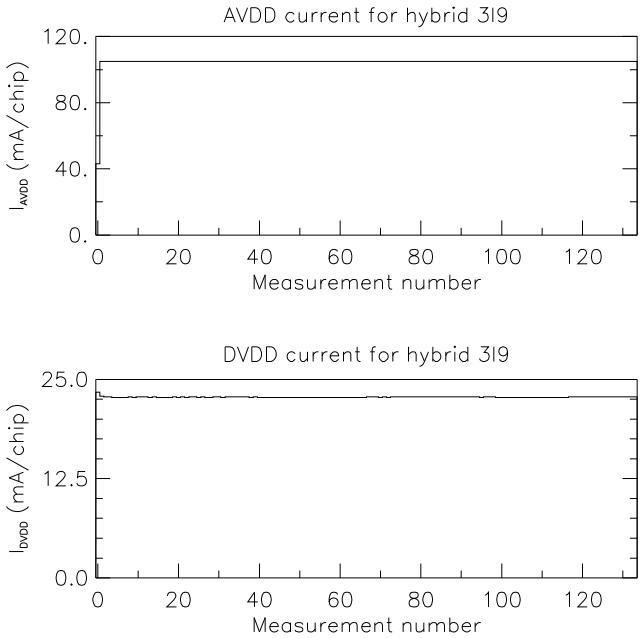
**Supply Currents During Burn-in**

The following plots show the supply currents per chip as a function of measurment number. Currents are measured approximately every 10 minutes:
