# Hybrid 3p115 Traveler

December 14, 1999

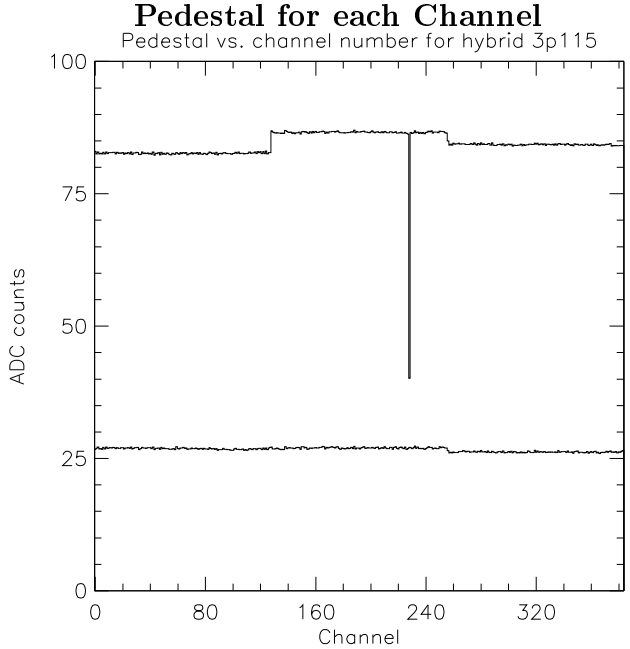
**Pedestal for each Channel**

The following plot shows the pedestals vs. channel number with and without charge injection:

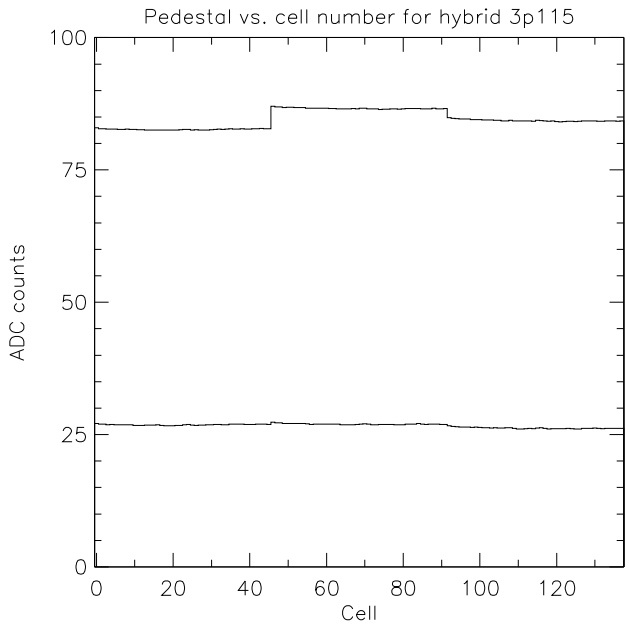
**Pedestal vs. Pipeline Cell ID**

The following plot shows the average pedestal vs. pipeline cell ID with and without charge injection. The x-axis is cell ID offset by 46 for each chip. Thus cell ID 5 for chip 1 is at x=5, chip 2 at x=51, chip 3 at x=97, etc.

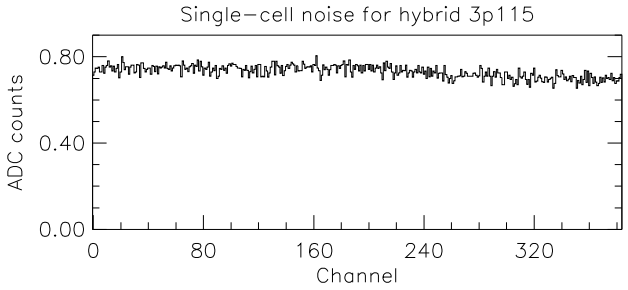
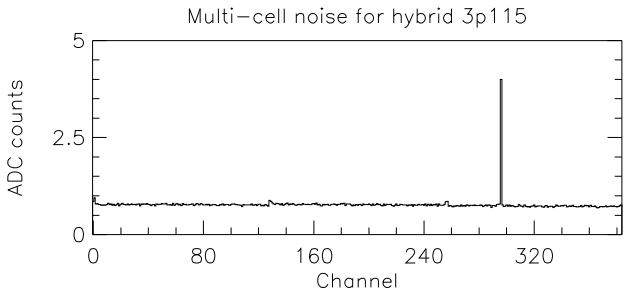
**RMS Noise**

The following plots show the single-cell and multi-cell RMS noise:

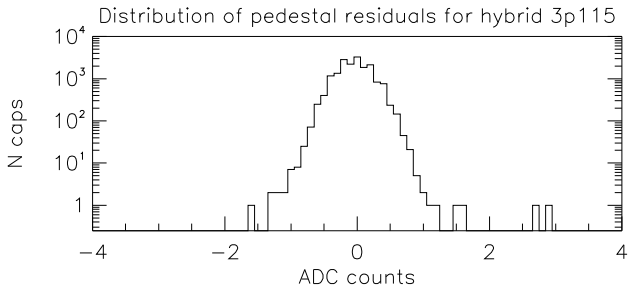
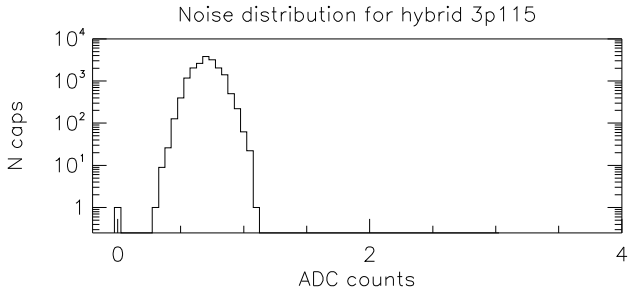
**Distribution of Pedestals and Noise**

The following are histograms of the pedestal of each pipeline capacitor relative to the chip average (top); and the RMS noise of each capacitor (bottom):

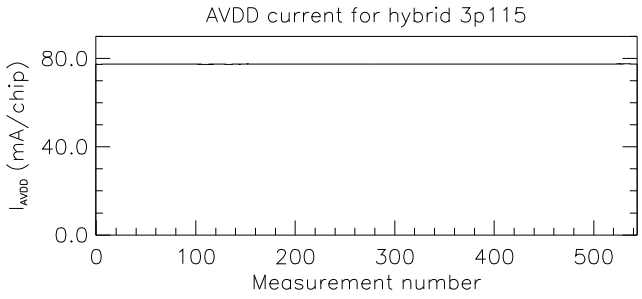
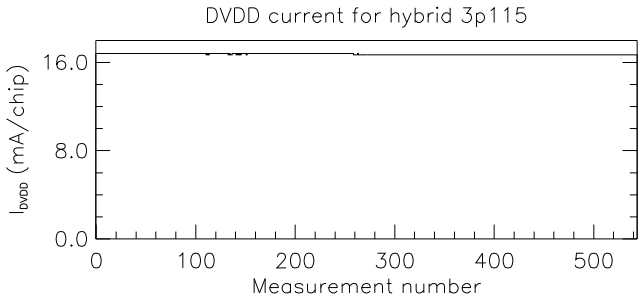
**Supply Currents During Burn-in**

The following plots show the supply currents per chip as a function of measurment number. Currents are measured approximately every 10 minutes:
