# Hybrid 3p116 Traveler

November 3, 1999

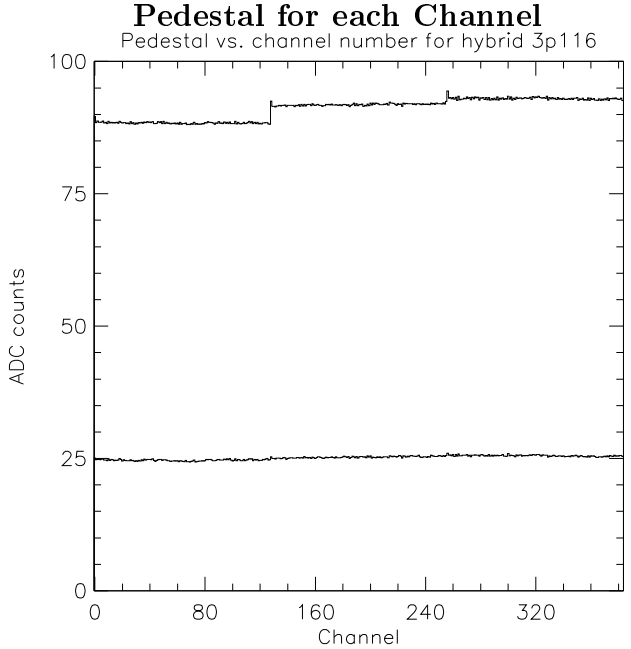
**Pedestal for each Channel**

The following plot shows the pedestals vs. channel number with and without charge injection:

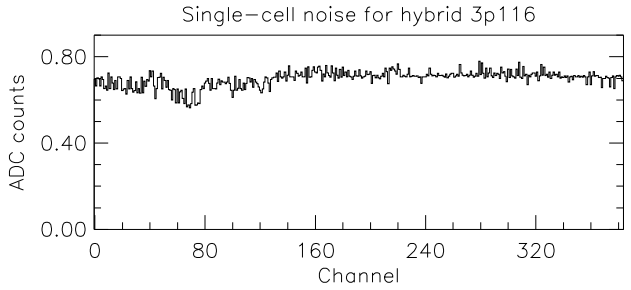
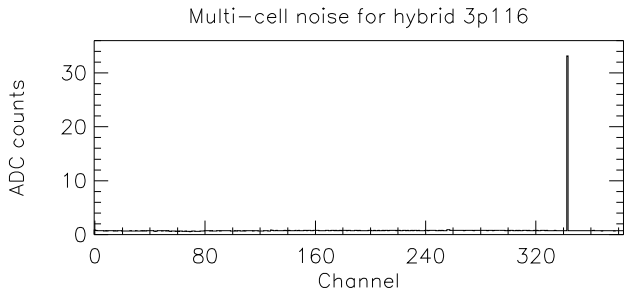
**RMS Noise**

1 noisy channel in chip 3. Has 4.7$\mu$F digital Caps.
