Hybrid 3p136 Traveler

December 17, 1999

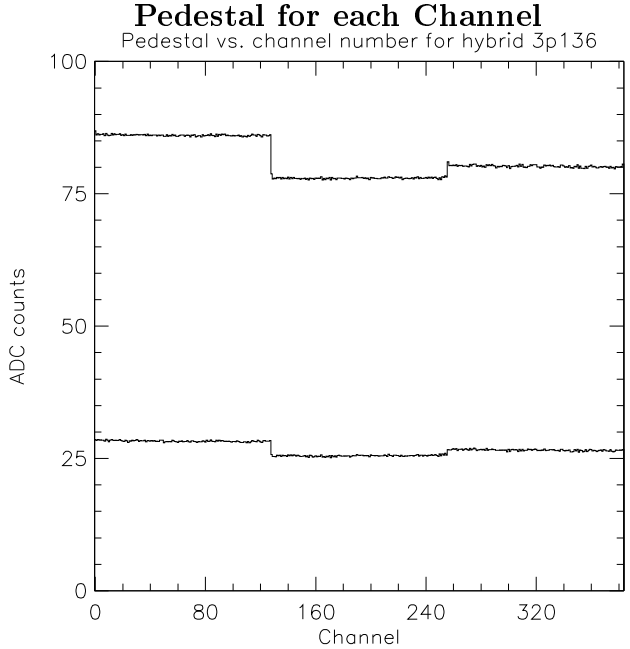
Pedestal for each Channel

The following plot shows the pedestals vs. channel number with and without charge injection:

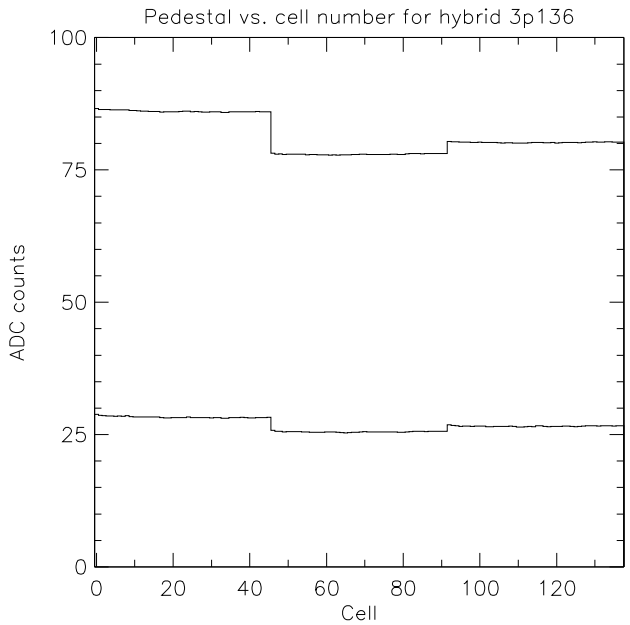
Pedestal vs. Pipeline Cell ID

The following plot shows the average pedestal vs. pipeline cell ID with and without charge injection. The x-axis is cell ID offset by 46 for each chip. Thus cell ID 5 for chip 1 is at x=5, chip 2 at x=51, chip 3 at x=97, etc.

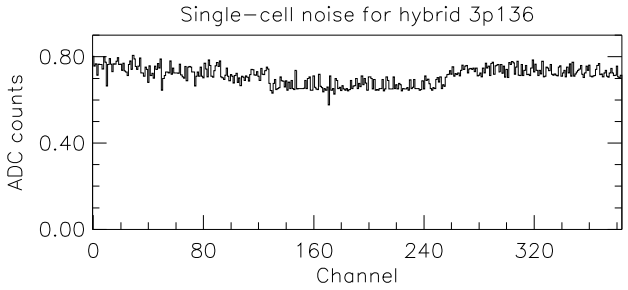
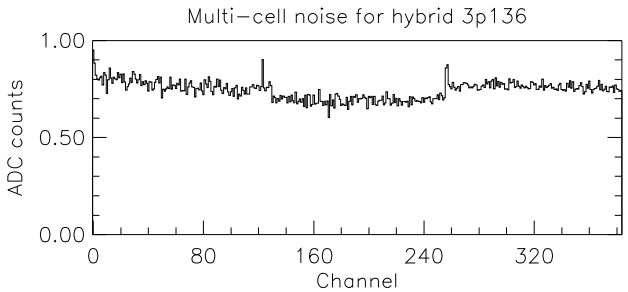
RMS Noise

The following plots show the single-cell and multi-cell RMS noise:

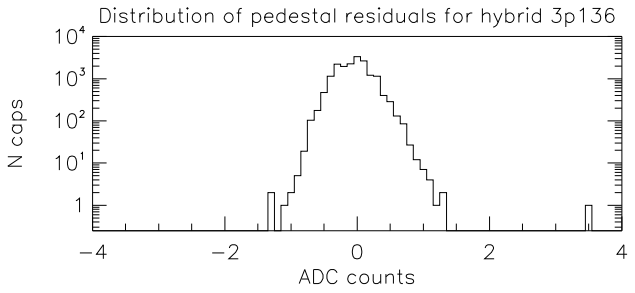
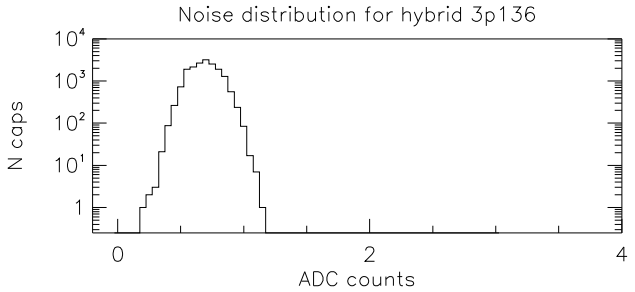
Distribution of Pedestals and Noise

The following are histograms of the pedestal of each pipeline capacitor relative to the chip average (top); and the RMS noise of each capacitor (bottom):

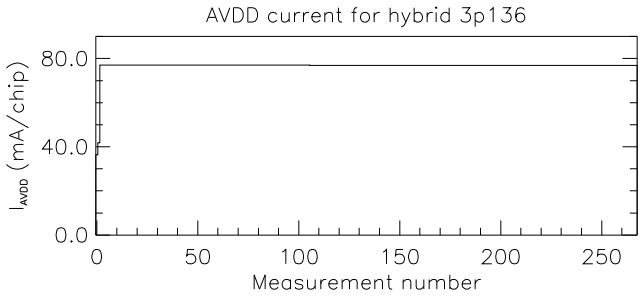
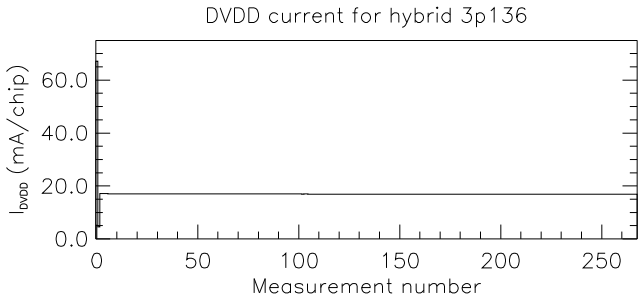
Supply Currents During Burn-in

The following plots show the supply currents per chip as a function of measurment number. Currents are measured approximately every 10 minutes:
