Hybrid 3p37 Traveler

October 11, 1999

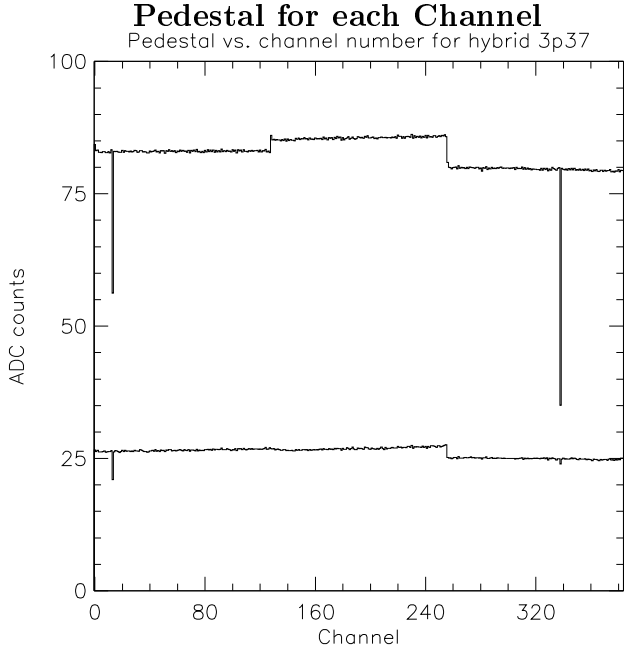
Pedestal for each Channel

Hybrid 3p37 quality: bad
Chip classification: bad good fair
Bad channels (chip-channel): 0-13 0-113 0-114 2-82
Bad cells: none
Random bad capacitors (chip-cell-channel): 0-11-113
Channels at pedestal needed for DCMS: 37.1 38.2 39.6
```

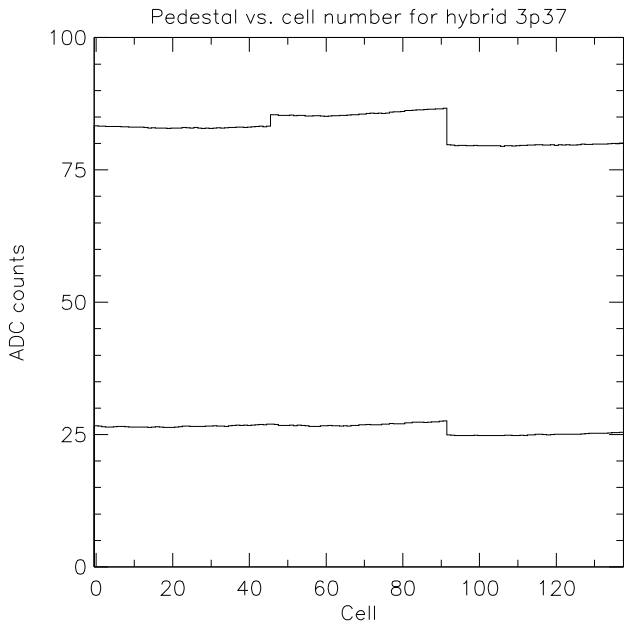
Pedestal vs. Pipeline Cell ID

The following plot shows the average pedestal vs. pipeline cell ID with and without charge injection. The x-axis is cell ID offset by 46 for each chip. Thus cell ID 5 for chip 1 is at x=5, chip 2 at x=51, chip 3 at x=97, etc.

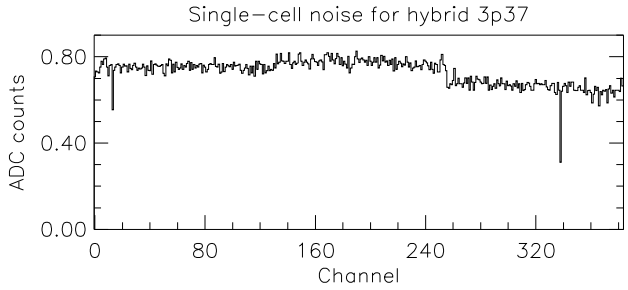
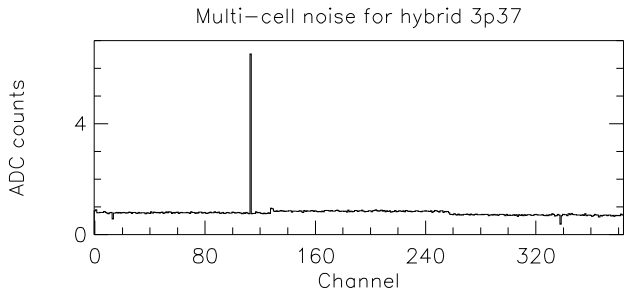
RMS Noise

The following plots show the single-cell and multi-cell RMS noise:

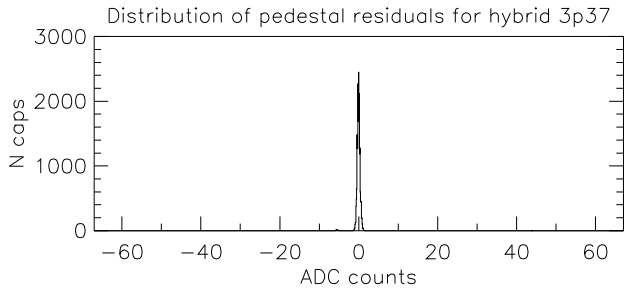
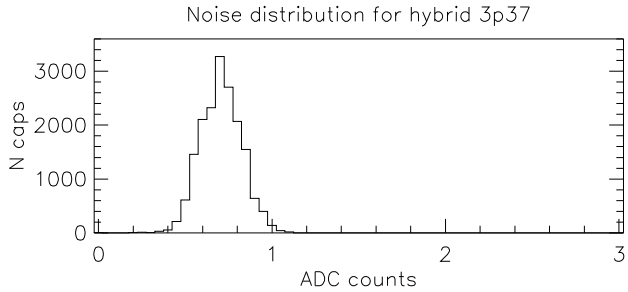
Distribution of Pedestals and Noise

The following are histograms of the pedestal of each pipeline capacitor relative to the chip average (top); and the RMS noise of each capacitor (bottom):

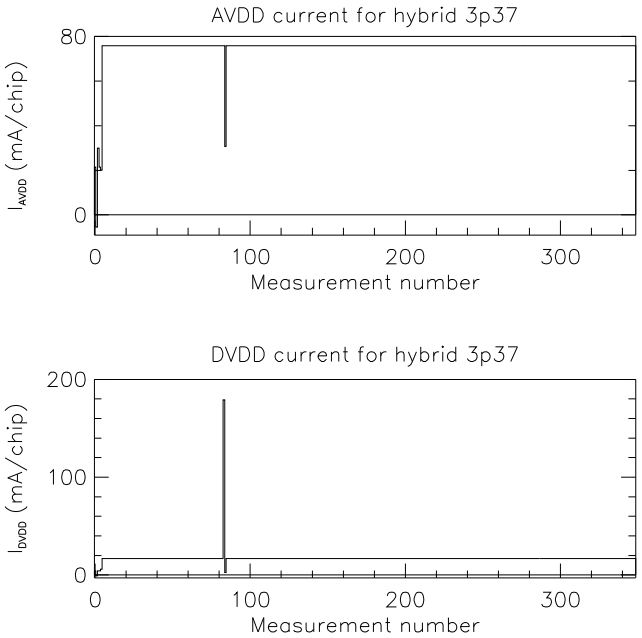
Supply Currents During Burn-in

The following plots show the supply currents per chip as a function of measurment number. Currents are measured approximately every 10 minutes:
