Hybrid 3p72 Traveler

January 14, 2000

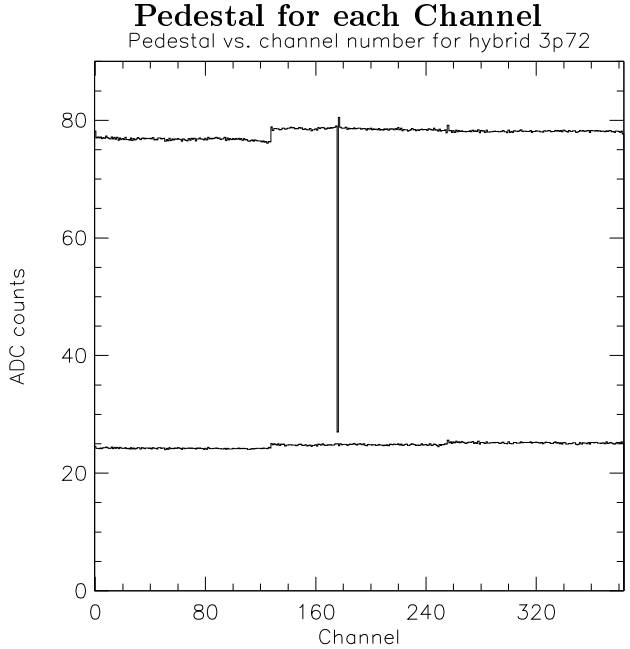
Pedestal for each Channel

Hybrid 3p72 quality: fair
Chip classification: fair fair good
Bad channels (chip-channel): 1-48
Bad cells: none
Random bad capacitors (chip-cell-channel): 0-17-25 0-17-26 0-18-25
Channels at pedestal needed for DCMS: 33.7 29.6 32.7
```

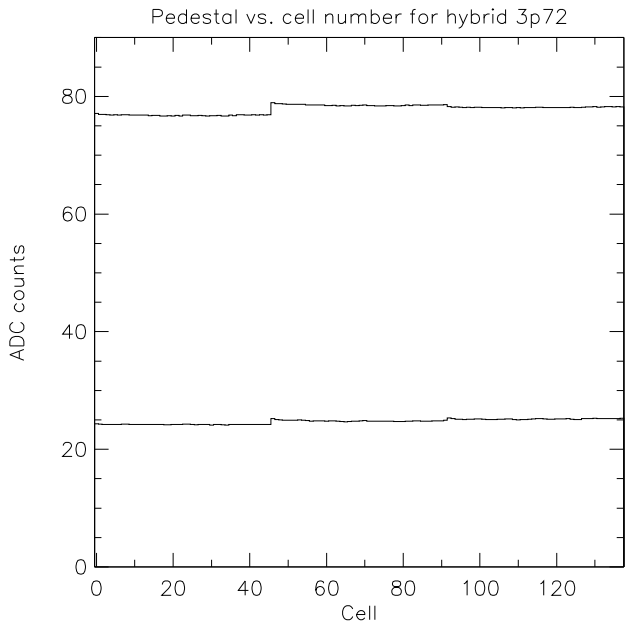
Pedestal vs. Pipeline Cell ID

The following plot shows the average pedestal vs. pipeline cell ID with and without charge injection. The x-axis is cell ID offset by 46 for each chip. Thus cell ID 5 for chip 1 is at x=5, chip 2 at x=51, chip 3 at x=97, etc.

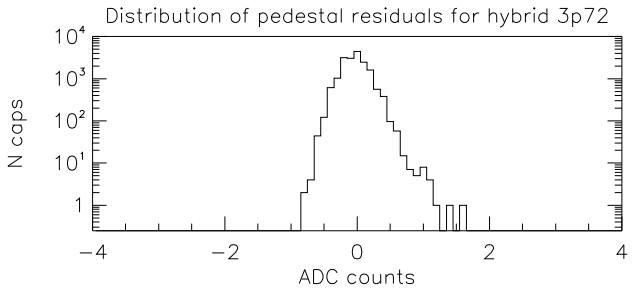
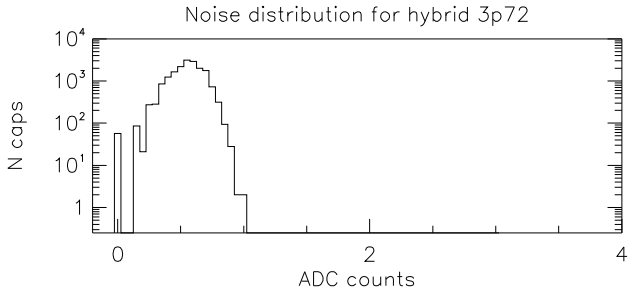
Distribution of Pedestals and Noise

The following are histograms of the pedestal of each pipeline capacitor relative to the chip average (top); and the RMS noise of each capacitor (bottom):

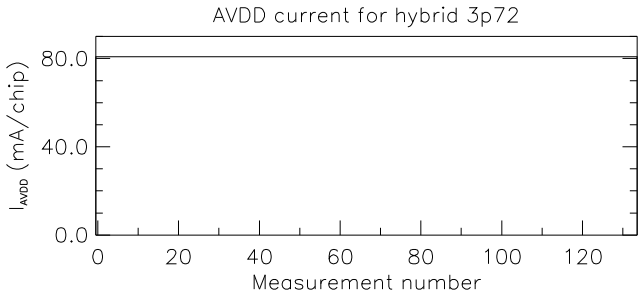
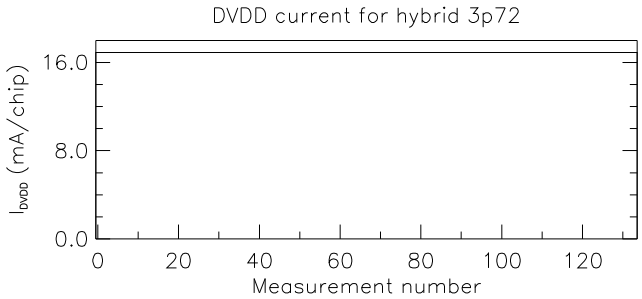
Supply Currents During Burn-in

The following plots show the supply currents per chip as a function of measurment number. Currents are measured approximately every 10 minutes:
