Hybrid 3z100 Traveler

February 17, 2000

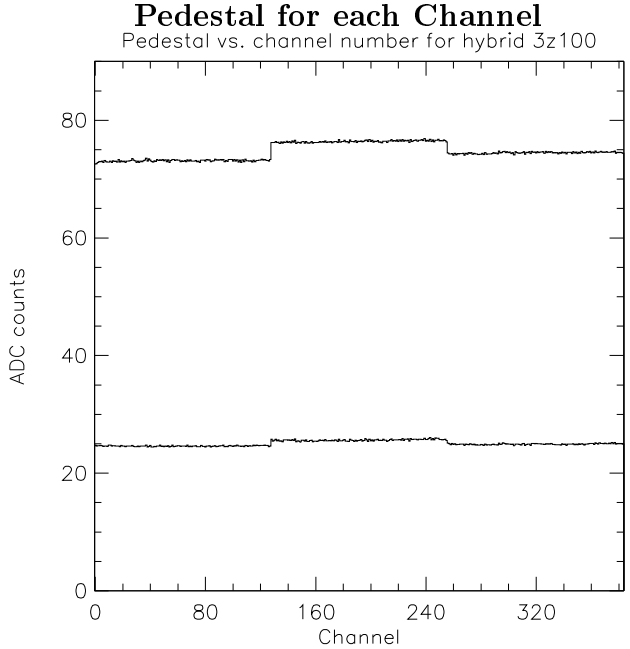
Pedestal for each Channel

The following plot shows the pedestals vs. channel number with and without charge injection:

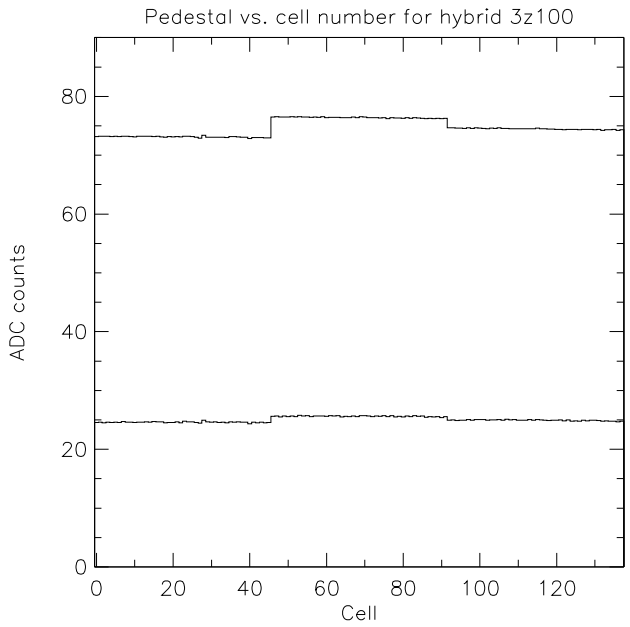
Pedestal vs. Pipeline Cell ID

The following plot shows the average pedestal vs. pipeline cell ID with and without charge injection. The x-axis is cell ID offset by 46 for each chip. Thus cell ID 5 for chip 1 is at x=5, chip 2 at x=51, chip 3 at x=97, etc.

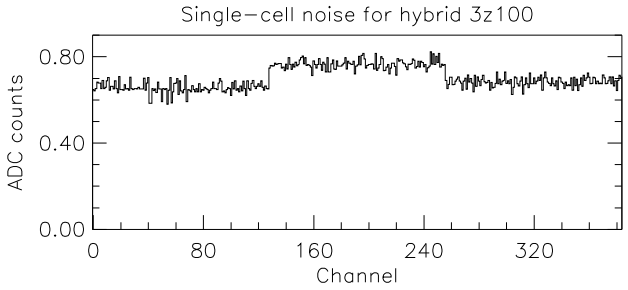
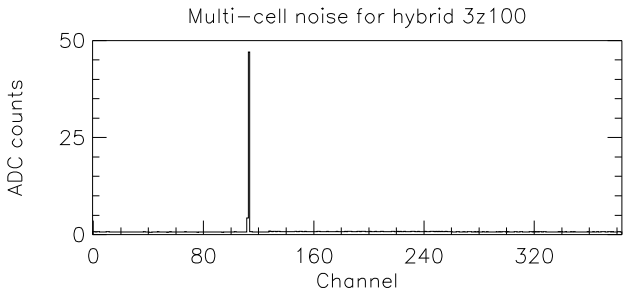
RMS Noise

The following plots show the single-cell and multi-cell RMS noise:

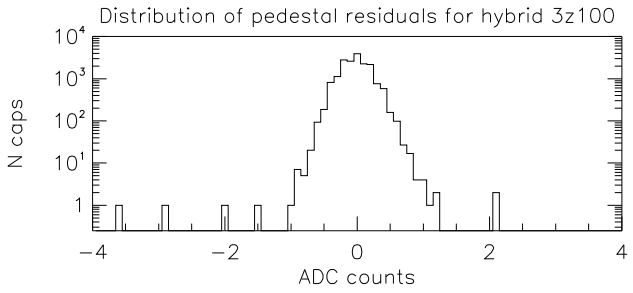
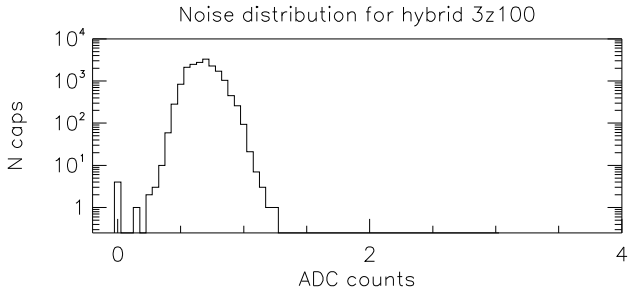
Distribution of Pedestals and Noise

The following are histograms of the pedestal of each pipeline capacitor relative to the chip average (top); and the RMS noise of each capacitor (bottom):

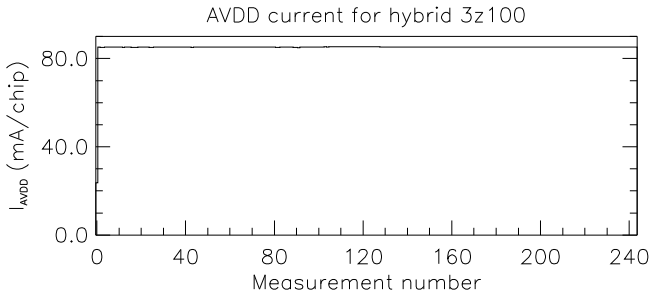
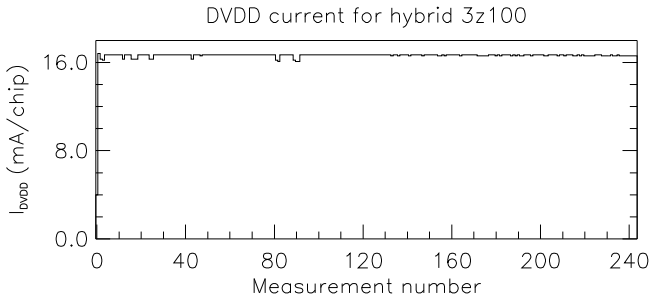
Supply Currents During Burn-in

The following plots show the supply currents per chip as a function of measurment number. Currents are measured approximately every 10 minutes:
