Hybrid 3z107 Traveler

December 14, 1999

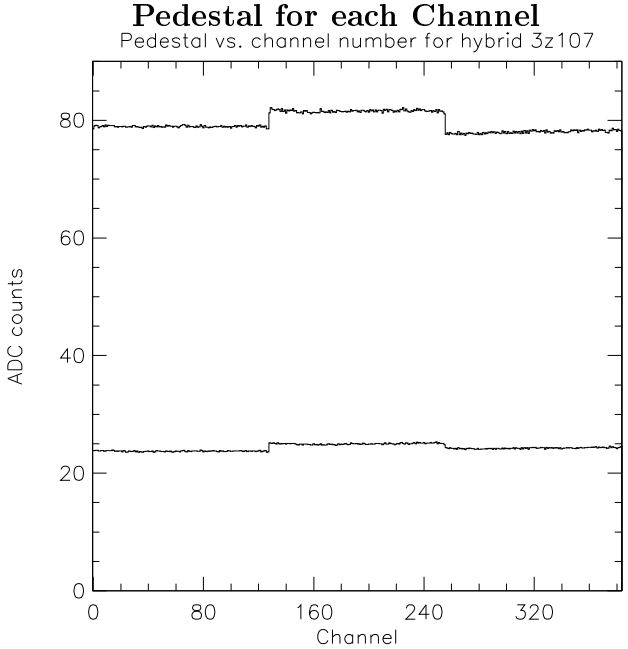
Pedestal for each Channel

The following plot shows the pedestals vs. channel number with and without charge injection:

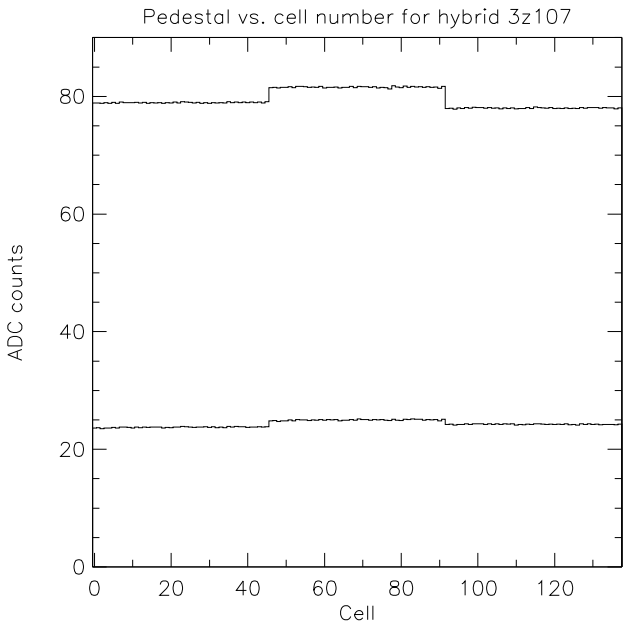
Pedestal vs. Pipeline Cell ID

The following plot shows the average pedestal vs. pipeline cell ID with and without charge injection. The x-axis is cell ID offset by 46 for each chip. Thus cell ID 5 for chip 1 is at x=5, chip 2 at x=51, chip 3 at x=97, etc.

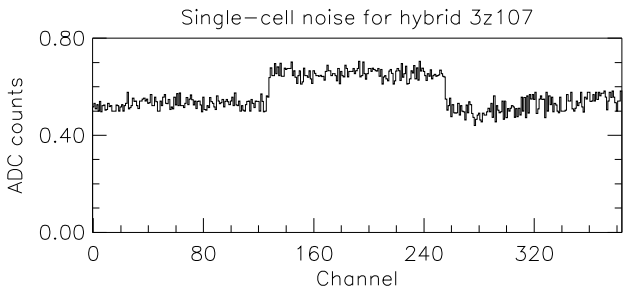
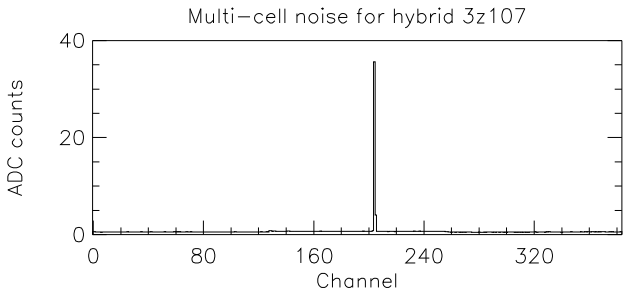
RMS Noise

The following plots show the single-cell and multi-cell RMS noise:

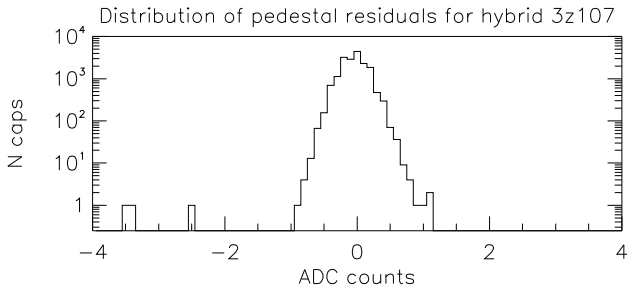
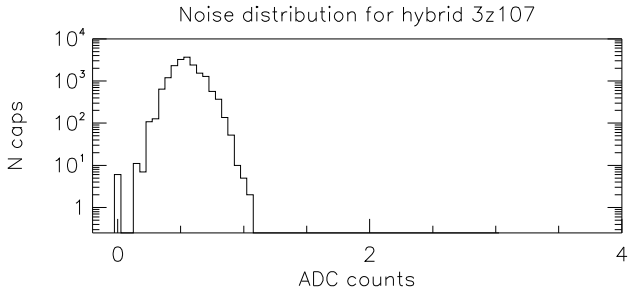
Distribution of Pedestals and Noise

The following are histograms of the pedestal of each pipeline capacitor relative to the chip average (top); and the RMS noise of each capacitor (bottom):

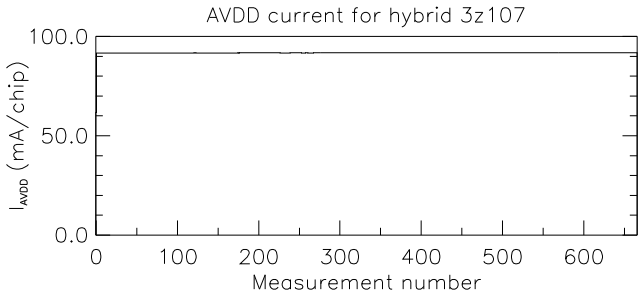
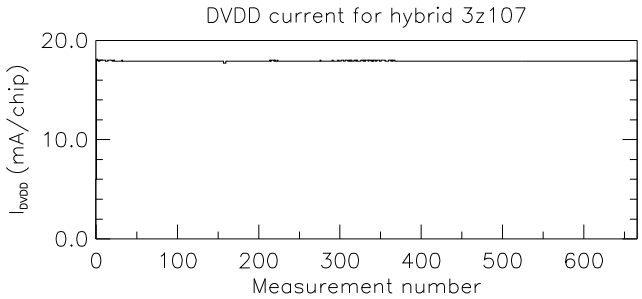
Supply Currents During Burn-in

The following plots show the supply currents per chip as a function of measurment number. Currents are measured approximately every 10 minutes:
