Hybrid 3z110 Traveler

February 15, 2000

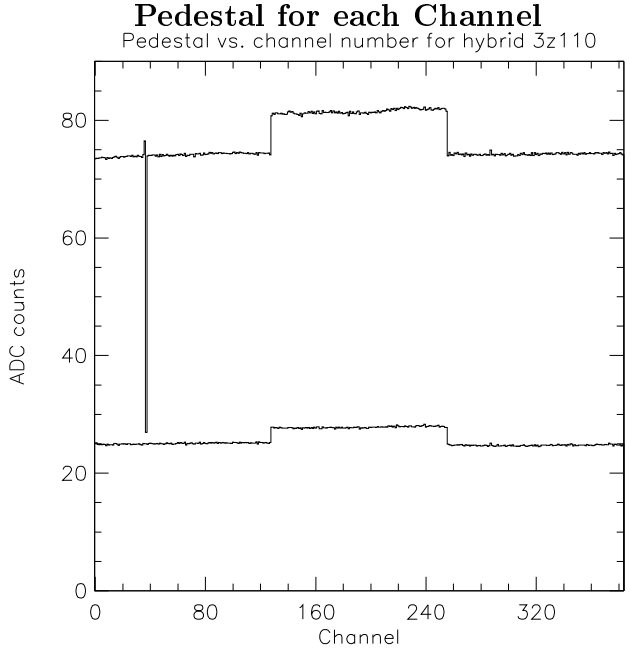
Pedestal for each Channel

Hybrid 3z110 quality: fair
Chip classification: fair good good
Bad channels (chip-channel): 0-37
Bad cells: none
Random bad capacitors: none
Channels at pedestal needed for DCMS: 26.7 30.6 30.7
```

The following plot shows the pedestals vs. channel number with and without charge injection:

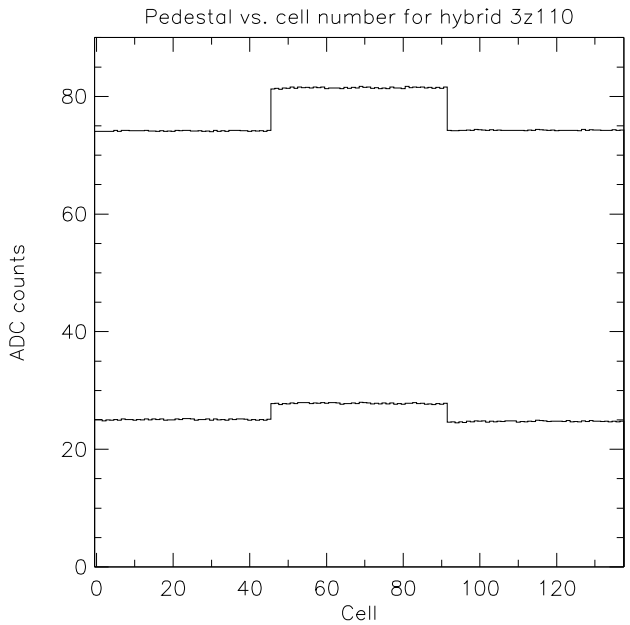
Pedestal vs. Pipeline Cell ID

The following plot shows the average pedestal vs. pipeline cell ID with and without charge injection. The x-axis is cell ID offset by 46 for each chip. Thus cell ID 5 for chip 1 is at x=5, chip 2 at x=51, chip 3 at x=97, etc.

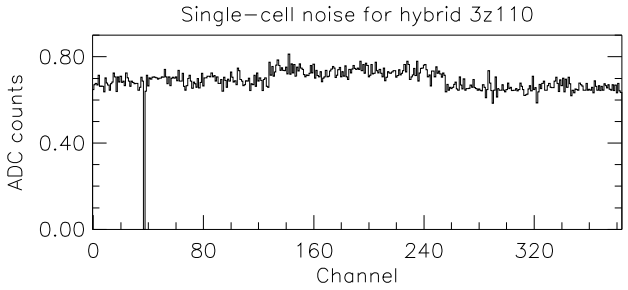
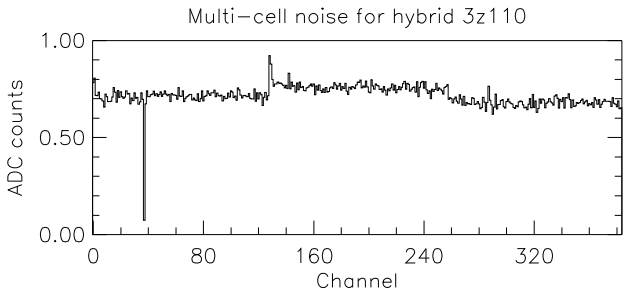
RMS Noise

The following plots show the single-cell and multi-cell RMS noise:

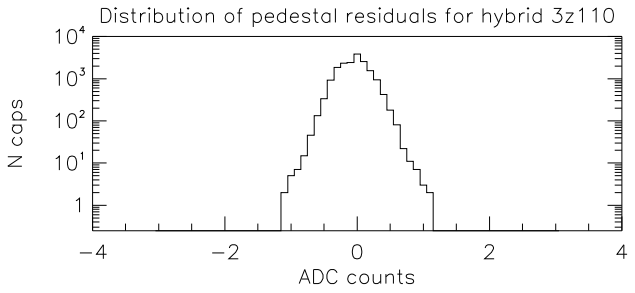
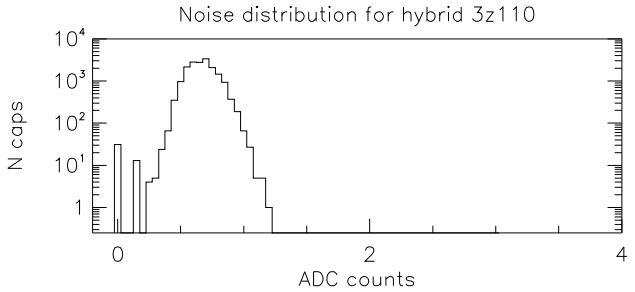
Distribution of Pedestals and Noise

The following are histograms of the pedestal of each pipeline capacitor relative to the chip average (top); and the RMS noise of each capacitor (bottom):

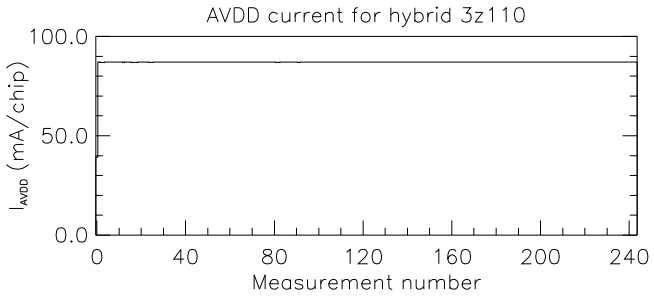
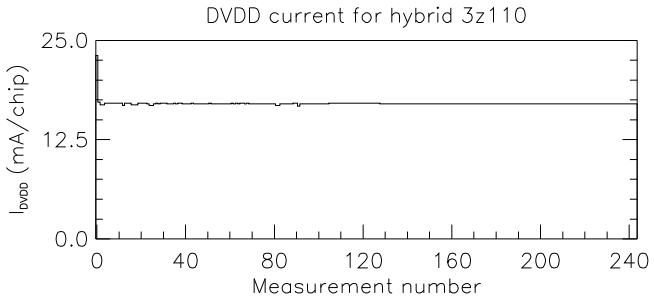
Supply Currents During Burn-in

The following plots show the supply currents per chip as a function of measurment number. Currents are measured approximately every 10 minutes:
