Hybrid 3z112 Traveler

December 14, 1999

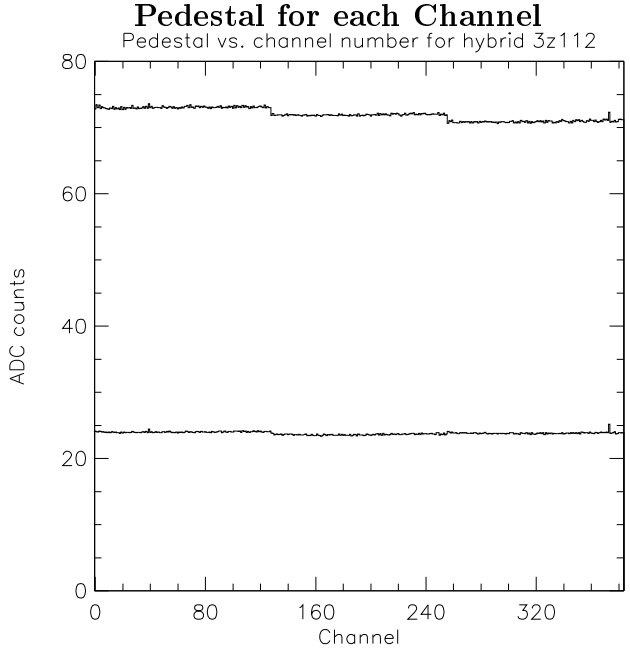
Pedestal for each Channel

The following plot shows the pedestals vs. channel number with and without charge injection:

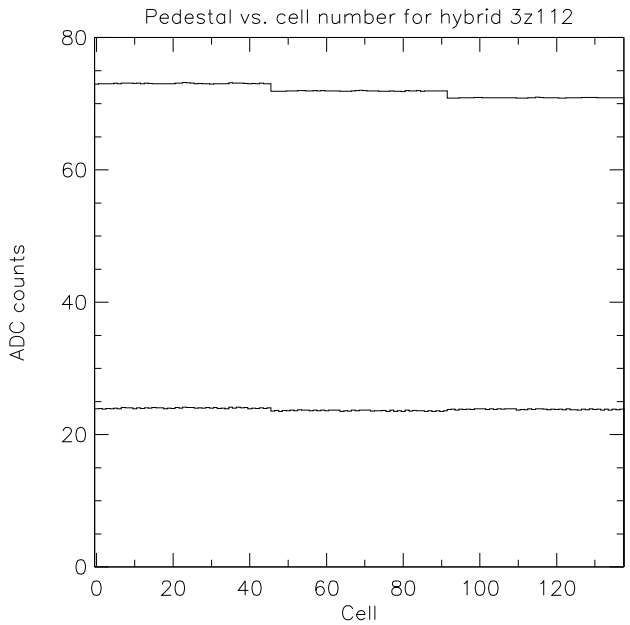
Pedestal vs. Pipeline Cell ID

The following plot shows the average pedestal vs. pipeline cell ID with and without charge injection. The x-axis is cell ID offset by 46 for each chip. Thus cell ID 5 for chip 1 is at x=5, chip 2 at x=51, chip 3 at x=97, etc.

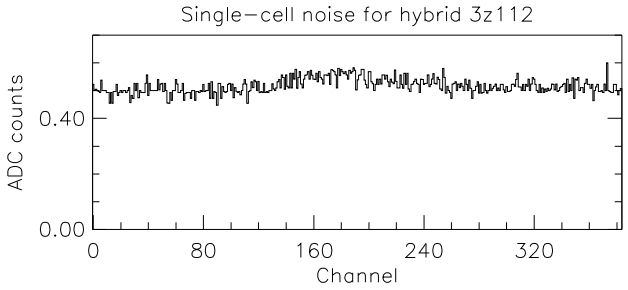
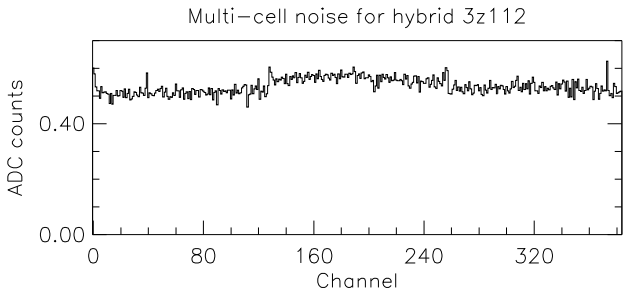
RMS Noise

The following plots show the single-cell and multi-cell RMS noise:

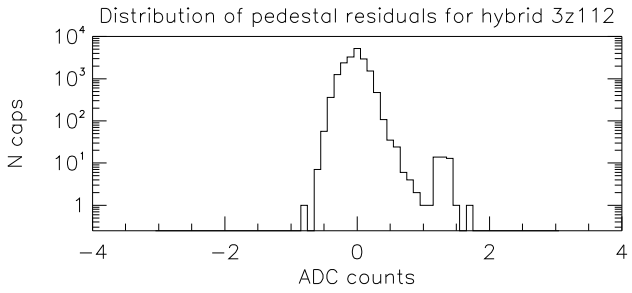
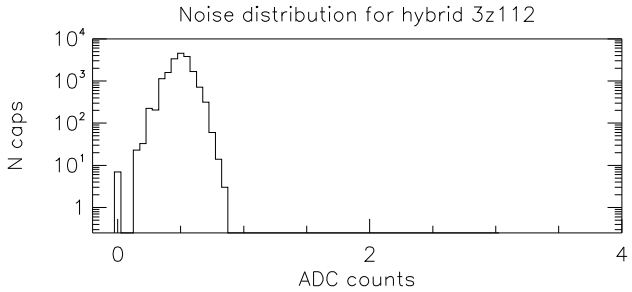
Distribution of Pedestals and Noise

The following are histograms of the pedestal of each pipeline capacitor relative to the chip average (top); and the RMS noise of each capacitor (bottom):

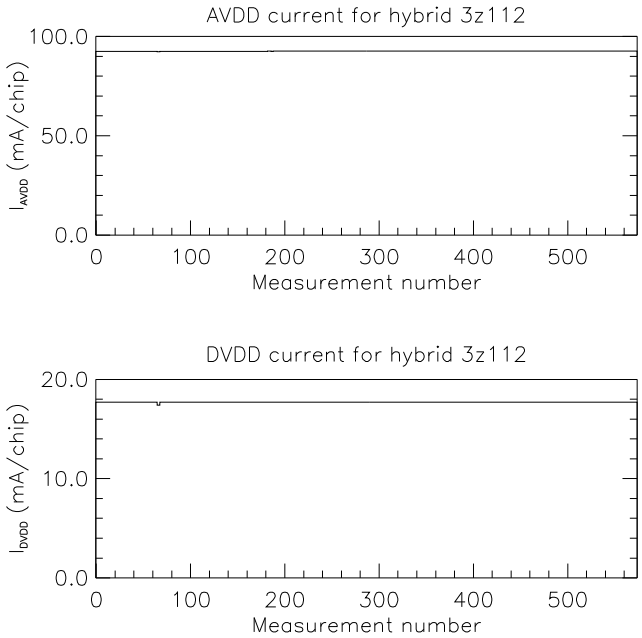
Supply Currents During Burn-in

The following plots show the supply currents per chip as a function of measurment number. Currents are measured approximately every 10 minutes:
