Hybrid 3z114 Traveler

December 9, 1999

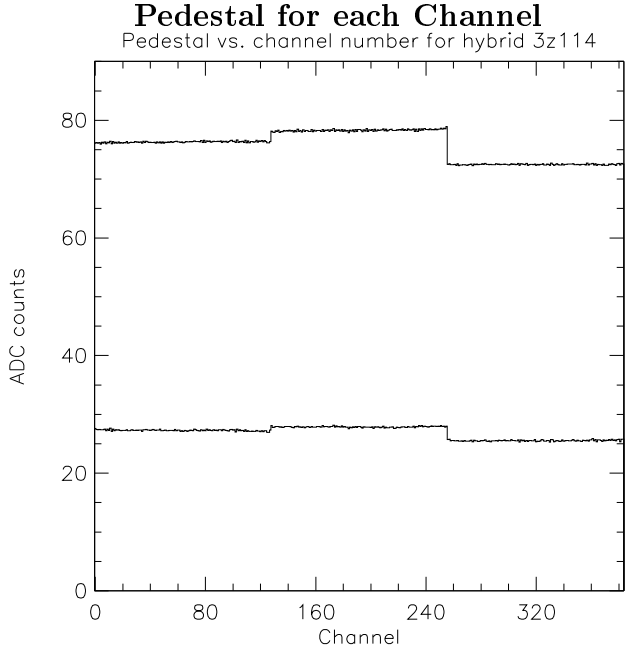
Pedestal for each Channel

The following plot shows the pedestals vs. channel number with and without charge injection:

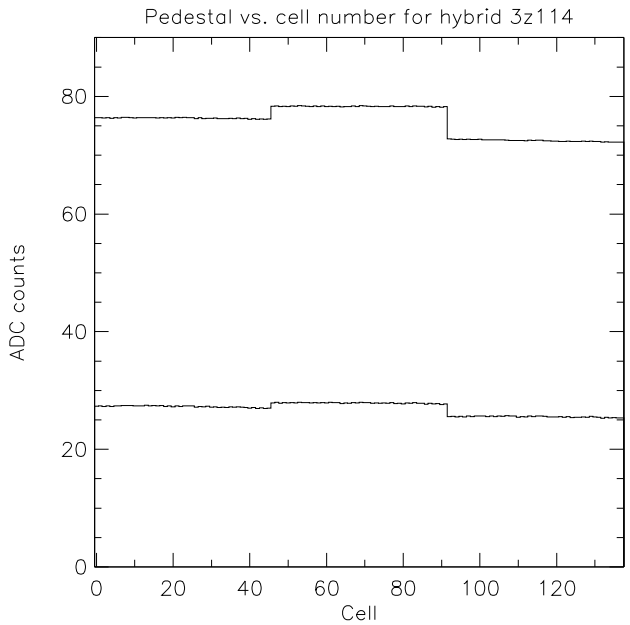
Pedestal vs. Pipeline Cell ID

The following plot shows the average pedestal vs. pipeline cell ID with and without charge injection. The x-axis is cell ID offset by 46 for each chip. Thus cell ID 5 for chip 1 is at x=5, chip 2 at x=51, chip 3 at x=97, etc.

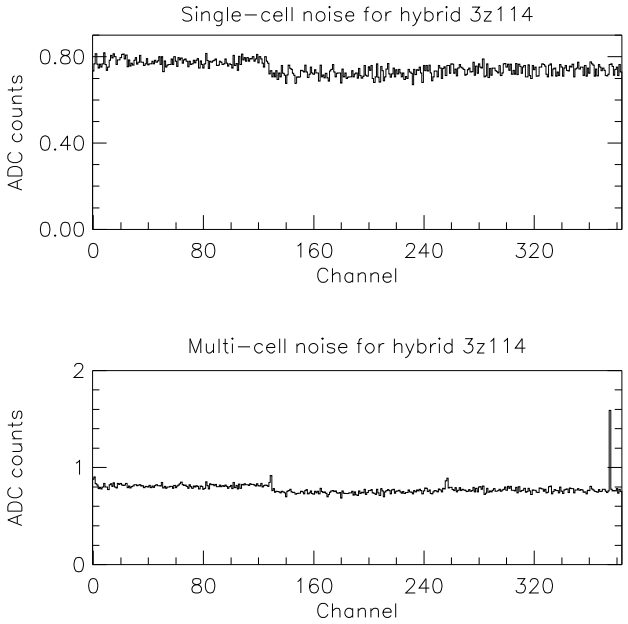
RMS Noise

The following plots show the single-cell and multi-cell RMS noise:

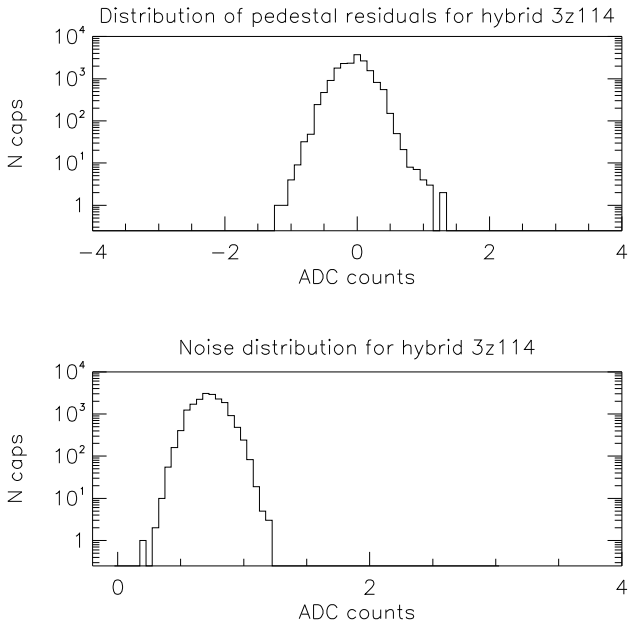
Distribution of Pedestals and Noise

The following are histograms of the pedestal of each pipeline capacitor relative to the chip average (top); and the RMS noise of each capacitor (bottom):

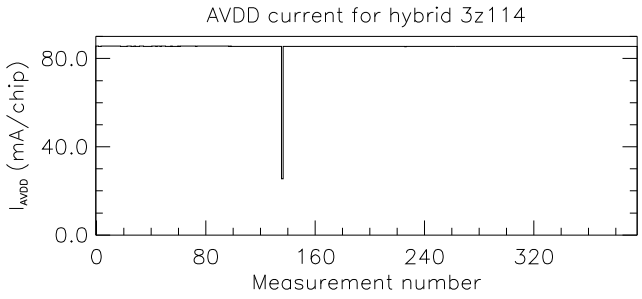
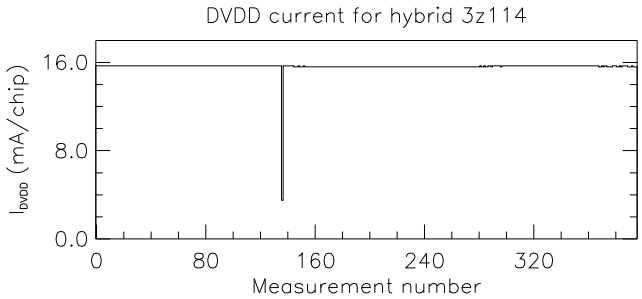
Supply Currents During Burn-in

The following plots show the supply currents per chip as a function of measurment number. Currents are measured approximately every 10 minutes:
