Hybrid 3z116 Traveler

November 4, 1999

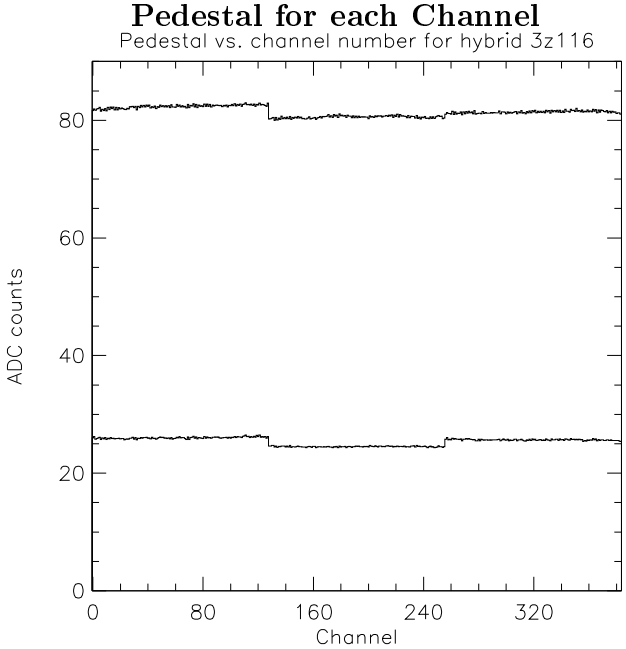
Pedestal for each Channel

The following plot shows the pedestals vs. channel number with and without charge injection:

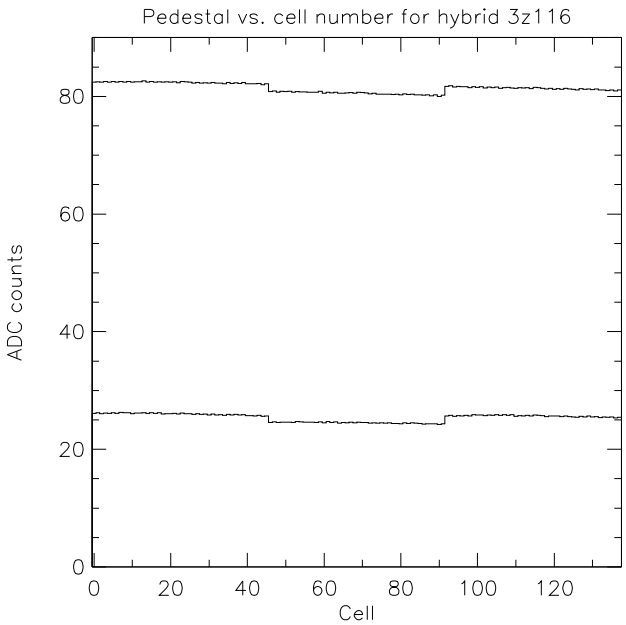
Pedestal vs. Pipeline Cell ID

The following plot shows the average pedestal vs. pipeline cell ID with and without charge injection. The x-axis is cell ID offset by 46 for each chip. Thus cell ID 5 for chip 1 is at x=5, chip 2 at x=51, chip 3 at x=97, etc.

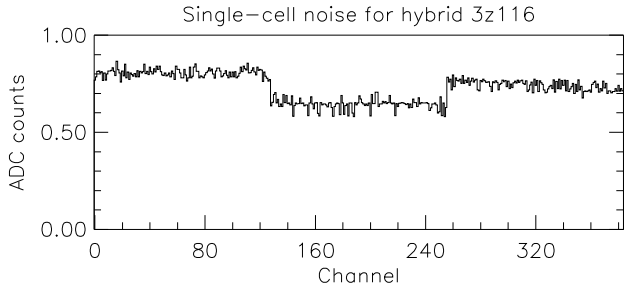
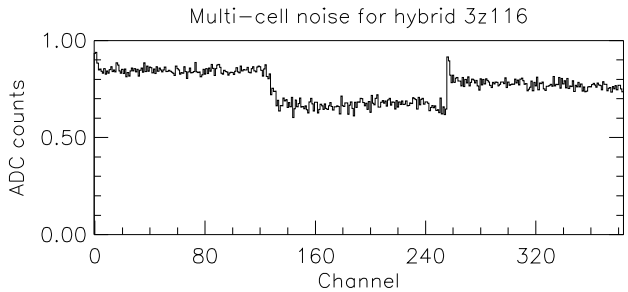
RMS Noise

The following plots show the single-cell and multi-cell RMS noise:

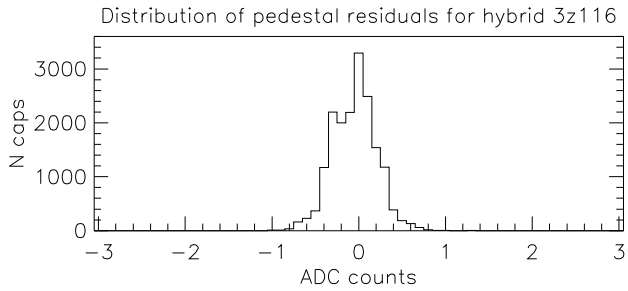
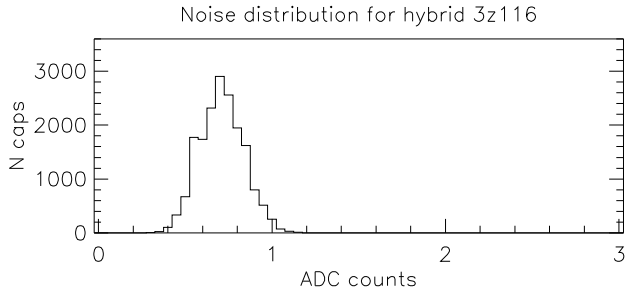
Distribution of Pedestals and Noise

The following are histograms of the pedestal of each pipeline capacitor relative to the chip average (top); and the RMS noise of each capacitor (bottom):

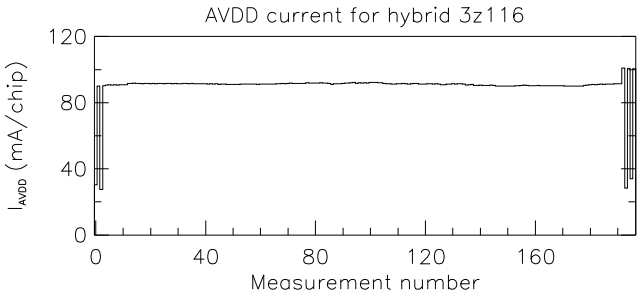
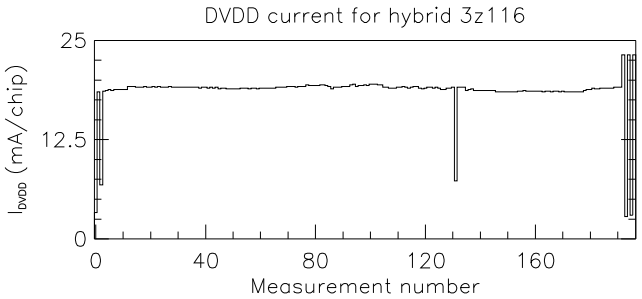
Supply Currents During Burn-in

The following plots show the supply currents per chip as a function of measurment number. Currents are measured approximately every 10 minutes:
