Hybrid 3z119 Traveler

May 30, 2000

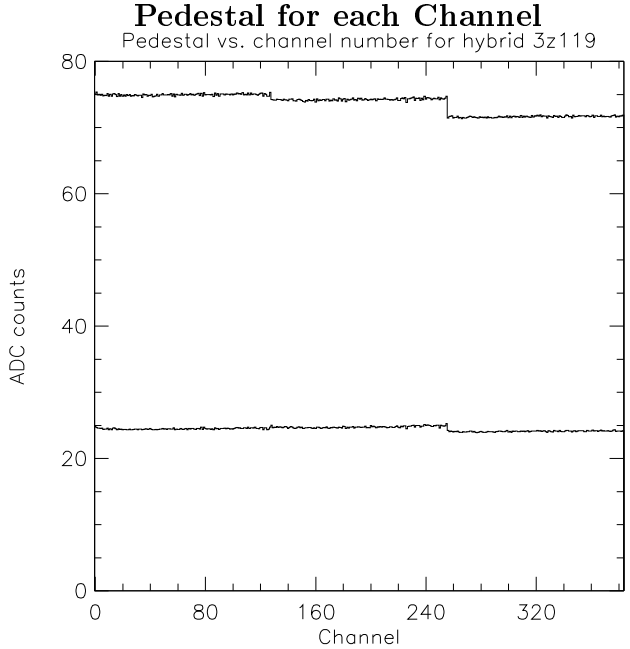
Pedestal for each Channel

The following plot shows the pedestals vs. channel number with and without charge injection:

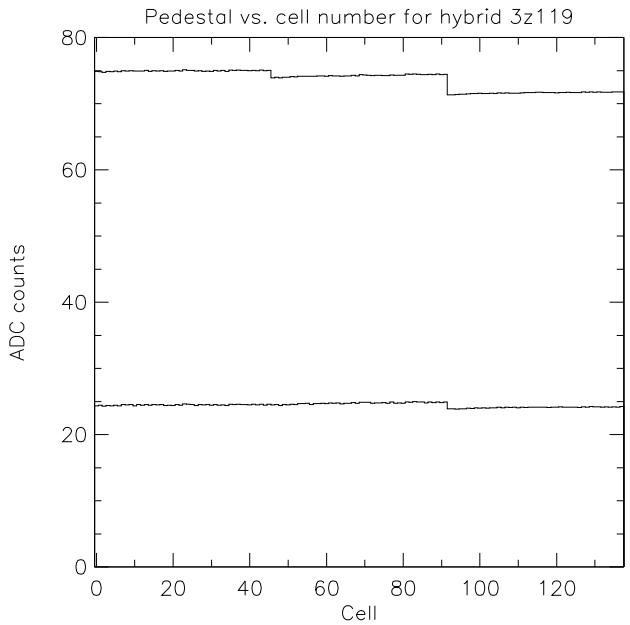
Pedestal vs. Pipeline Cell ID

The following plot shows the average pedestal vs. pipeline cell ID with and without charge injection. The x-axis is cell ID offset by 46 for each chip. Thus cell ID 5 for chip 1 is at x=5, chip 2 at x=51, chip 3 at x=97, etc.

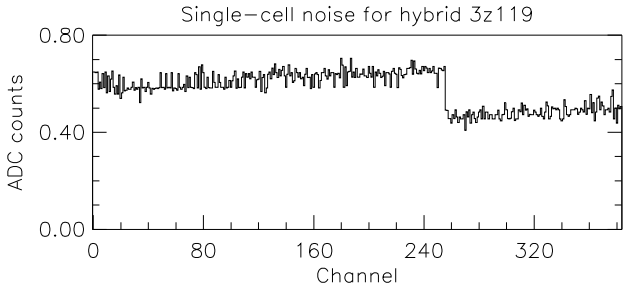
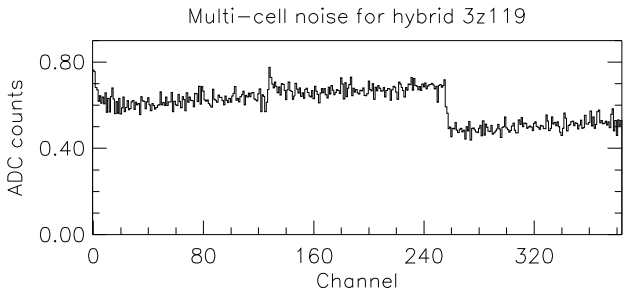
RMS Noise

The following plots show the single-cell and multi-cell RMS noise:

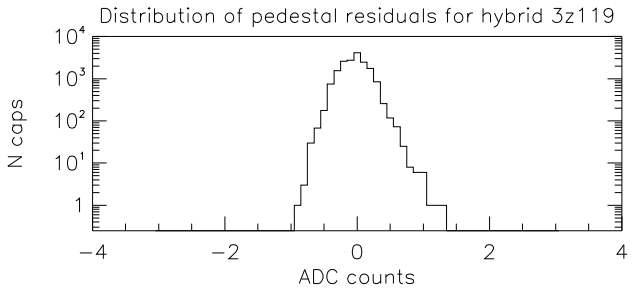
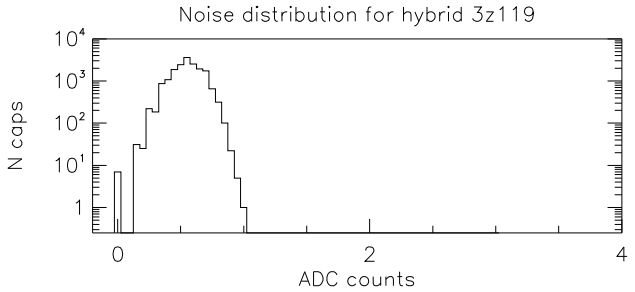
Distribution of Pedestals and Noise

The following are histograms of the pedestal of each pipeline capacitor relative to the chip average (top); and the RMS noise of each capacitor (bottom):

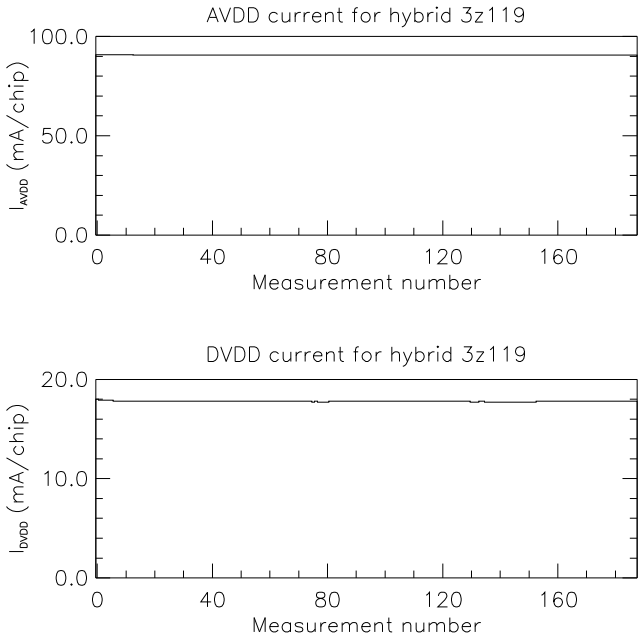
Supply Currents During Burn-in

The following plots show the supply currents per chip as a function of measurment number. Currents are measured approximately every 10 minutes:
