Hybrid 3z122 Traveler

December 17, 1999

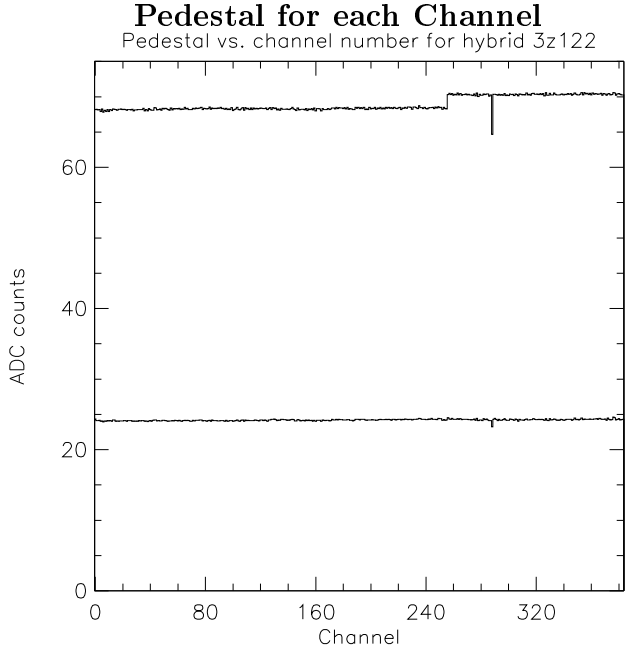
Pedestal for each Channel

The following plot shows the pedestals vs. channel number with and without charge injection:

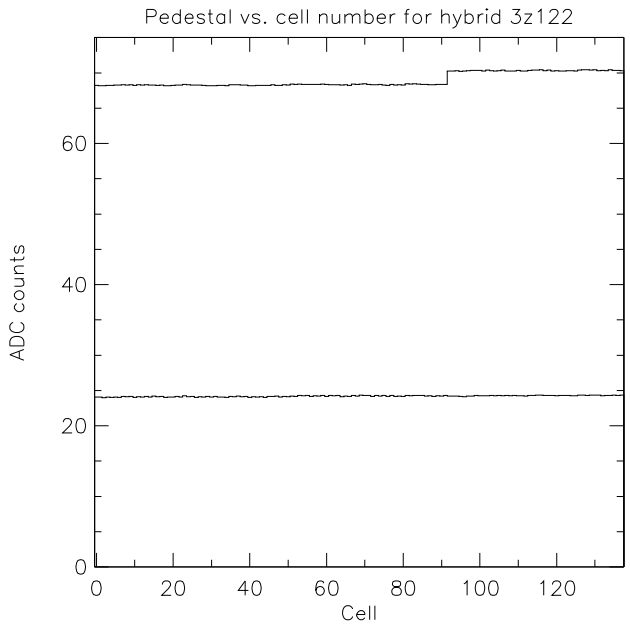
Pedestal vs. Pipeline Cell ID

The following plot shows the average pedestal vs. pipeline cell ID with and without charge injection. The x-axis is cell ID offset by 46 for each chip. Thus cell ID 5 for chip 1 is at x=5, chip 2 at x=51, chip 3 at x=97, etc.

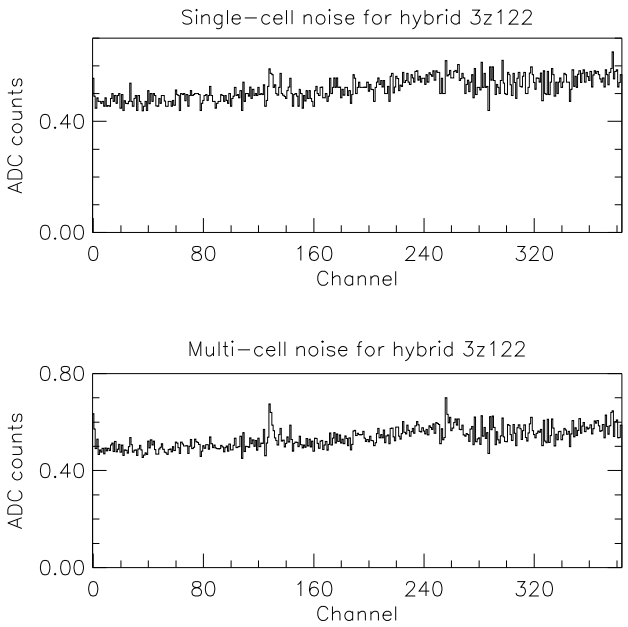
RMS Noise

The following plots show the single-cell and multi-cell RMS noise:

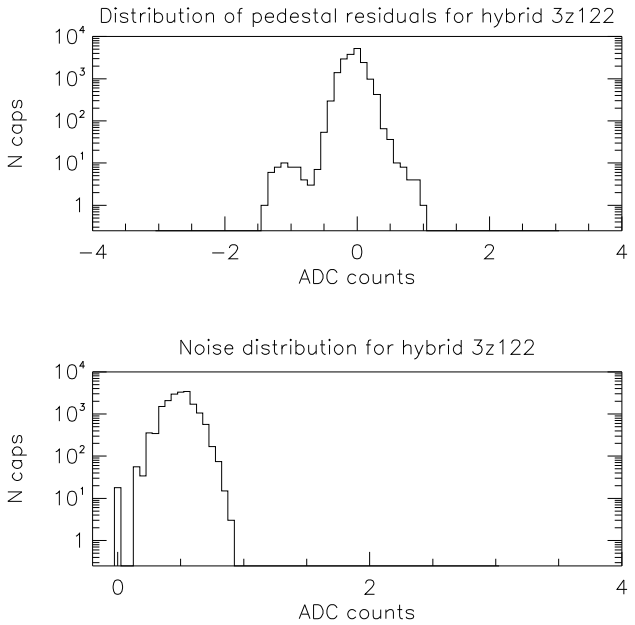
Distribution of Pedestals and Noise

The following are histograms of the pedestal of each pipeline capacitor relative to the chip average (top); and the RMS noise of each capacitor (bottom):

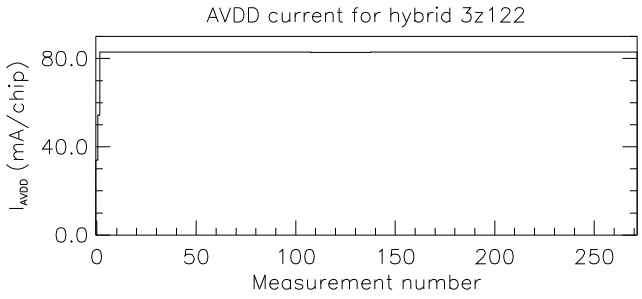
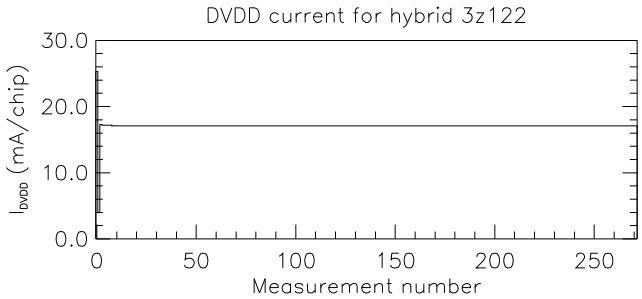
Supply Currents During Burn-in

The following plots show the supply currents per chip as a function of measurment number. Currents are measured approximately every 10 minutes:
