Hybrid 3z125 Traveler

January 19, 2000

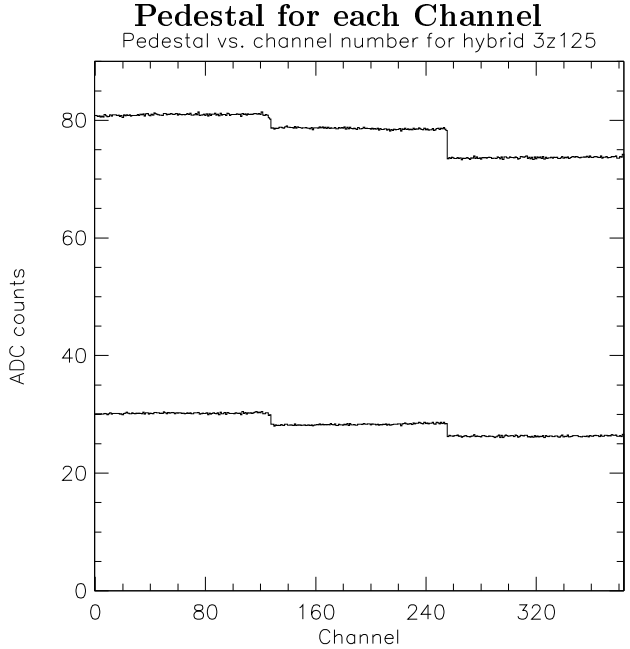
Pedestal for each Channel

The following plot shows the pedestals vs. channel number with and without charge injection:

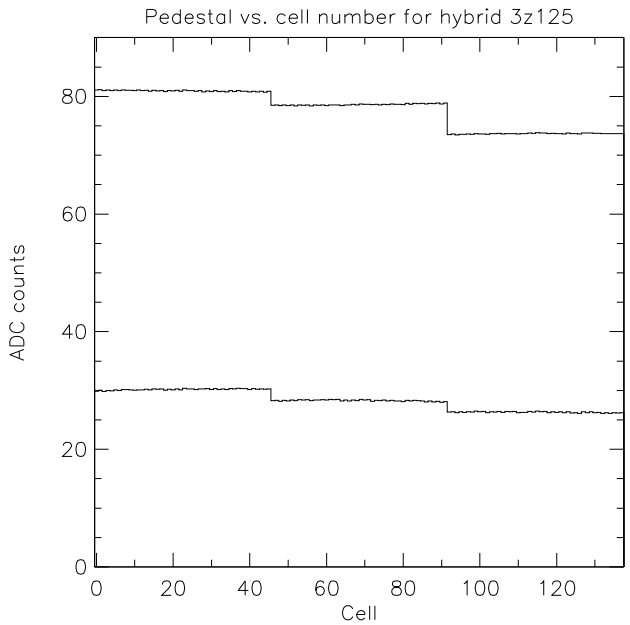
Pedestal vs. Pipeline Cell ID

The following plot shows the average pedestal vs. pipeline cell ID with and without charge injection. The x-axis is cell ID offset by 46 for each chip. Thus cell ID 5 for chip 1 is at x=5, chip 2 at x=51, chip 3 at x=97, etc.

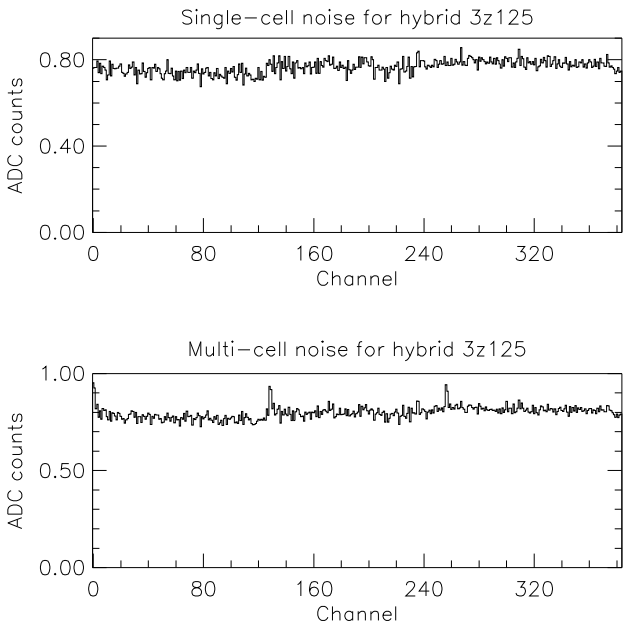
RMS Noise

The following plots show the single-cell and multi-cell RMS noise:

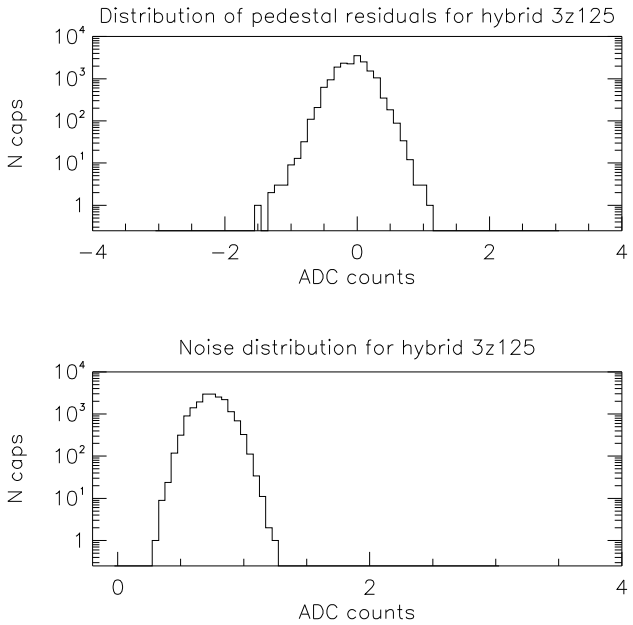
Distribution of Pedestals and Noise

The following are histograms of the pedestal of each pipeline capacitor relative to the chip average (top); and the RMS noise of each capacitor (bottom):

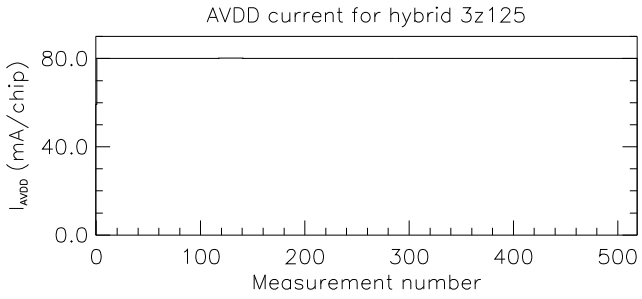
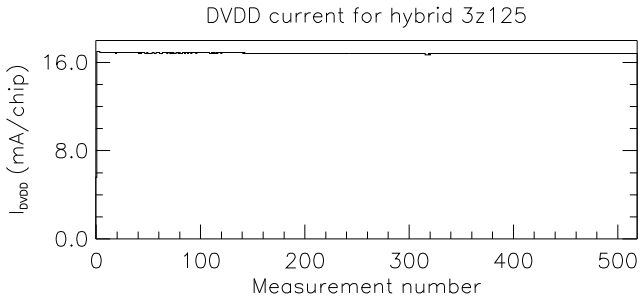
Supply Currents During Burn-in

The following plots show the supply currents per chip as a function of measurment number. Currents are measured approximately every 10 minutes:
