Hybrid 3z135 Traveler

December 3, 1999

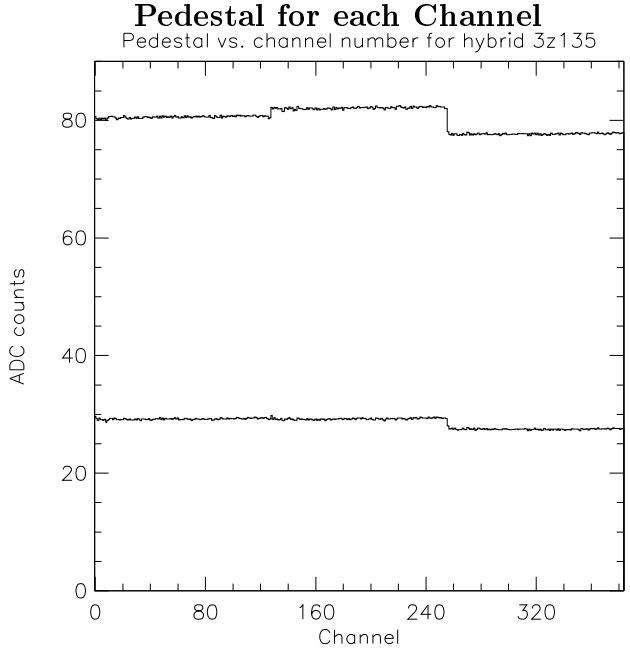
Pedestal for each Channel

The following plot shows the pedestals vs. channel number with and without charge injection:

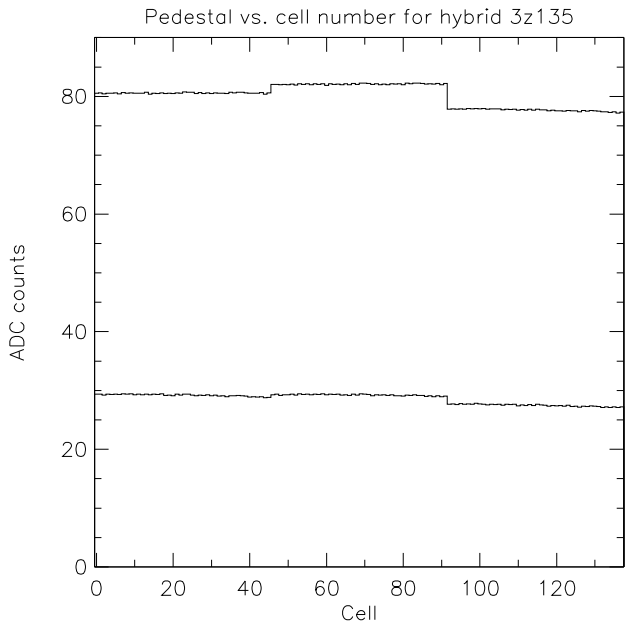
Pedestal vs. Pipeline Cell ID

The following plot shows the average pedestal vs. pipeline cell ID with and without charge injection. The x-axis is cell ID offset by 46 for each chip. Thus cell ID 5 for chip 1 is at x=5, chip 2 at x=51, chip 3 at x=97, etc.

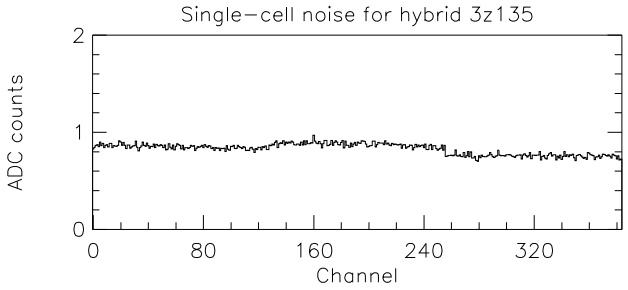
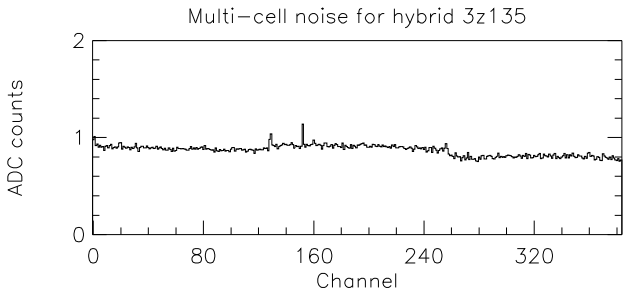
RMS Noise

The following plots show the single-cell and multi-cell RMS noise:

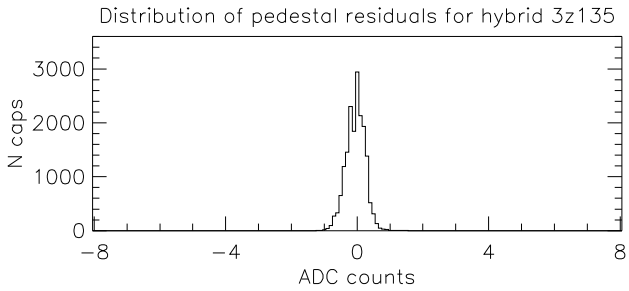
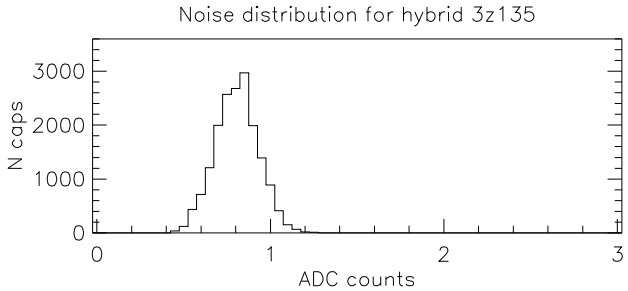
Distribution of Pedestals and Noise

The following are histograms of the pedestal of each pipeline capacitor relative to the chip average (top); and the RMS noise of each capacitor (bottom):

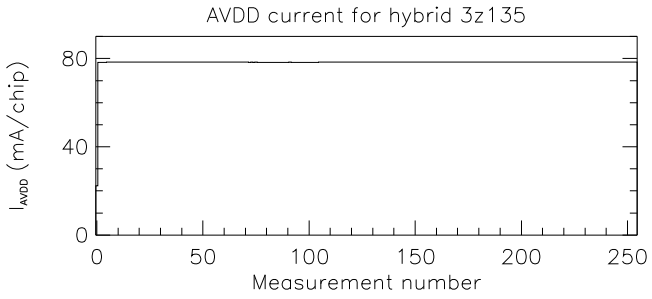
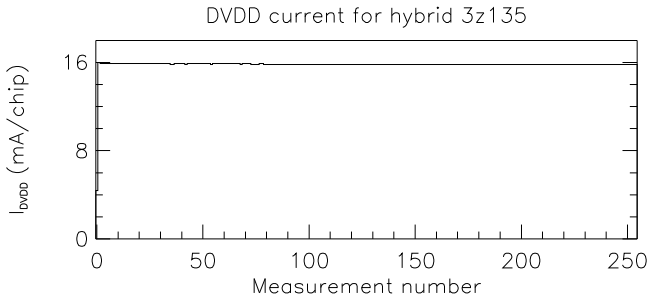
Supply Currents During Burn-in

The following plots show the supply currents per chip as a function of measurment number. Currents are measured approximately every 10 minutes:
