# Hybrid 3z152 Traveler

June 13, 2000

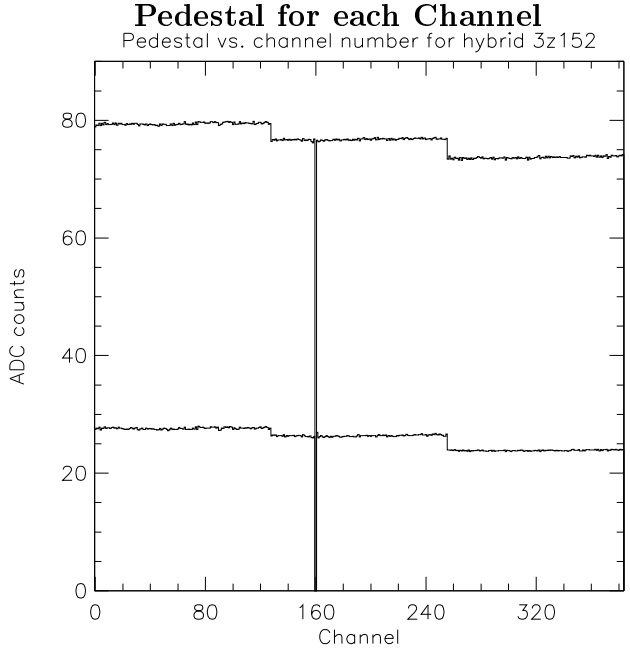
**Pedestal for each Channel**

The following plot shows the pedestals vs. channel number with and without charge injection:

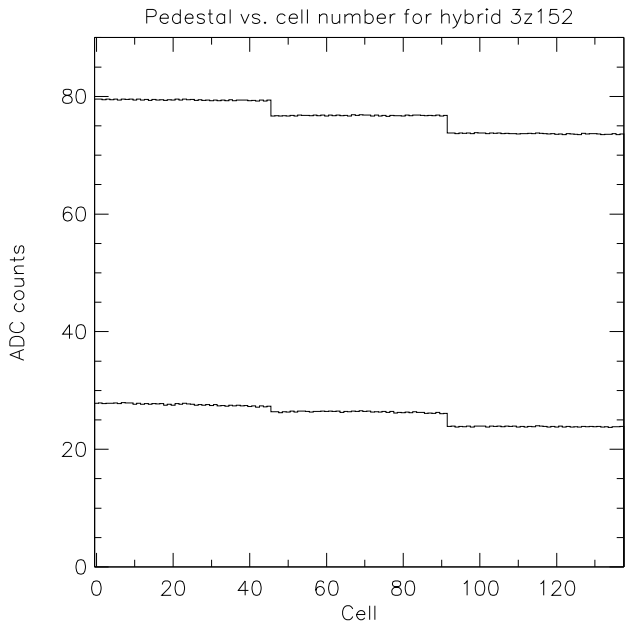
**Pedestal vs. Pipeline Cell ID**

The following plot shows the average pedestal vs. pipeline cell ID with and without charge injection. The x-axis is cell ID offset by 46 for each chip. Thus cell ID 5 for chip 1 is at x=5, chip 2 at x=51, chip 3 at x=97, etc.

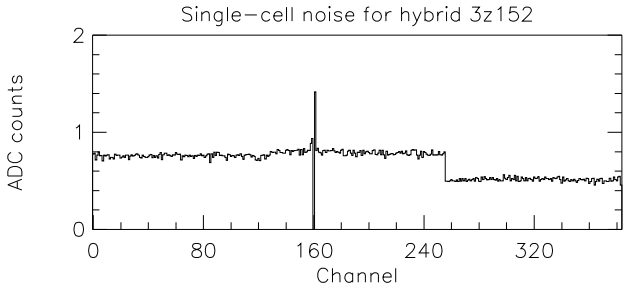
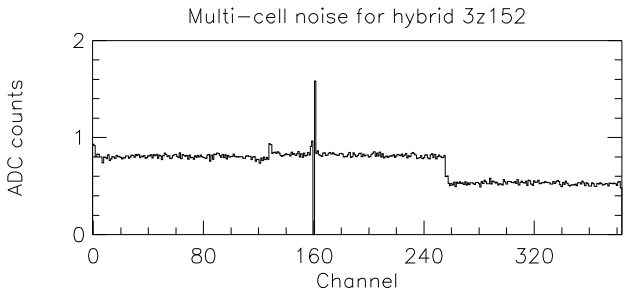
**RMS Noise**

The following plots show the single-cell and multi-cell RMS noise:

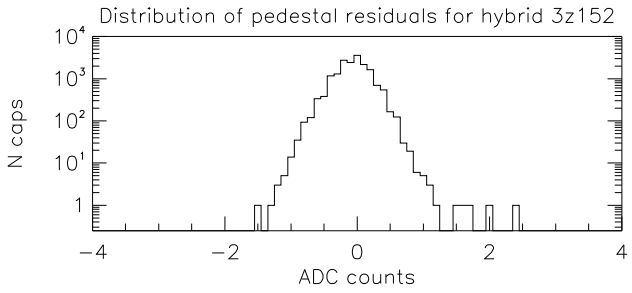
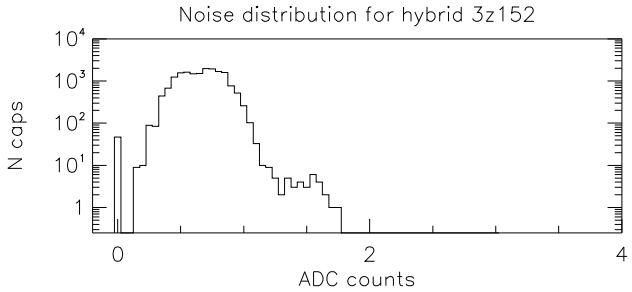
**Distribution of Pedestals and Noise**

The following are histograms of the pedestal of each pipeline capacitor relative to the chip average (top); and the RMS noise of each capacitor (bottom):

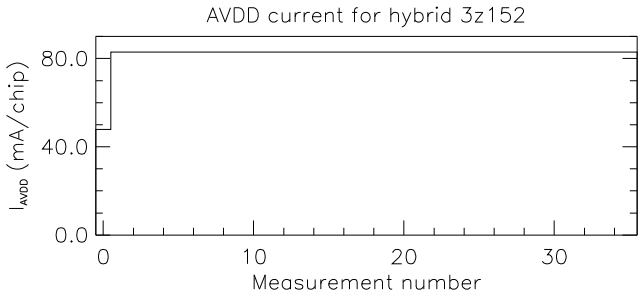
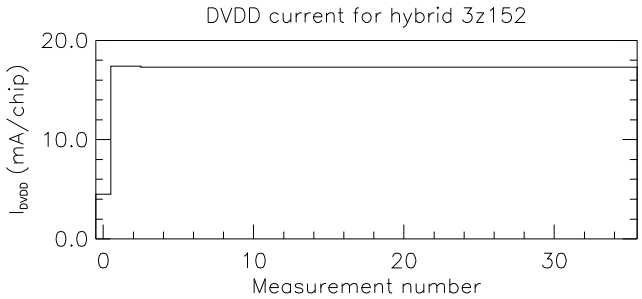
**Supply Currents During Burn-in**

The following plots show the supply currents per chip as a function of measurment number. Currents are measured approximately every 10 minutes:
