Hybrid 3z156 Traveler

December 21, 1999

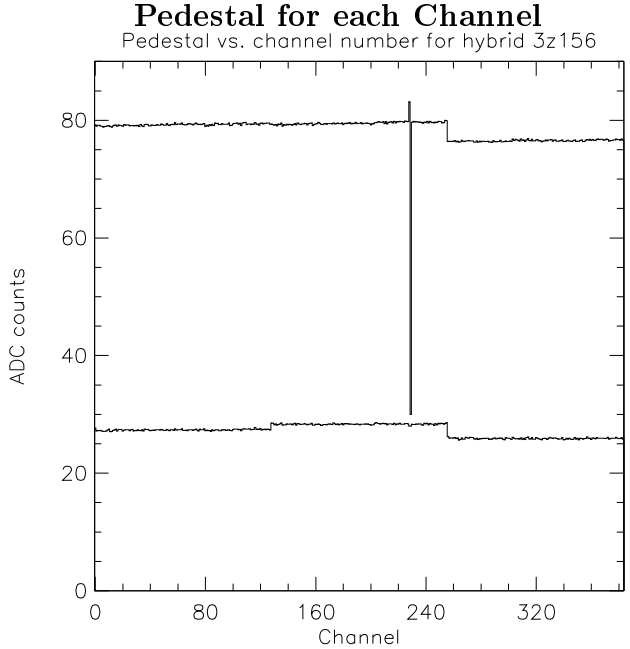
Pedestal for each Channel

The following plot shows the pedestals vs. channel number with and without charge injection:

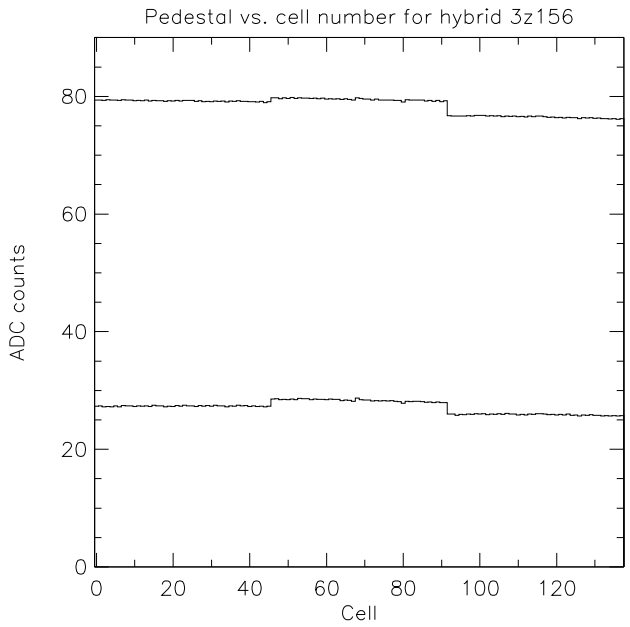
Pedestal vs. Pipeline Cell ID

The following plot shows the average pedestal vs. pipeline cell ID with and without charge injection. The x-axis is cell ID offset by 46 for each chip. Thus cell ID 5 for chip 1 is at x=5, chip 2 at x=51, chip 3 at x=97, etc.

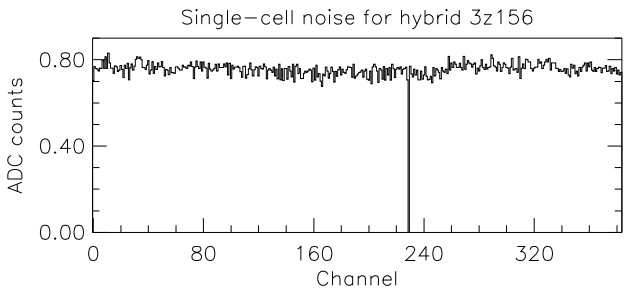
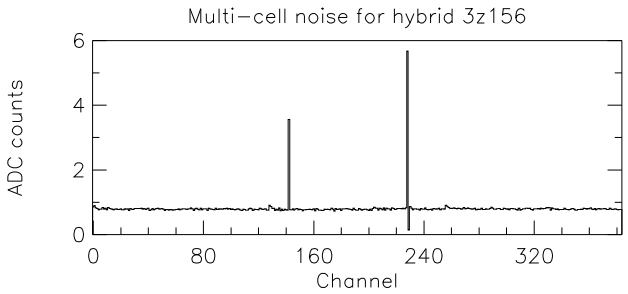
RMS Noise

The following plots show the single-cell and multi-cell RMS noise:

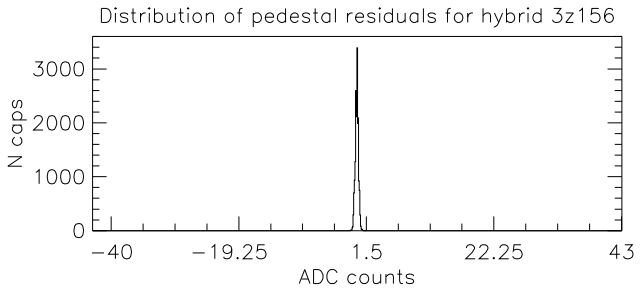
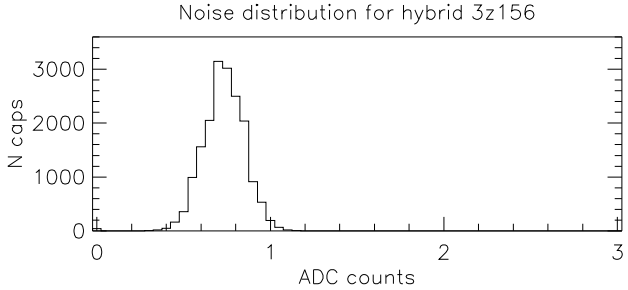
Distribution of Pedestals and Noise

The following are histograms of the pedestal of each pipeline capacitor relative to the chip average (top); and the RMS noise of each capacitor (bottom):

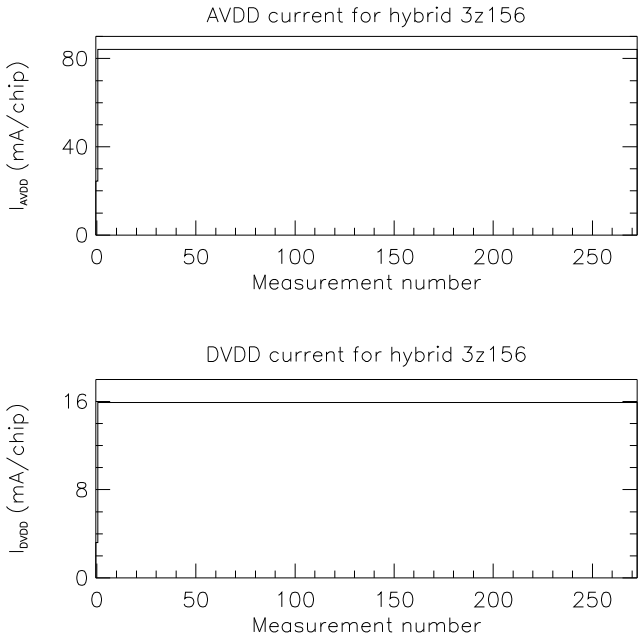
Supply Currents During Burn-in

The following plots show the supply currents per chip as a function of measurment number. Currents are measured approximately every 10 minutes:
