Hybrid 3z158 Traveler

December 14, 1999

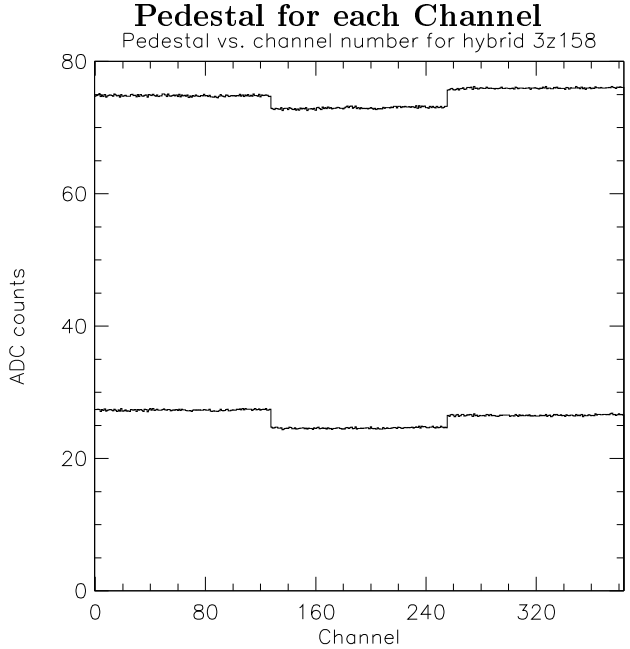
Pedestal for each Channel

The following plot shows the pedestals vs. channel number with and without charge injection:

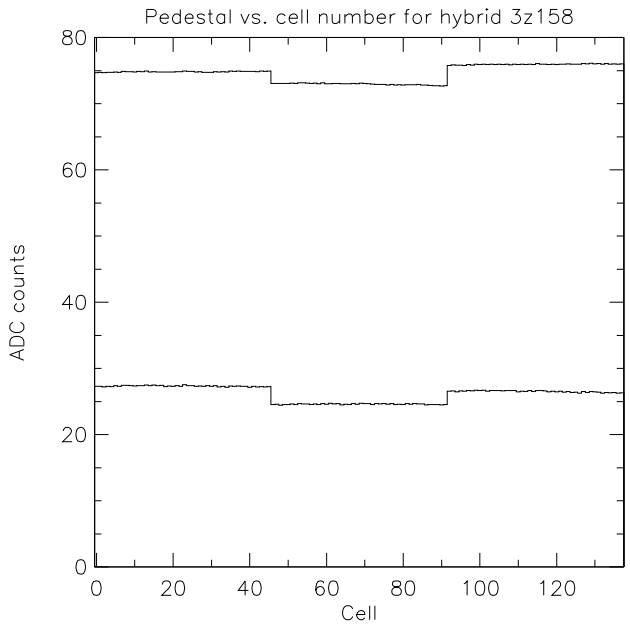
Pedestal vs. Pipeline Cell ID

The following plot shows the average pedestal vs. pipeline cell ID with and without charge injection. The x-axis is cell ID offset by 46 for each chip. Thus cell ID 5 for chip 1 is at x=5, chip 2 at x=51, chip 3 at x=97, etc.

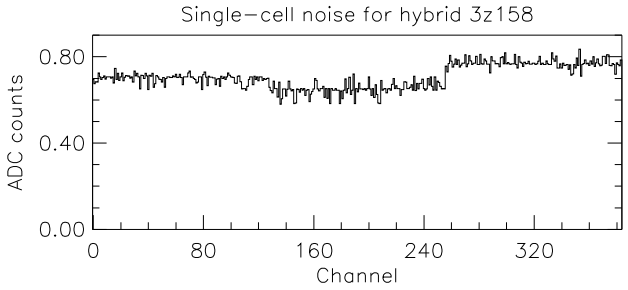
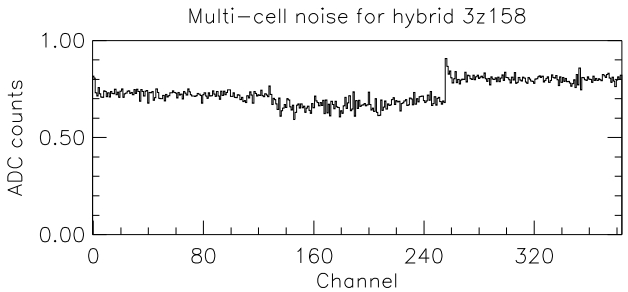
RMS Noise

The following plots show the single-cell and multi-cell RMS noise:

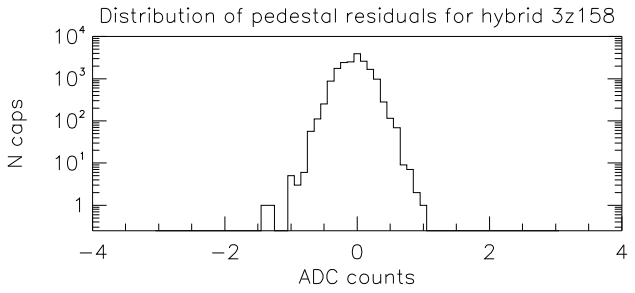
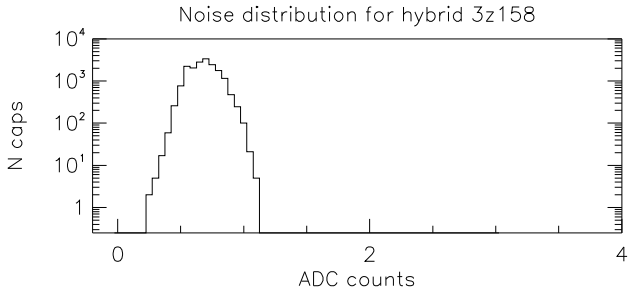
Distribution of Pedestals and Noise

The following are histograms of the pedestal of each pipeline capacitor relative to the chip average (top); and the RMS noise of each capacitor (bottom):

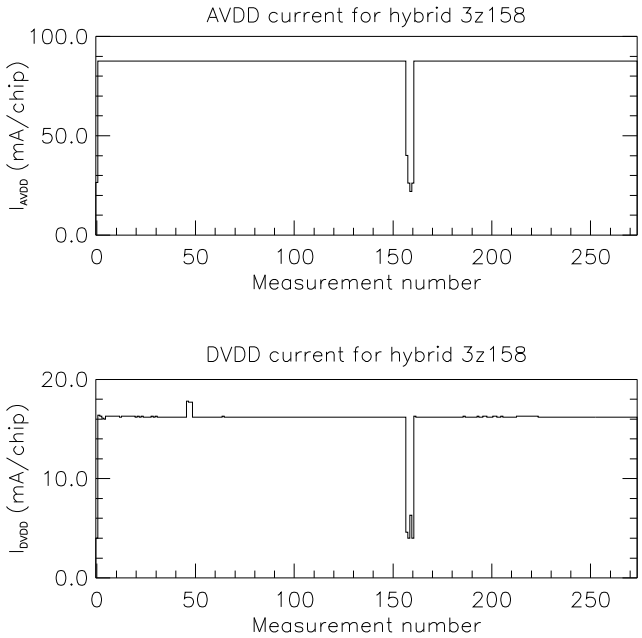
Supply Currents During Burn-in

The following plots show the supply currents per chip as a function of measurment number. Currents are measured approximately every 10 minutes:
