Hybrid 3z19 Traveler

January 13, 2000

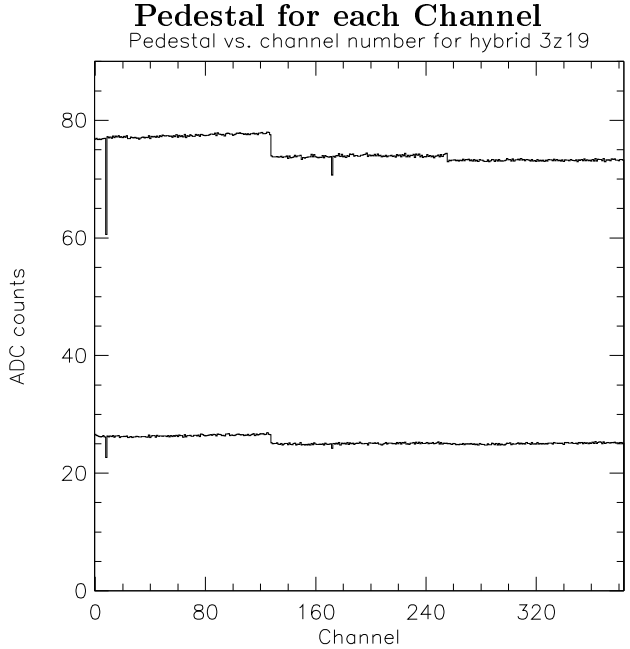
Pedestal for each Channel

Hybrid 3z19 quality: fair
Chip classification: fair good good
Bad channels (chip-channel): 0-8
Bad cells: none
Random bad capacitors: none
Channels at pedestal needed for DCMS: 29.3 28.7 29.6
```
