# Hybrid 3z192 Traveler

April 25, 2000

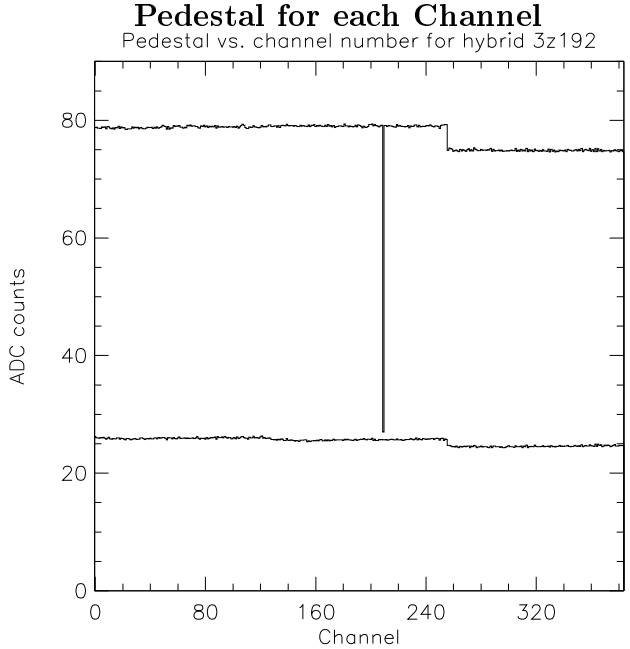
**Pedestal for each Channel**

The following plot shows the pedestals vs. channel number with and without charge injection:

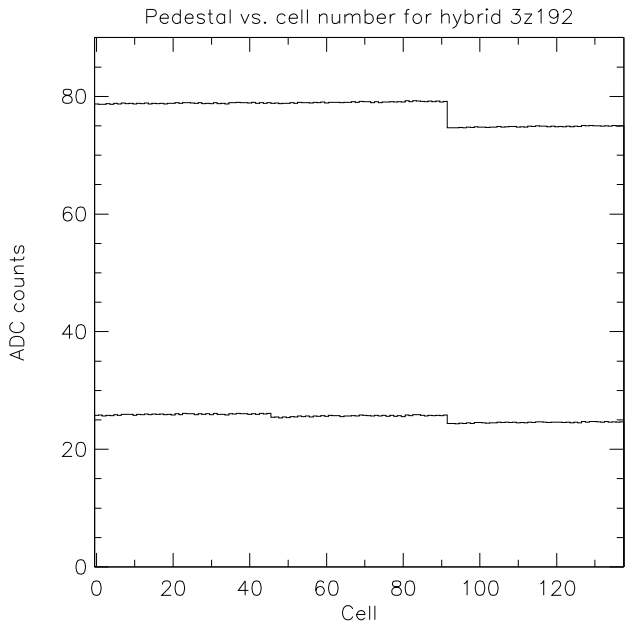
**Pedestal vs. Pipeline Cell ID**

The following plot shows the average pedestal vs. pipeline cell ID with and without charge injection. The x-axis is cell ID offset by 46 for each chip. Thus cell ID 5 for chip 1 is at x=5, chip 2 at x=51, chip 3 at x=97, etc.

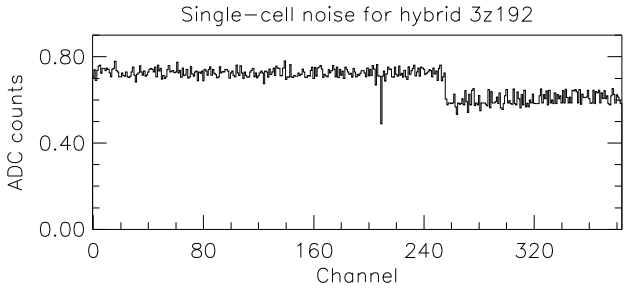
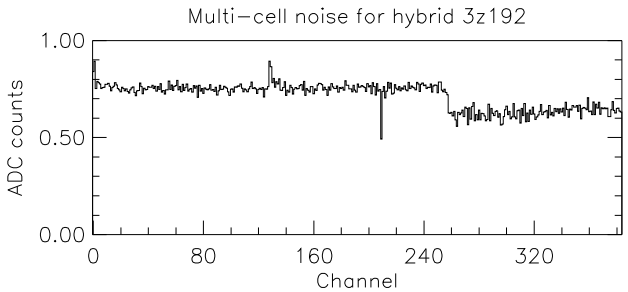
**RMS Noise**

The following plots show the single-cell and multi-cell RMS noise:

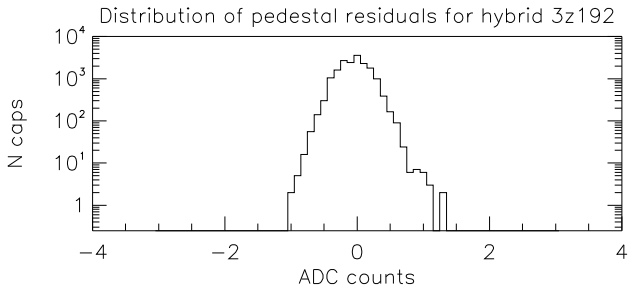
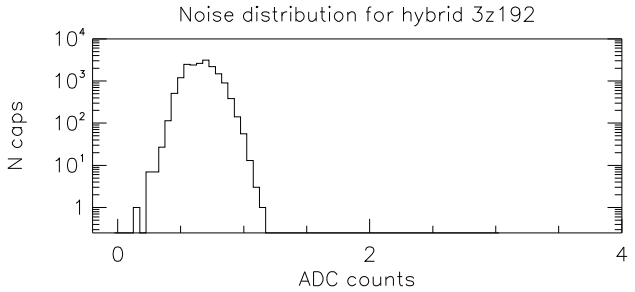
**Distribution of Pedestals and Noise**

The following are histograms of the pedestal of each pipeline capacitor relative to the chip average (top); and the RMS noise of each capacitor (bottom):

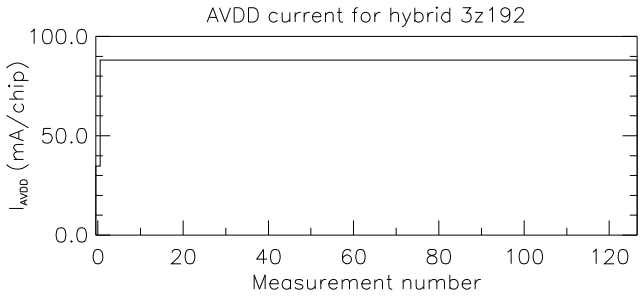
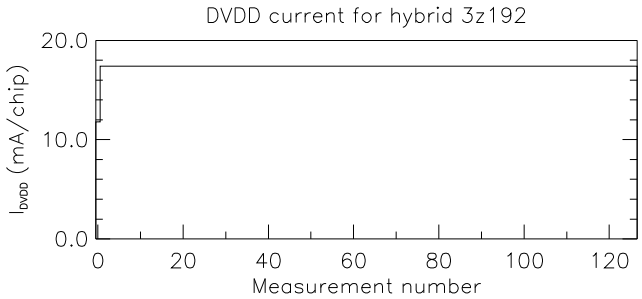
**Supply Currents During Burn-in**

The following plots show the supply currents per chip as a function of measurment number. Currents are measured approximately every 10 minutes:
