Hybrid 3z3 Traveler

October 8, 1999

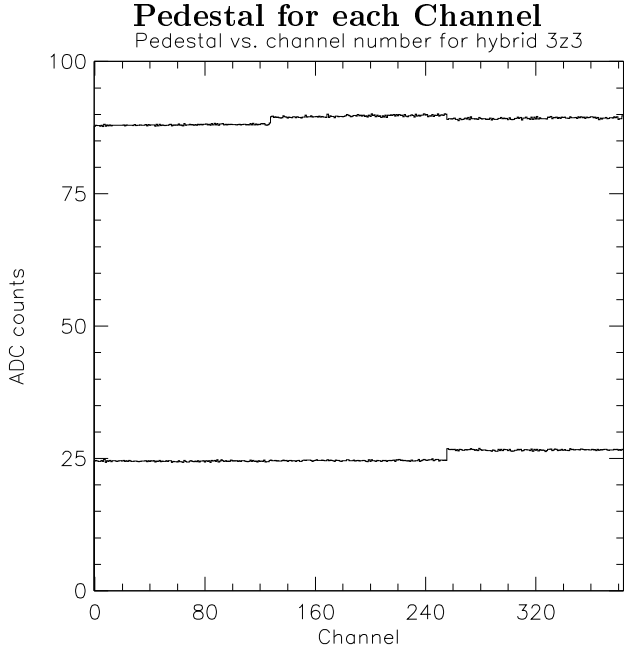
Pedestal for each Channel

Hybrid 3z3 quality: fair
Chip classification: fair good good
Bad channels (chip-channel): 0-27
Bad cells: none
Random bad capacitors: none
Channels at pedestal needed for DCMS: 33.9 35.7 31.7
```
