# Hybrid 3z39 Traveler

October 4, 1999

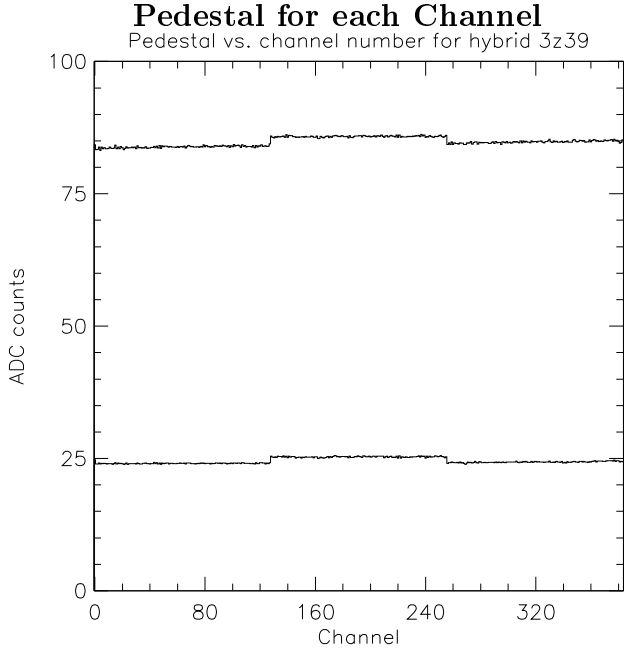
**Pedestal for each Channel**

The following plot shows the pedestals vs. channel number with and without charge injection:

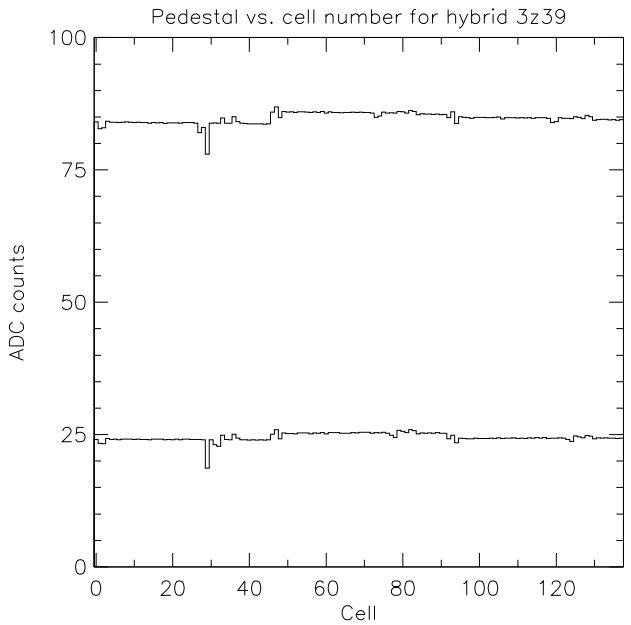
**Pedestal vs. Pipeline Cell ID**

The following plot shows the average pedestal vs. pipeline cell ID with and without charge injection. The x-axis is cell ID offset by 46 for each chip. Thus cell ID 5 on chip 1 is at x=5, chip 2 at x=49, chip 3 at x=97, etc.

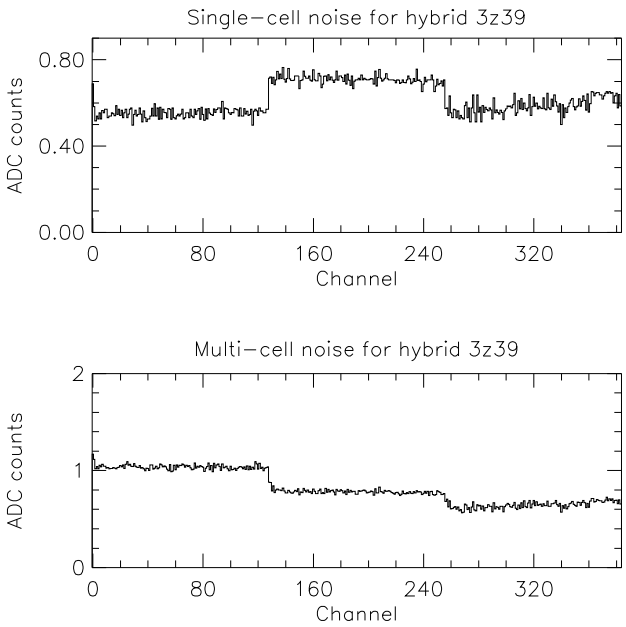
**RMS Noise**

The following plots show the single-cell and multi-cell RMS noise:

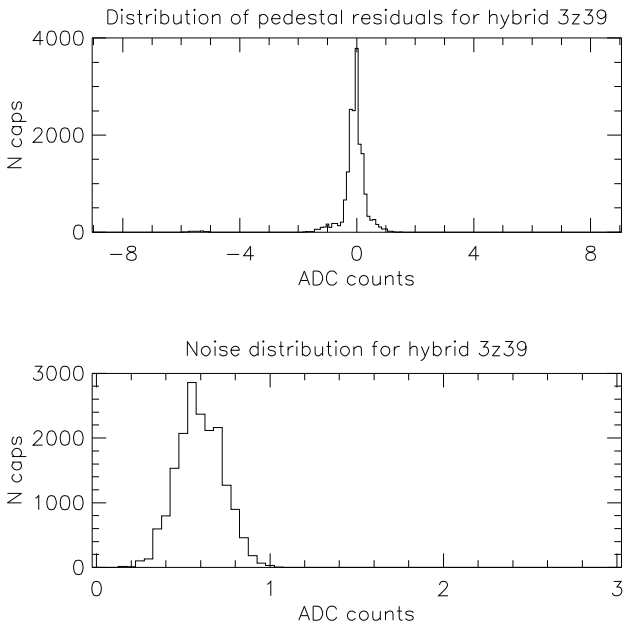
**Distribution of pedestals and noise**

The upper plot shows the difference between the pedestal of each channel and the average pedestal and the lower plots shows the RMS noise of all the channels:

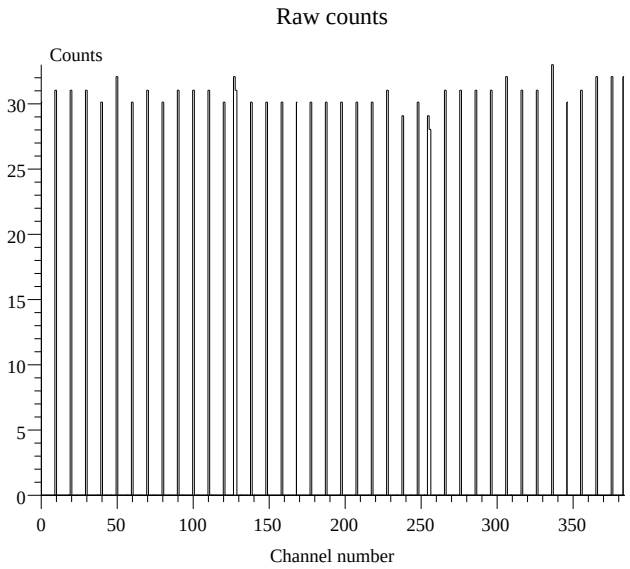
**Dynamic Threshold Subtraction**

The following plot shows the readout of channels with charge injection with the dynamic threshold subtraction turned on:
