Hybrid 3z45 Traveler

January 7, 2000

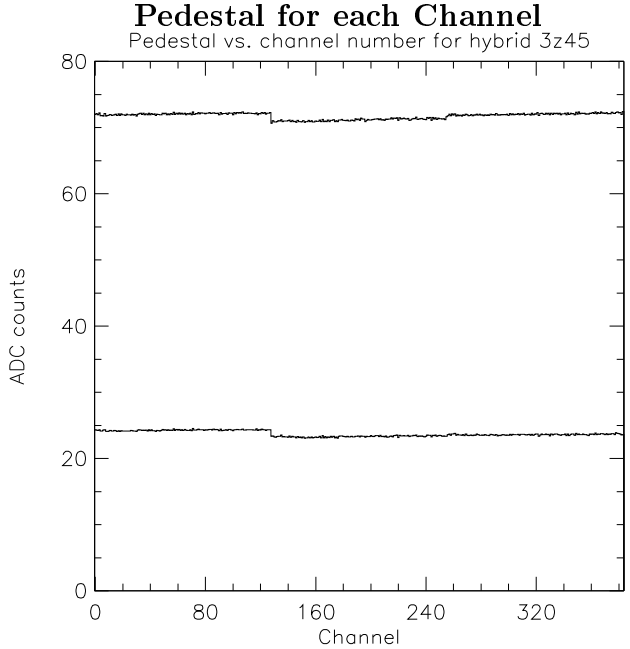
Pedestal for each Channel

The following plot shows the pedestals vs. channel number with and without charge injection:

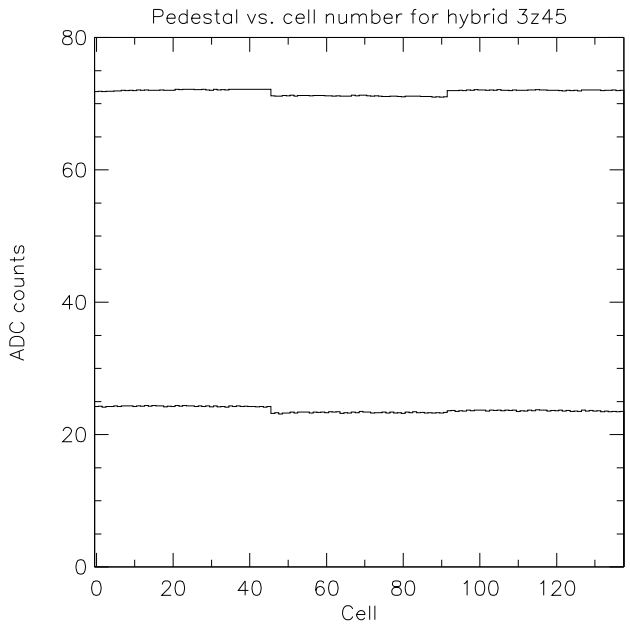
Pedestal vs. Pipeline Cell ID

The following plot shows the average pedestal vs. pipeline cell ID with and without charge injection. The x-axis is cell ID offset by 46 for each chip. Thus cell ID 5 for chip 1 is at x=5, chip 2 at x=51, chip 3 at x=97, etc.

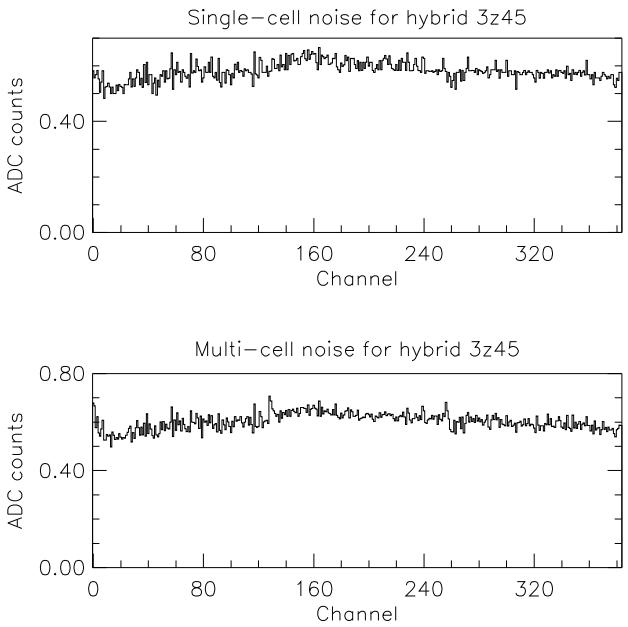
RMS Noise

The following plots show the single-cell and multi-cell RMS noise:

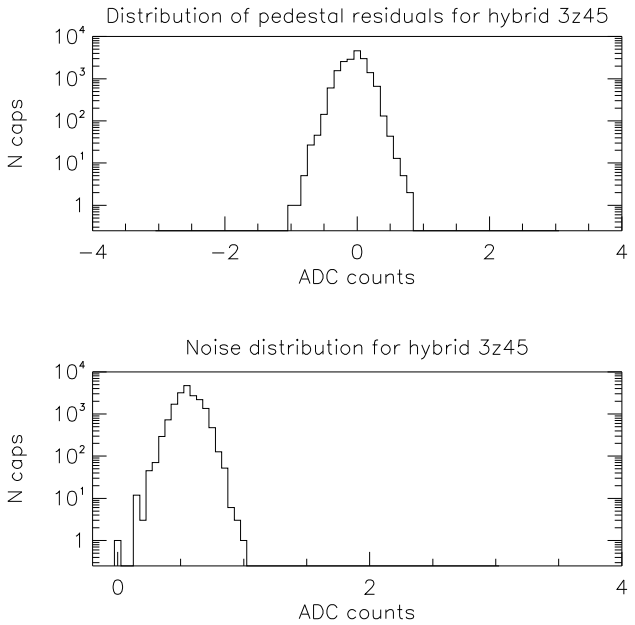
Distribution of Pedestals and Noise

The following are histograms of the pedestal of each pipeline capacitor relative to the chip average (top); and the RMS noise of each capacitor (bottom):

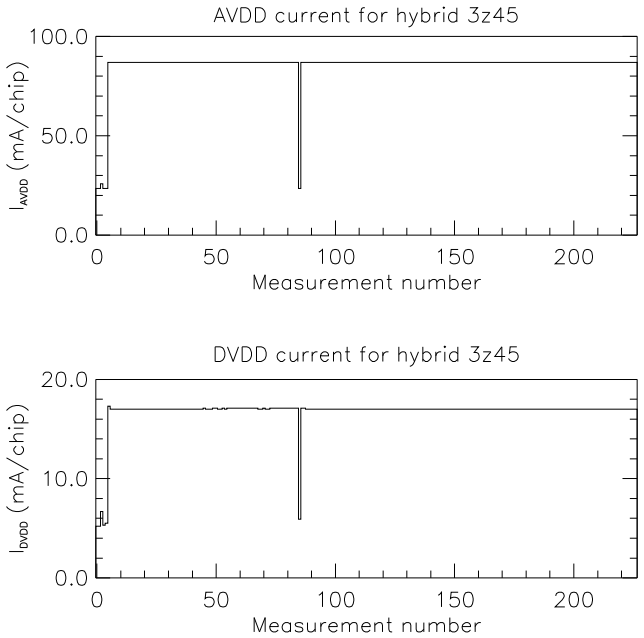
Supply Currents During Burn-in

The following plots show the supply currents per chip as a function of measurment number. Currents are measured approximately every 10 minutes:
