Hybrid 3z55 Traveler

March 2, 2000

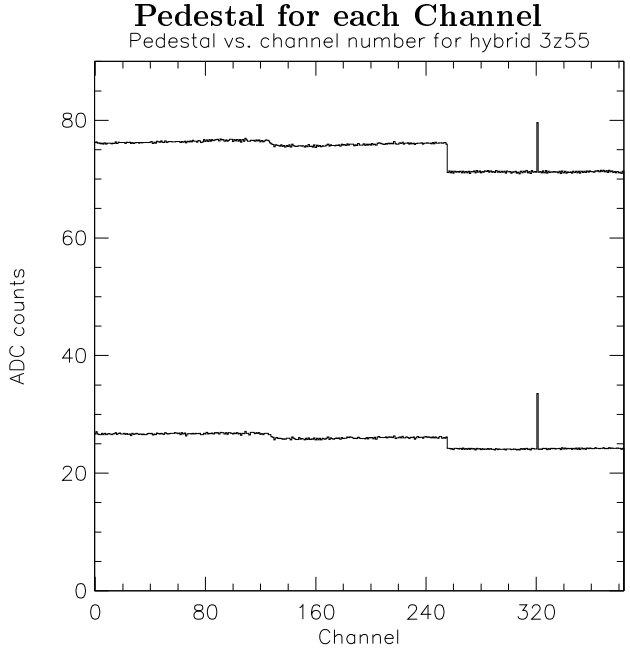
Pedestal for each Channel

The following plot shows the pedestals vs. channel number with and without charge injection:

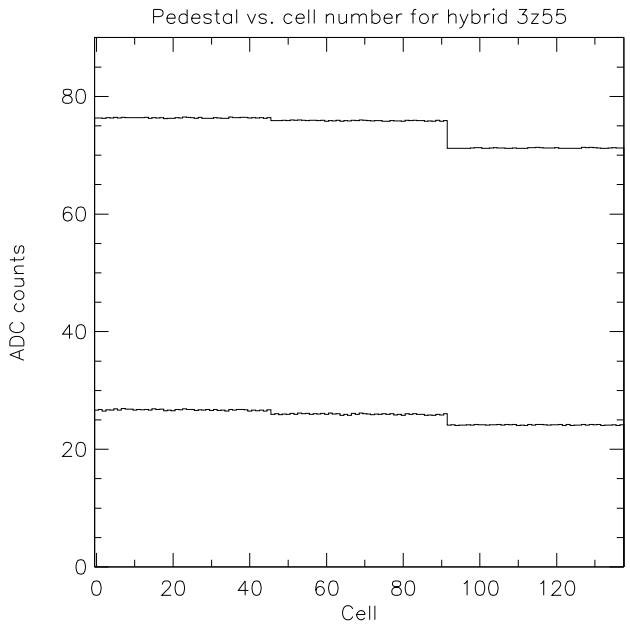
Pedestal vs. Pipeline Cell ID

The following plot shows the average pedestal vs. pipeline cell ID with and without charge injection. The x-axis is cell ID offset by 46 for each chip. Thus cell ID 5 for chip 1 is at x=5, chip 2 at x=51, chip 3 at x=97, etc.

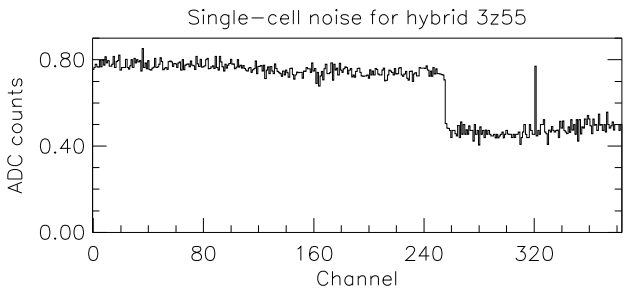
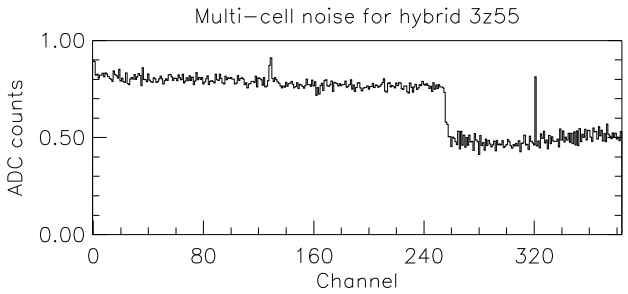
RMS Noise

The following plots show the single-cell and multi-cell RMS noise:

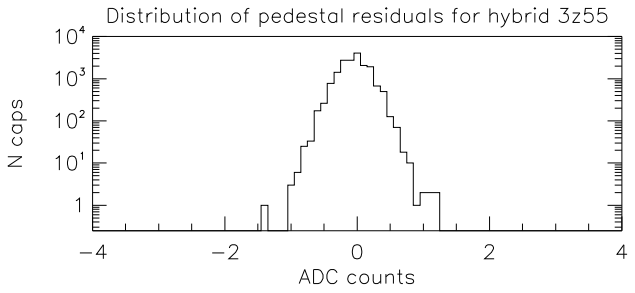
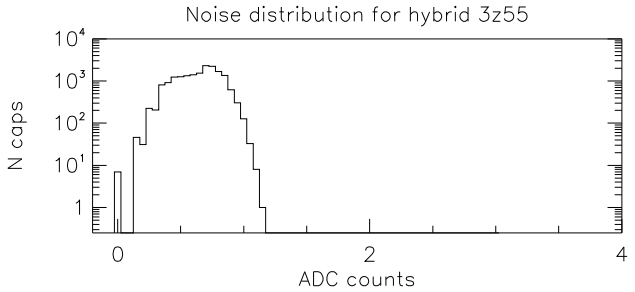
Distribution of Pedestals and Noise

The following are histograms of the pedestal of each pipeline capacitor relative to the chip average (top); and the RMS noise of each capacitor (bottom):

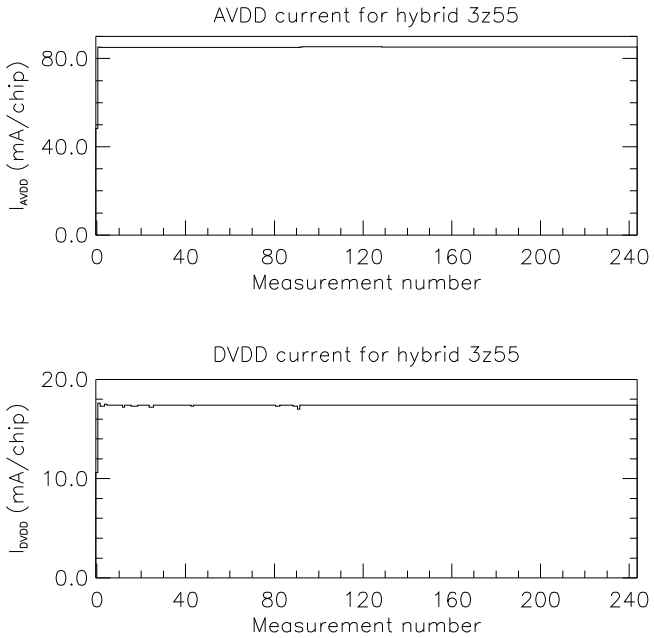
Supply Currents During Burn-in

The following plots show the supply currents per chip as a function of measurment number. Currents are measured approximately every 10 minutes:
